# DETERIORATION OF ELECTRICAL INSULATION OF MAIN MAGNET COILS FROM MAGNET G-1

Collider Accelerator Department  
**Brookhaven National Laboratory**

AGS DIVISION TECHNICAL NOTE

No. 70

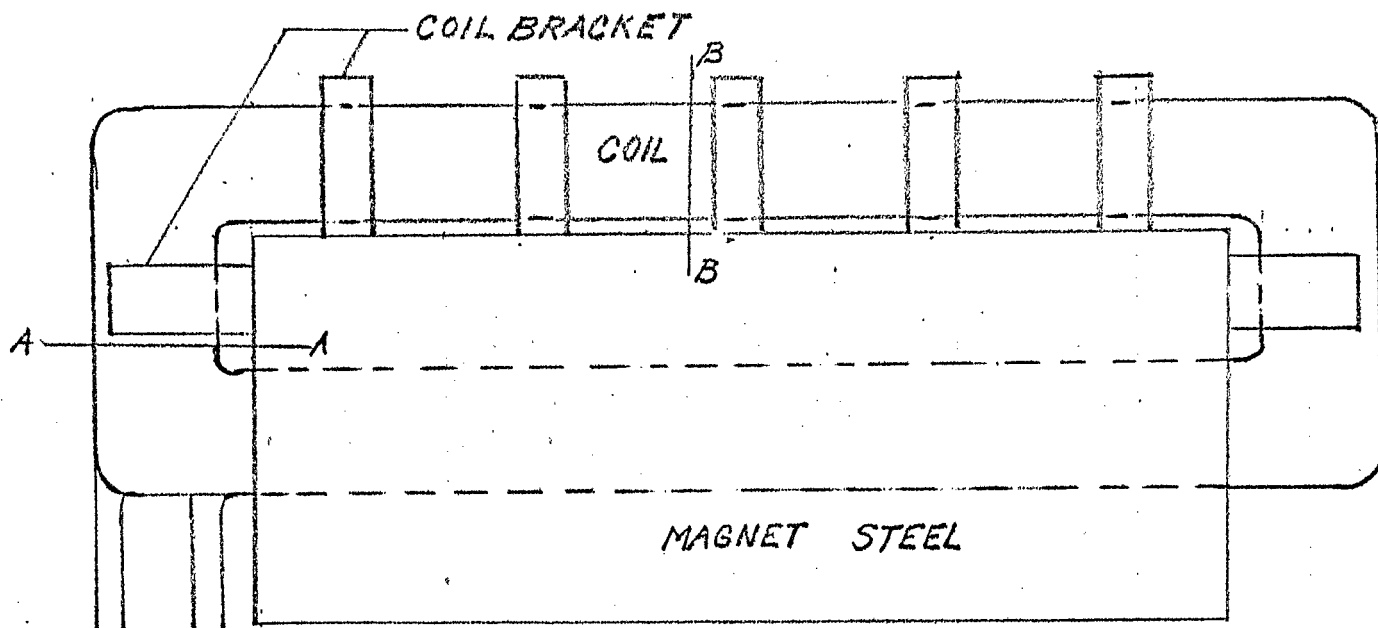
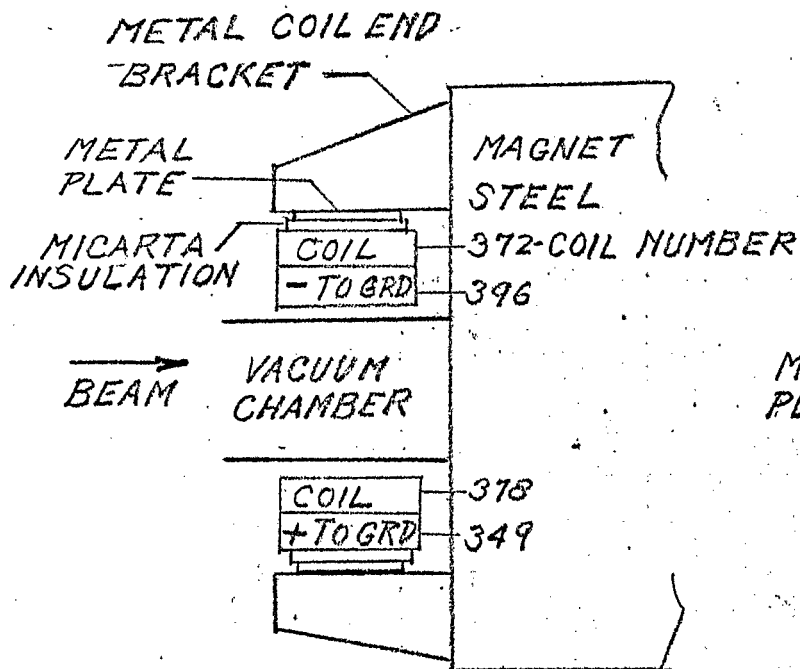
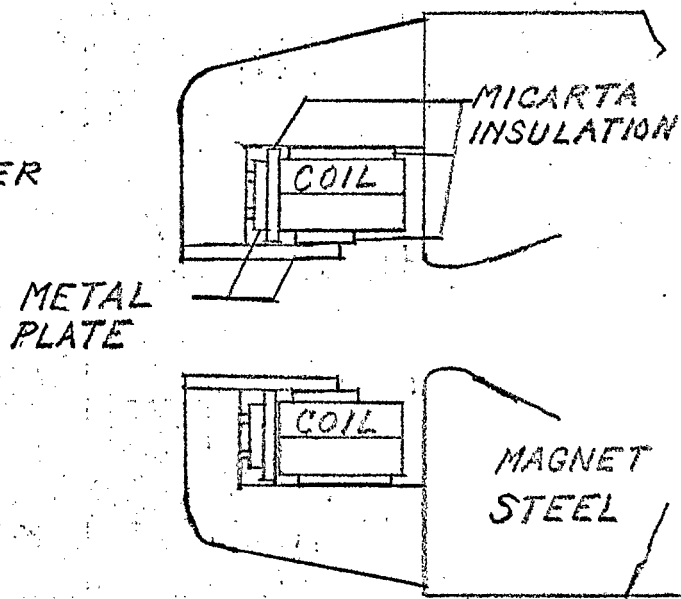
MAGNET G-1 PLAN

A sketch of the coil assembly on the magnet is shown in Fig. 1. Photographs of the burned areas are shown in Figs. 2, 3, 4, 5, 6 and 7. (The coil numbers are shown on Fig. 1.)

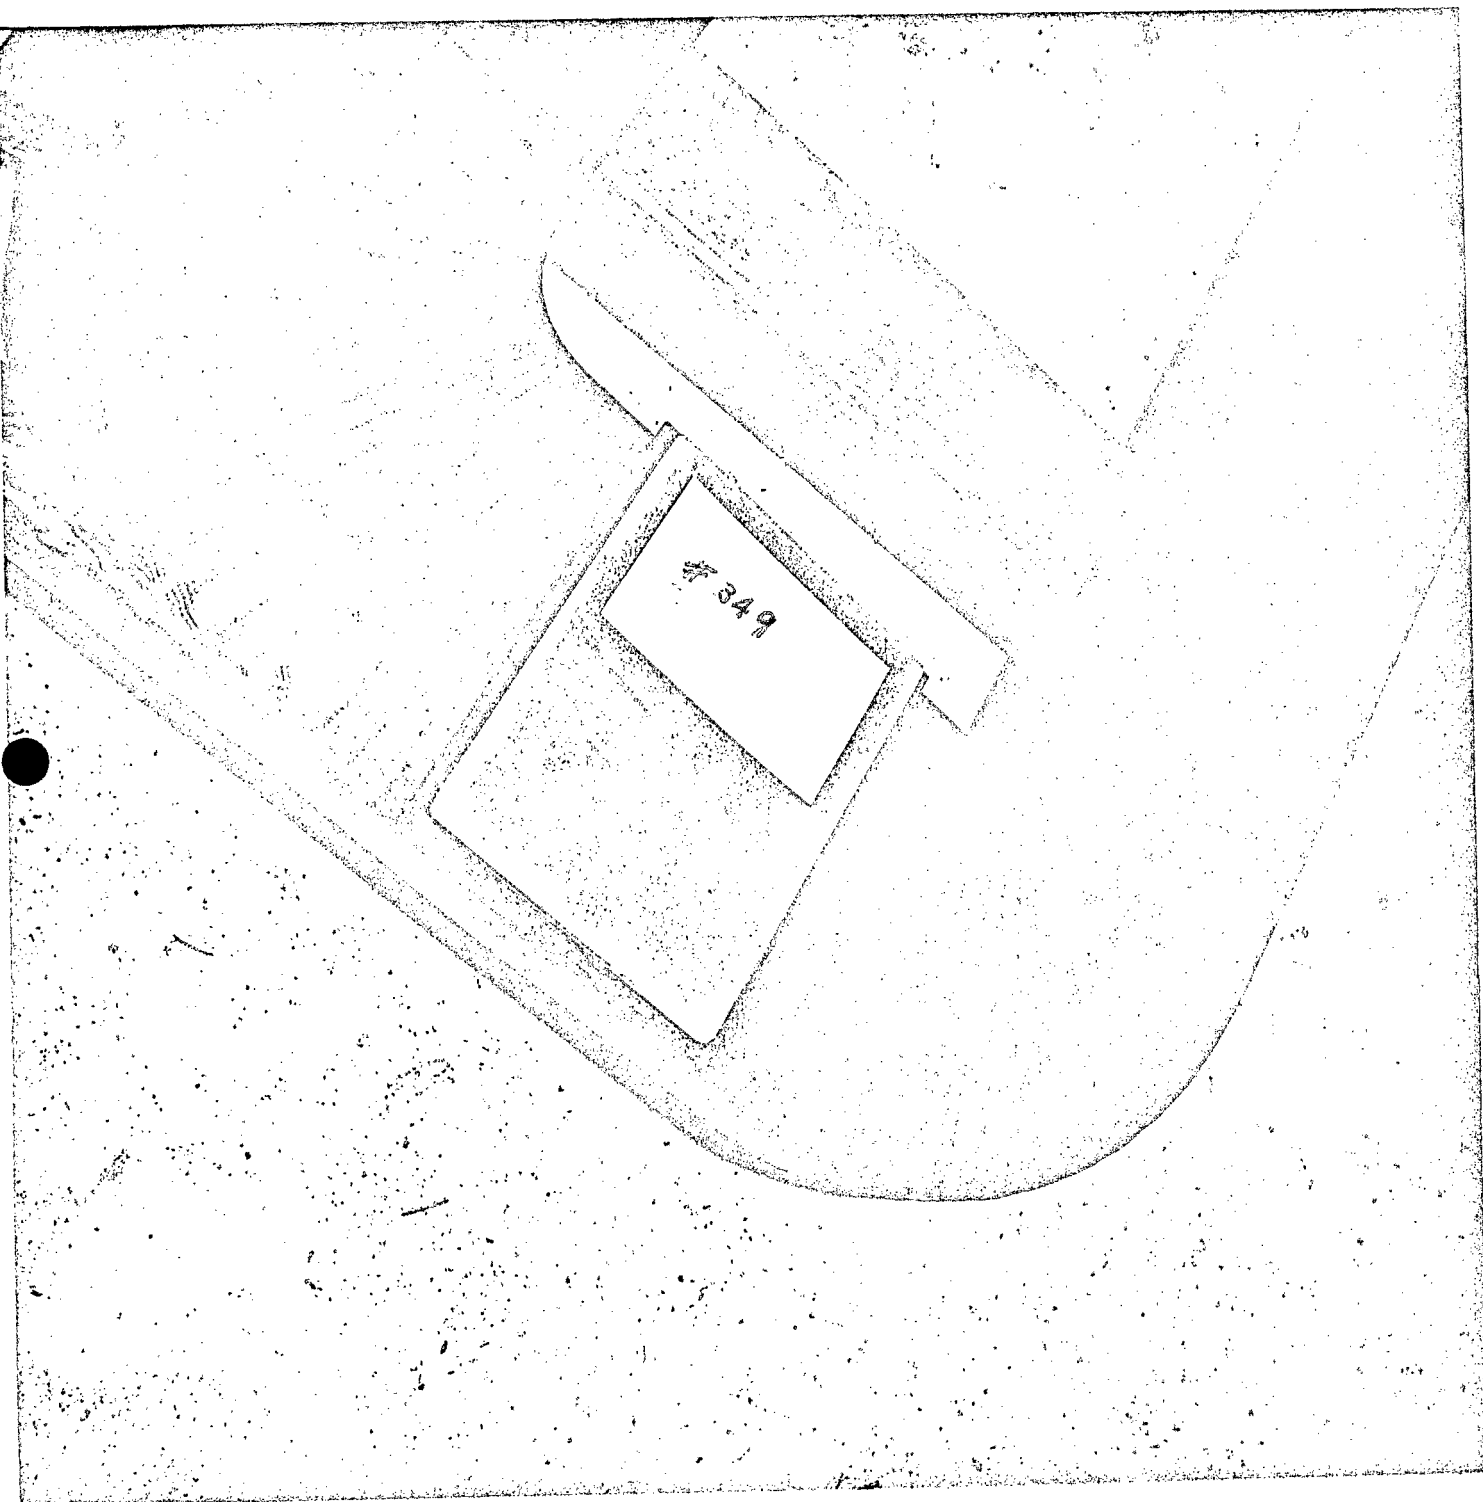
FIG 2

During a routine inspection of the coils on magnet G-1, some burning was noticed on the micarta insulating spacers at the up-stream bracket. The coils were removed. The burned spots were at areas at the edges of the micarta spacers under end brackets and one side bracket, (third from the up-stream end about the middle of the coil side).

The mica coil insulation at the burned areas was not punctured. Coil 372 at the burned area (using a 1-3/4 in. diameter electrode) withstood 6 kV ac for 15 seconds. Coil 349 at the burned area had too great a leakage current at 6 kV but withstood 3 kV for 30 seconds.

The micarta insulation had the appearance of being eroded. Coil 349 was positive to ground and coils 372 and 396 were negative to ground.

ASSEMBLED

New coils and micarta insulation had been put on the magnet before the tests reported herein were made. Changes were being made on magnet G-11 which is also in a high radiation area. It was decided, after discussions between Messrs. Czaja, Gefers, Grisoli, Plotkin and Rutan to use two mica plates with a film of Kapton (polyimide) between. The mica selected was NEMA Grade 9 rigid plate with inorganic bond. This provides the high resistance of mica to radiation and ionization (corona). The Kapton film has high radiation resistance and has a high fire resistance. This is a trial installation.
