# DETERIORATION OF ELECTRICAL INSULATION OF MAIN MAGNET COILS FROM MAGNET G-1

AGS DIVISION TECHNICAL NOTE

No. 70

DETERIORATION OF ELECTRICAL INSULATION  
OF MAIN MAGNET COILS FROM MAGNET G-1

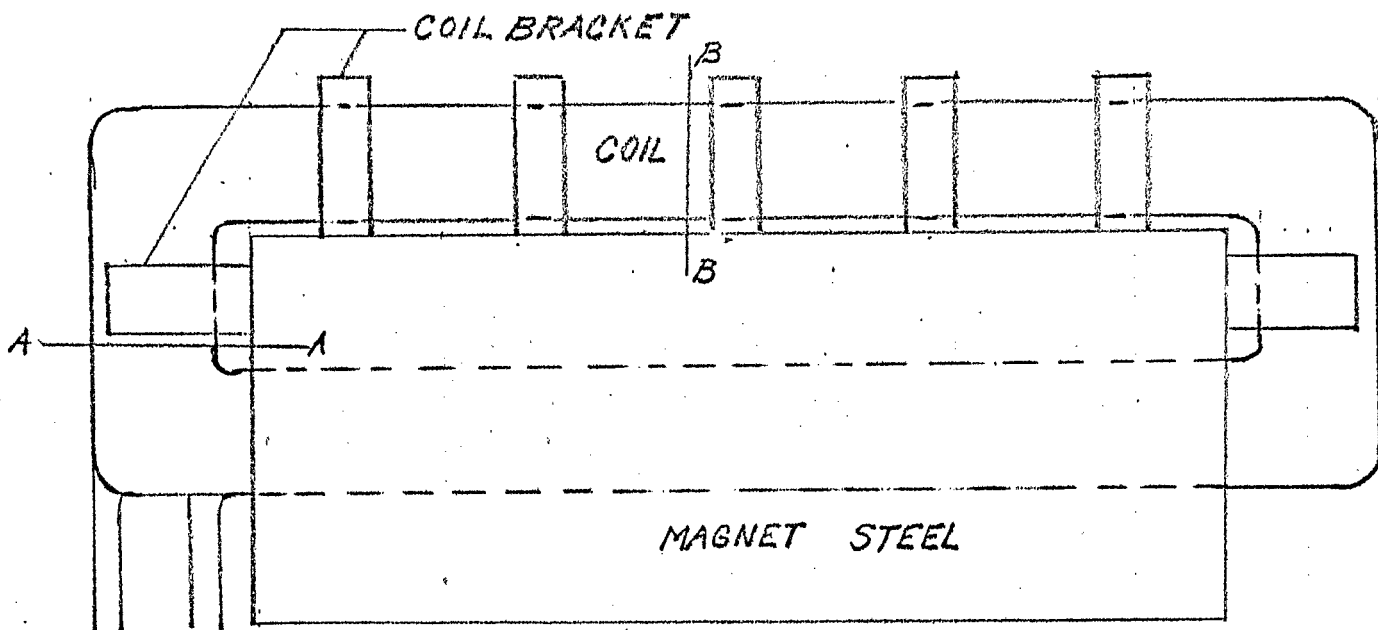
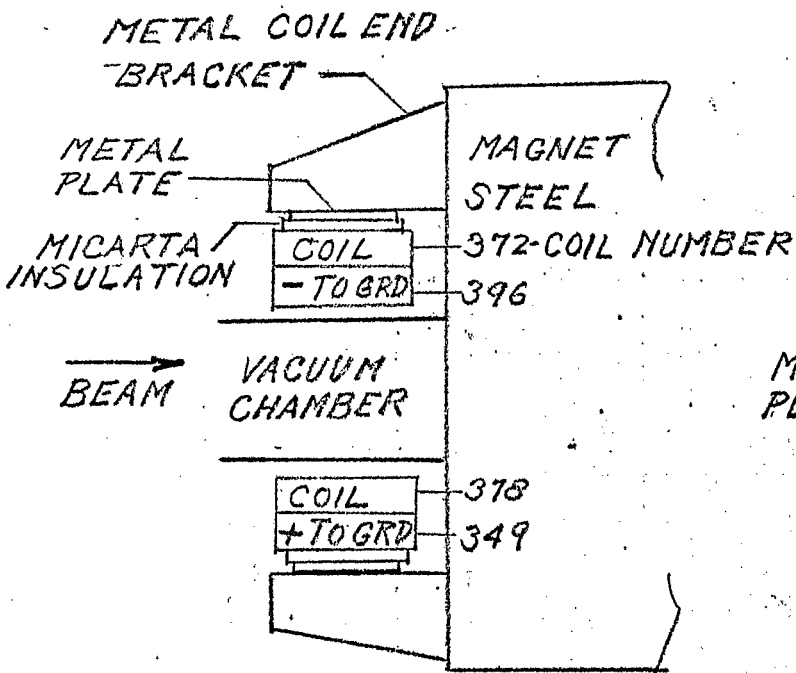
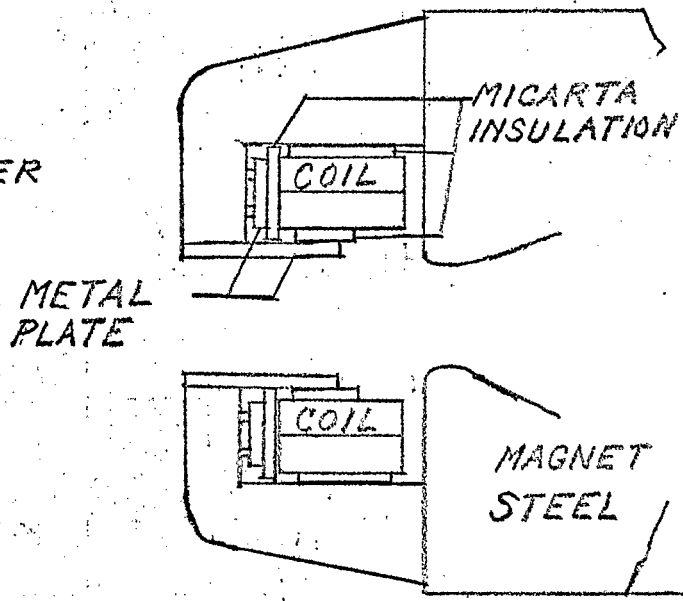
SUBJECT SCHEMATIC COIL MOUNTING - MAIN MAGNET - MICARTA INSULATION SPACERS

A sketch of the coil assembly on the magnet is shown in Fig. 1. Photographs of the burned areas are shown in Figs. 2, 3, 4, 5, 6 and 7. (The coil numbers are shown on Fig. 1.)
