DETERIORATION OF ELECTRICAL INSULATION OF MAIN MAGNET COILS FROM MAGNET G-1

Collider Accelerator Department
Brookhaven National Laboratory

AGS DIVISION TECHNICAL NOTE

No. 70

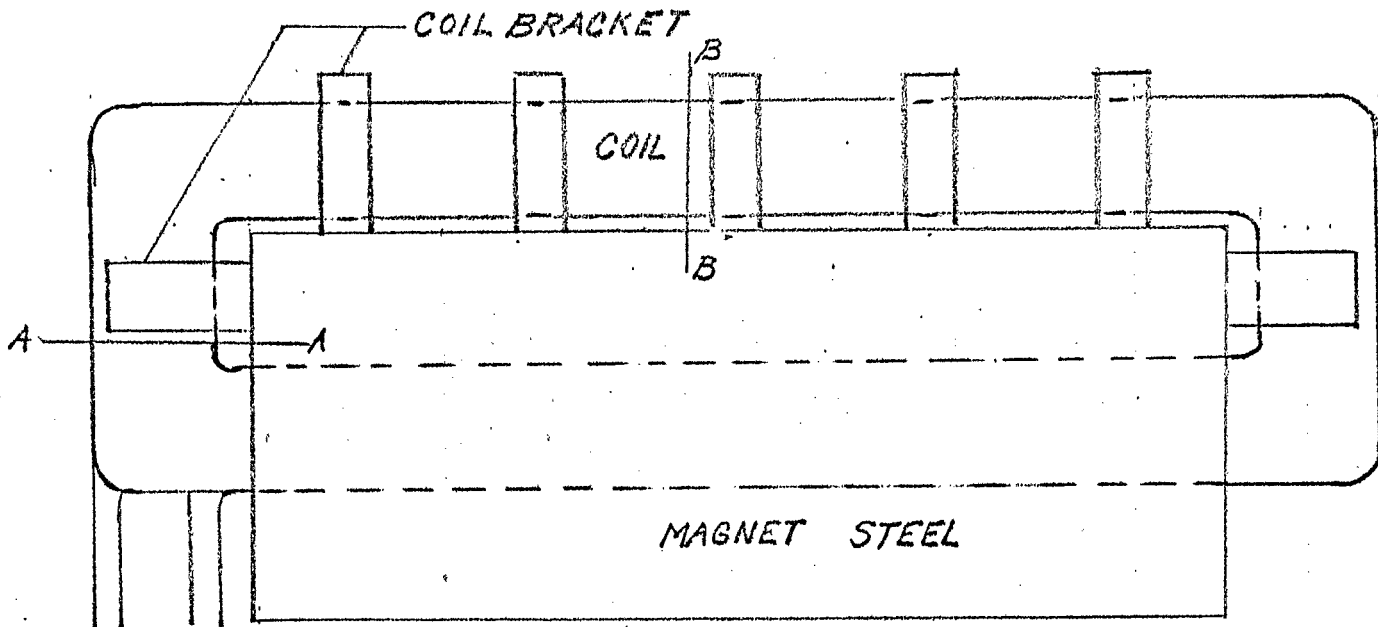
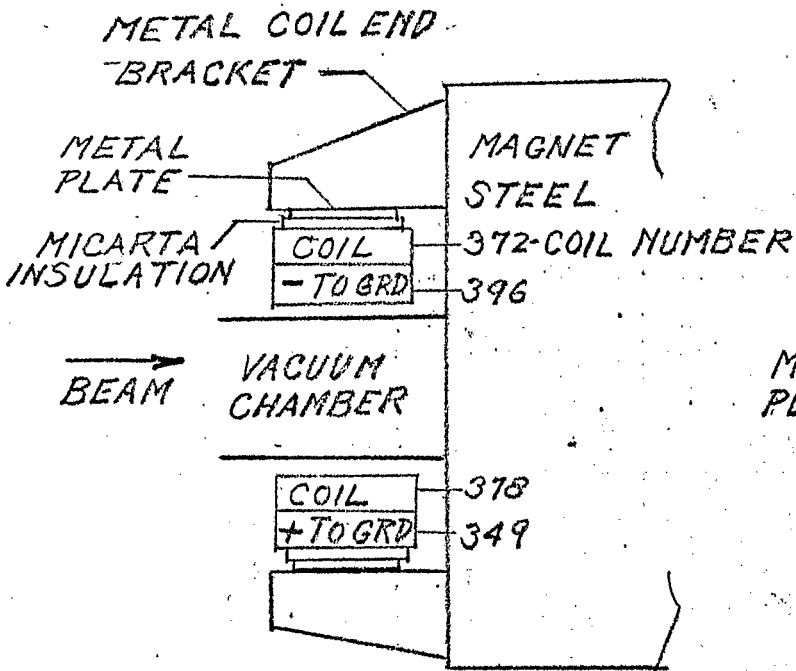
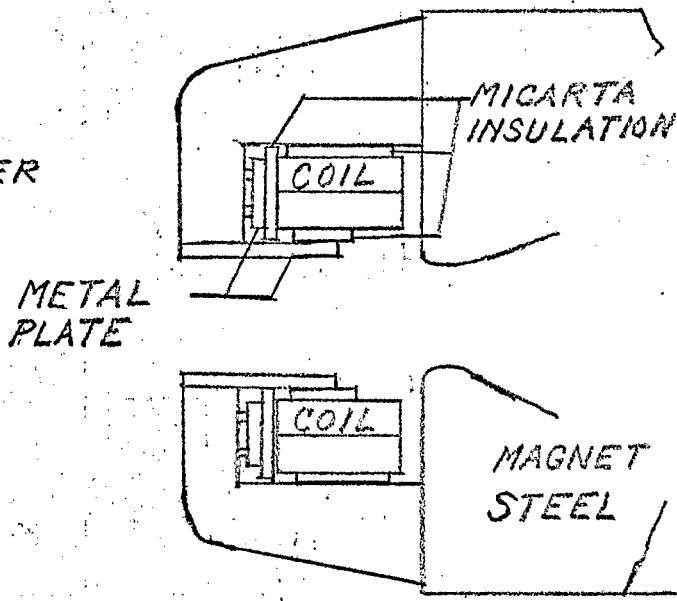
SUBJECT SCHEMATIC COIL MOUNTING - MAIN MAGNET - MICARTA INSULATION SPACERS

A sketch of the coil assembly on the magnet is shown in Fig. 1. Photographs of the burned areas are shown in Figs. 2, 3, 4, 5, 6 and 7. (The coil numbers are shown on Fig. 1.)
