INVESTIGATION OF NON-UNIFORM C-RING SEAL COMPRESSION IN AGS CONVERSION CHAMBERS

AGS DIVISION TECHNICAL NOTE

No. 81

J.C. Schuchman
September 28, 1970

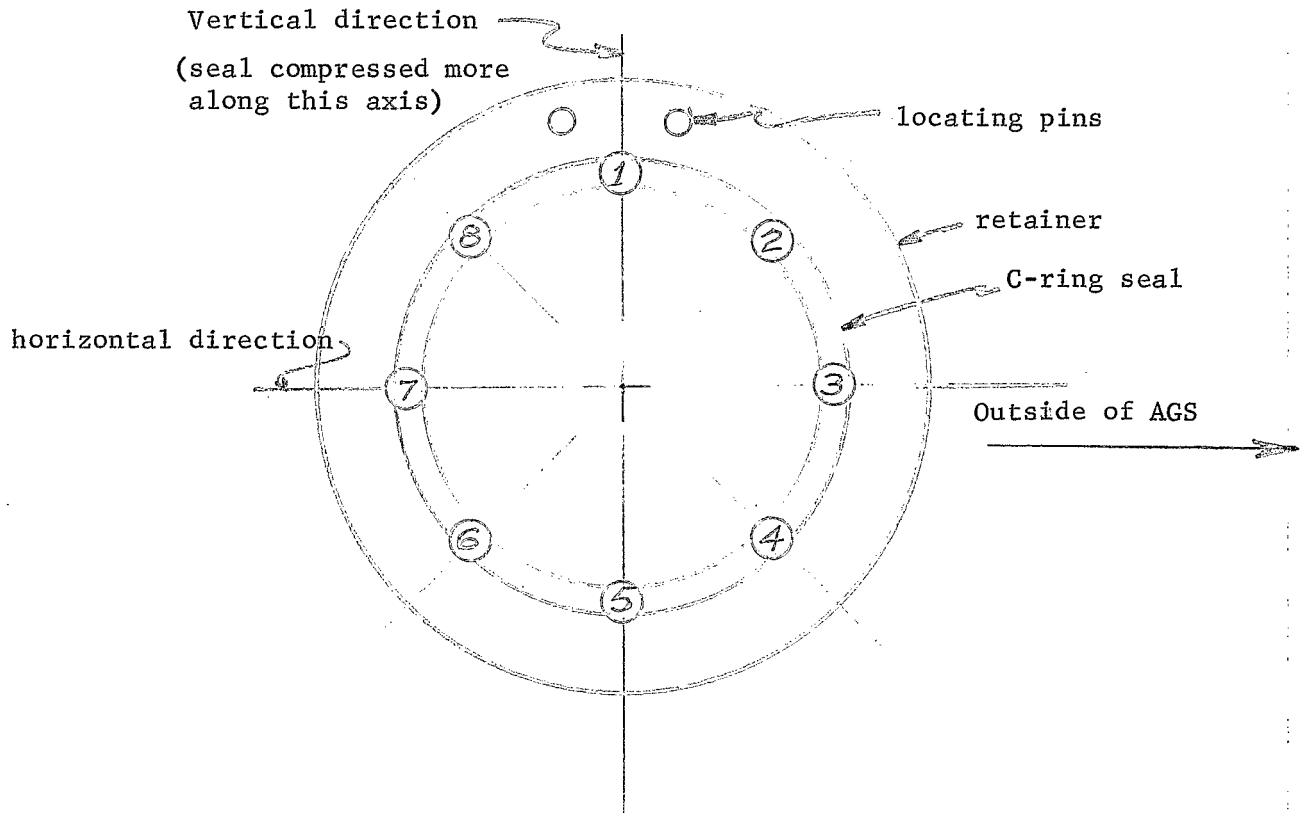
Fig. #1

The conversion C-ring seals, which were removed from the "C" super-period because of leaks, were measured for height. All the seals which were used in flanges clamped with Vee-band couplings consistently were compressed more along the vertical axis than along the horizontal, in some case up to .015 inches difference, see Fig. 1. The seals used in bolted joints, i.e., new chamber to old, were uniformly compressed, to about .003 inches.

Seal Location	Measuring Points								Max. Diff.
	1	2	3	4	5	6	7	8	
C-9	.175	-	.188	-	.178	-	.190	-	.015
C-8	.170	-	.175	-	.170	-	.169	-	.006
D-4	.176	.179	.187	.184	.179	.180	.188	.178	.012
D-6	.177	-	.182	-	.185	-	.175	-	.010
E-2	.174	-	.188	-	.175	-	.187	-	.014
* D-10	.173	-	.175	-	.174	-	.173	-	.002
*D-10 Bolted flange from rf cavity

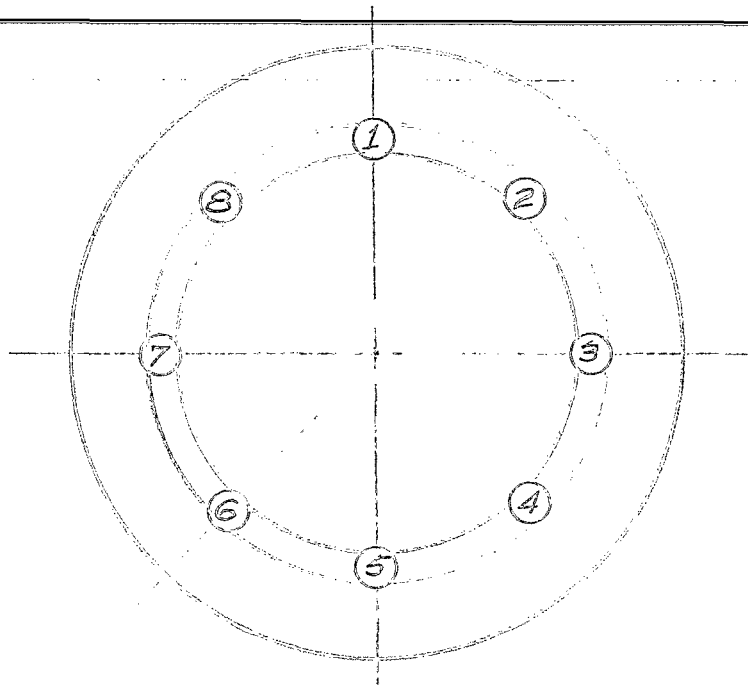
It is believed that this non-uniformity is directly related to seal leakage. Tests were made on standard conversion chambers which simulated ring conditions. Test results are shown in sketch #2.

The test results indicate that flange misalignment and clamp tightening procedure are the causes of non-uniform compression of the seal. The problem of flange misalignment is essentially resolved by using the spring-loaded locating plungers on the side of the clamp. Where space prohibits the use of these plungers the outer parts of this assembly can be removed after tightening the clamp.

Max. Diff.	Seal No.	Measuring Points								Conditions
		1	2	3	4	5	6	7	8	
.003	1	.176	.176	.177	.177	.178	.177	.176	.175	Unrestrained chambers
.001	2	-	.176	.177	.177	-	.177	.177	.177	Unrestrained chambers, clamp struck with mallet and retorqued.
.002	3	.178	.178	.180	.178	.179	.180	.180	.180	Restrained chambers.
.002	4	.176	.175	.177	.176	.175	.175	.175	.176	Unrestrained chambers, clamp struck and retorqued.
.007	5	.177	.183	.184	.179	.177	.180	.181	.177	Restrained chambers, clamp struck and retorqued, chambers under vacuum.
.010	6	.180	.188	.190	.183	.180	.181	.186	.182	Restrained chambers, clamp struck and retorqued, flanges offset 5/32 horizontally.
.004	7	.176	.179	.180	.177	.178	.178	.179	.178	Restrained chambers, clamp struck and retorqued, flanges offset, 5/32 under vacuum.
.002	8	.177	.180	.178	.178	.177	.178	.179	.178	Same as above, but with .005 shims on horizontal axis between flange and clamp

.004	9	.176	.180	.180	.177	.177	.178	.179	.178	Same as above but without shims.
.005	10	.180	.176	.177	.178	.179	.181	.181	.180	Same as seal #8.

With regard to tightening the clamp, it is essential that a torque wrench be used and a definite retorquing procedure be followed. The clamp should first be tightened to 250 in-lb, then the clamp should be "seated" by hitting it with a rawhide mallet and retorqued to 250 in-lbs. This procedure should be repeated once more with the chambers under vacuum.
