# INVESTIGATION OF NON-UNIFORM C-RING SEAL COMPRESSION IN AGS CONVERSION CHAMBERS

AGS DIVISION TECHNICAL NOTE

No. 81

J.C. Schuchman  
September 28, 1970

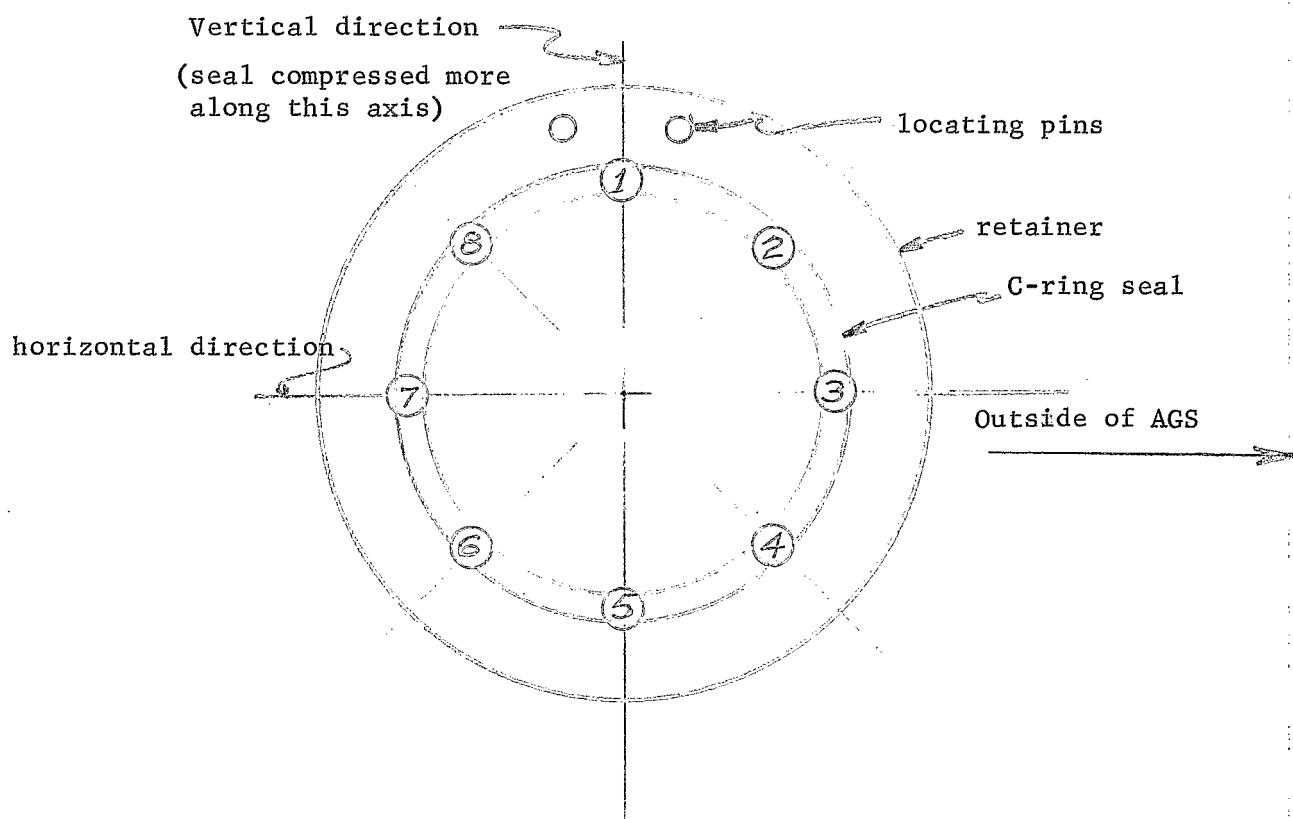
Fig. #1

The conversion C-ring seals, which were removed from the "C" super-period because of leaks, were measured for height. All the seals which were used in flanges clamped with Vee-band couplings consistently were compressed more along the vertical axis than along the horizontal, in some case up to .015 inches difference, see Fig. 1. The seals used in bolted joints, i.e., new chamber to old, were uniformly compressed, to about .003 inches.

Seal Location	Measuring Points								Max. Diff.
	1	2	3	4	5	6	7	8	
C-9	.175	-	.188	-	.178	-	.190	-	.015
C-8	.170	-	.175	-	.170	-	.169	-	.006
D-4	.176	.179	.187	.184	.179	.180	.188	.178	.012
D-6	.177	-	.182	-	.185	-	.175	-	.010
E-2	.174	-	.188	-	.175	-	.187	-	.014
* D-10	.173	-	.175	-	.174	-	.173	-	.002
*D-10 Bolted flange from rf cavity

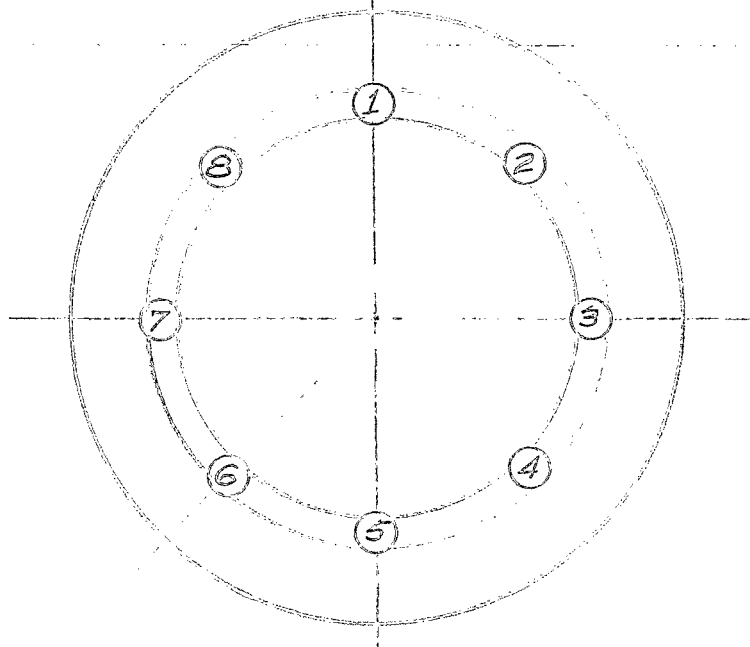
It is believed that this non-uniformity is directly related to seal leakage. Tests were made on standard conversion chambers which simulated ring conditions. Test results are shown in sketch #2.

The test results indicate that flange misalignment and clamp tightening procedure are the causes of non-uniform compression of the seal. The problem of flange misalignment is essentially resolved by using the spring-loaded locating plungers on the side of the clamp. Where space prohibits the use of these plungers the outer parts of this assembly can be removed after tightening the clamp.

Max. Diff.	Seal No.	Measuring Points								Conditions
		1	2	3	4	5	6	7	8	
.003	1	.176	.176	.177	.177	.178	.177	.176	.175	Unrestrained chambers
.001	2	-	.176	.177	.177	-	.177	.177	.177	Unrestrained chambers, clamp struck with mallet and retorqued.
.002	3	.178	.178	.180	.178	.179	.180	.180	.180	Restrained chambers.
.002	4	.176	.175	.177	.176	.175	.175	.175	.176	Unrestrained chambers, clamp struck and retorqued.
.007	5	.177	.183	.184	.179	.177	.180	.181	.177	Restrained chambers, clamp struck and retorqued, chambers under vacuum.
.010	6	.180	.188	.190	.183	.180	.181	.186	.182	Restrained chambers, clamp struck and retorqued, flanges offset 5/32 horizontally.
.004	7	.176	.179	.180	.177	.178	.178	.179	.178	Restrained chambers, clamp struck and retorqued, flanges offset, 5/32 under vacuum.
.002	8	.177	.180	.178	.178	.177	.178	.179	.178	Sames as above, but with .005 shims on horizontal axis between flange and clamp

.004	9	.176	.180	.180	.177	.177	.178	.179	.178	Same as above but without shims.
.005	10	.180	.176	.177	.178	.179	.181	.181	.180	Same as seal #8.

With regard to tightening the clamp, it is essential that a torque wrench be used and a definite retorquing procedure be followed. The clamp should first be tightened to 250 in-lb, then the clamp should be "seated" by hitting it with a rawhide mallet and retorqued to 250 in-lbs. This procedure should be repeated once more with the chambers under vacuum.
