# TESTS OF BRACKET AND COIL INSULATION - MAGNETS A-1, B-1, G-10, AND G-11 AFTER APRIL 1971 SHUTDOWN

AGS DIVISION TECHNICAL NOTE

No. 85

June 11, 1971

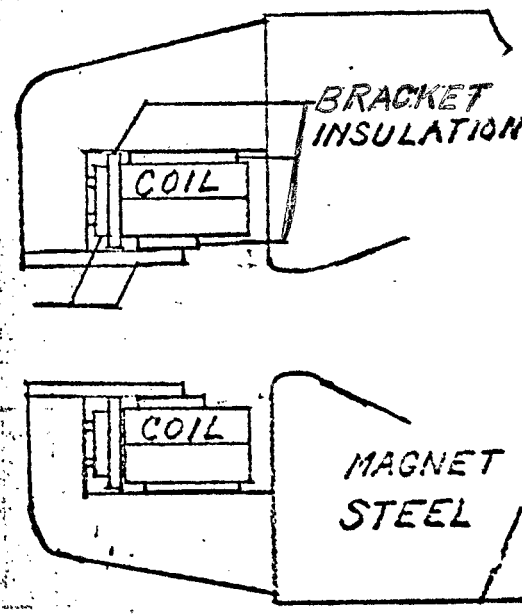
SUBJECT SCHEMATIC COIL MOUNTING - MAIN MAGNET - BRACKET INSULATION SPACERS

TEST LOCATION ①, ① - WHEN COILS ARE ASSEMBLED - TOP SURFACE OF TOP COIL AND TOP SURFACE OF TOP LOWER COIL

- 4) When making up the sandwich, the separate sheets shall be wiped clean and inspected for holes or foreign particles.
- 5) After the coils have been assembled on the magnet, surface and volume insulation resistance tests shall be measured following the procedure on Fig. 2 and Sheet No. 1 in the Appendix. The tests shall be made at locations 1A and B, 2, 5, 8A and B Fig. 1. This will serve as a bench mark for later after service tests.

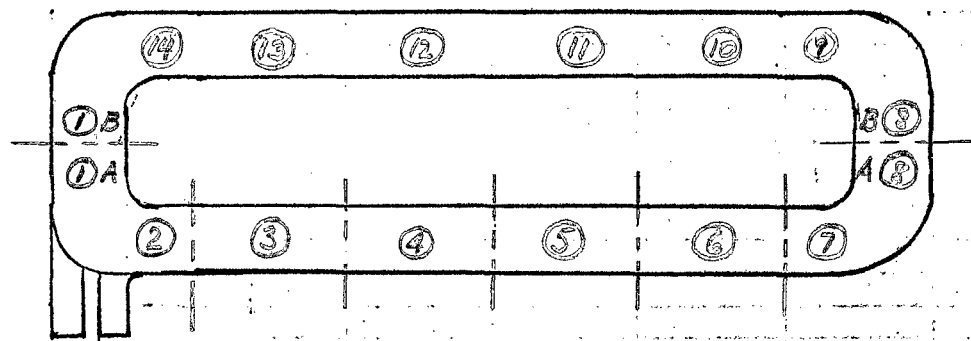
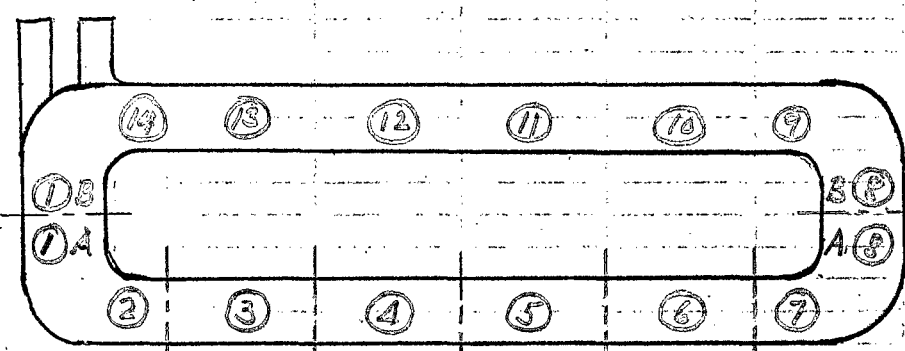
INSULATION TEST - MAIN MAGNET COILS  
LOCATION OF TEST ELECTRODES - ①  
WHEN COILS ARE NOT ASSEMBLED ON MAGNET  
LIST COIL NO., - POSITION, - SURFACE (TOP OR BOTTOM)

PROCEDURE - SURFACE INSULATION RESISTANCE

VOLUME INSULATION RESISTANCE

TEST - MEGGER - 1000, 2500, 5000 VOLTS

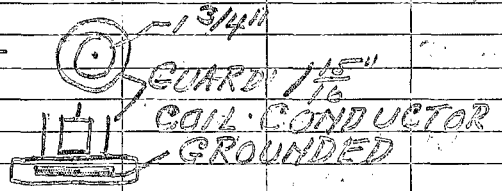
INSULATION RESISTANCE - MAGNET COILS - MAGNETS A-1 & B-1

On Sheet No. 1 tests of two coils on magnet A-1 are compared with two coils on magnet B-1. The differences are very marked. Although at present we do not have a definite value for rejecting magnet coils in service, the fact that the surface of coil 283 was burned prompted the decision to remove and replace these coils.

COIL NO	TEST LOCATION (SEE FIG 1)	SURFACE RES			VOLUME RES		
		1000V	2500V	5000V	1000V	2500V	5000V
A-1 283	1A	.4	.4	.3	4.0	2.6	2.7
NO MICARTA	2	1.2	.8	.6	2.5	3.7	3.0
TOP OF TOP	1B	.4	.3	.25	2.0	2.1*	2.4*
	14	60.	7.	3.3	9.0	7.0	5.0*
A-1 300	1A	.5	.3	.2*	2.0	1.7	2.5
TOP OF BOTTOM	2	1.2	.3	.3*	3.0	3.0*	2.7*
	1B	.3	.2	.2*	3.0	2.2	2.5
	14	.4	.35	.25	4.8	3.7*	3.0*

COIL 283  
 BURNED AREA ABOUT 1" x 3/8" ON TOP EDGE UNDER MICARTA UPSTREAM  
 END MICARTA ALSO BURNED (SEE DATA SHEET NO 2) COIL SURFACES  
 BROWNED  
 A-1 HAD BEEN IN A FORMER RADIATION AREA B-1 NOT A HOT AREA

B-1 COIL SURFACE VERY GOOD NO DISCOLORATION

RADIATION LEVEL 6/3/71 COIL 283 - 35 MR  
 B-1 MAGNET 20 MR
