AGS/AD/Tech Note No. 85;BNL-104518-2014-IR

TESTS OF BRACKET AND COIL INSULATION - MAGNETS A-1, B-1, G-10, AND G-11 AFTER APRIL 1971 SHUTDOWN

E. J. Rutan

June 1971

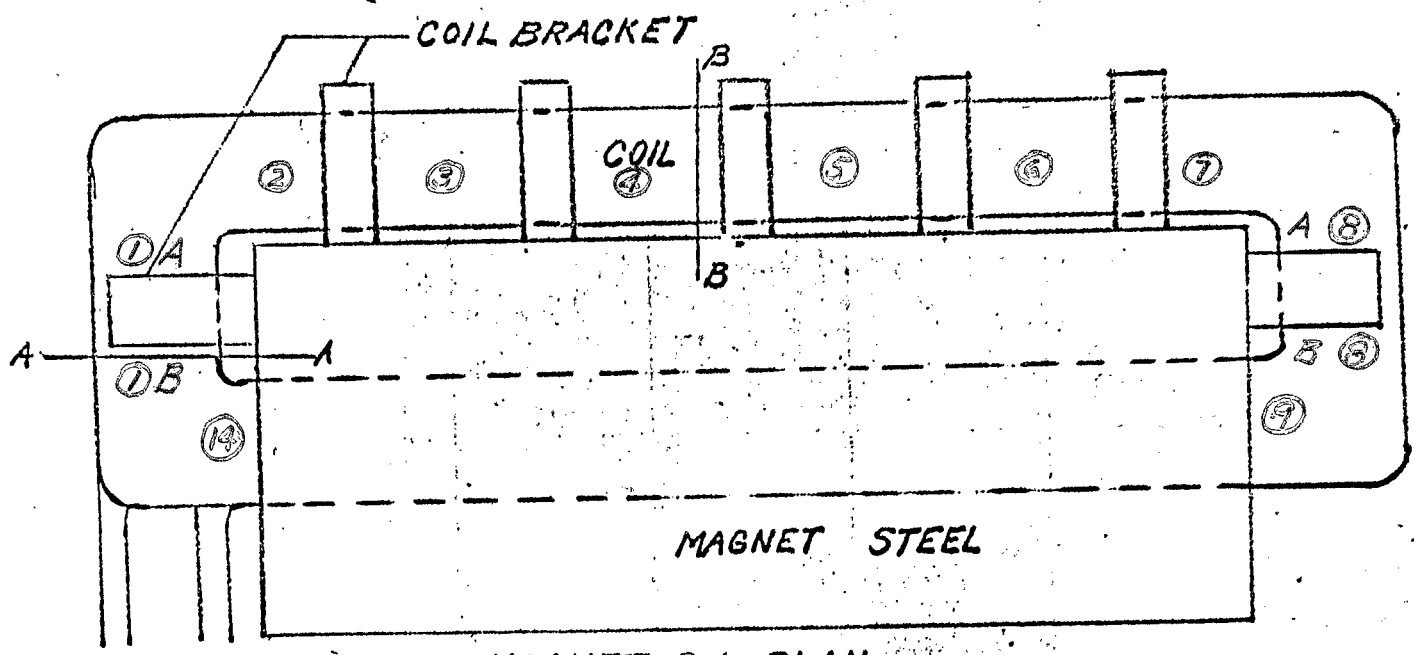
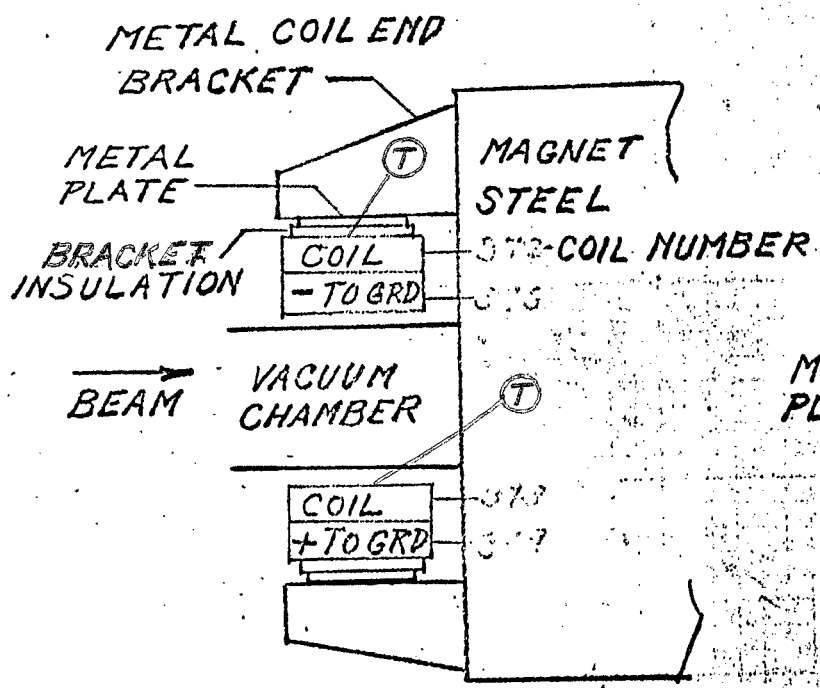
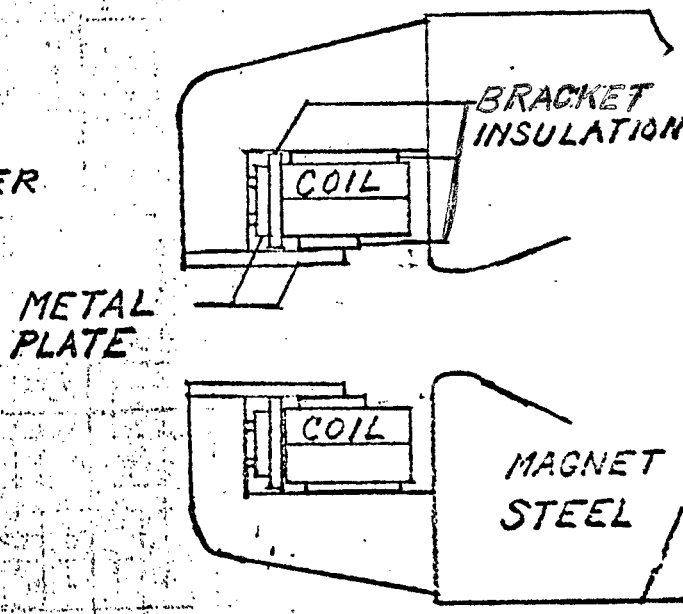
SUBJECT: SCHEMATIC COIL MOUNTING - MAIN MAGNET - BRACKET INSULATION SPACERS

TEST LOCATION ①, ① - WHEN COILS ARE ASSEMBLED - TOP SURFACE OF TOP COIL AND TOP SURFACE OF TOP LOWER COIL

- 4) When making up the sandwich, the separate sheets shall be wiped clean and inspected for holes or foreign particles.
- 5) After the coils have been assembled on the magnet, surface and volume insulation resistance tests shall be measured following the procedure on Fig. 2 and Sheet No. 1 in the Appendix. The tests shall be made at locations 1A and B, 2, 5, 8A and B Fig. 1. This will serve as a bench mark for later after service tests.

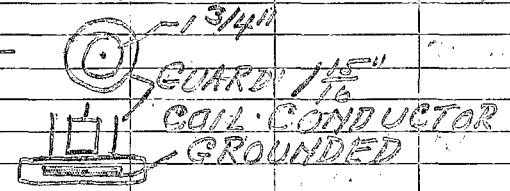
INSULATION RESISTANCE - MAGNET COILS - MAGNETS A-1 & B-1

On Sheet No. 1 tests of two coils on magnet A-1 are compared with two coils on magnet B-1. The differences are very marked. Although at present we do not have a definite value for rejecting magnet coils in service, the fact that the surface of coil 283 was burned prompted the decision to remove and replace these coils.

COIL 283
 BURNED AREA ABOUT 1" x 3/8" ON TOP EDGE UNDER MICARTA UPSTREAM
 END MICARTA ALSO BURNED (SEE DATA SHEET NO 2) COIL SURFACES
 BROWNED
 A-1 HAD BEEN IN A FORMER RADIATION AREA B-1 NOT A HOT AREA

B-1 COIL SURFACE VERY GOOD NO DISCOLORATION
