TESTS OF BRACKET AND COIL INSULATION - MAGNETS A-1, B-1, G-10, AND G-11 AFTER APRIL 1971 SHUTDOWN

June 1971

AGS DIVISION TECHNICAL NOTE

No. 85

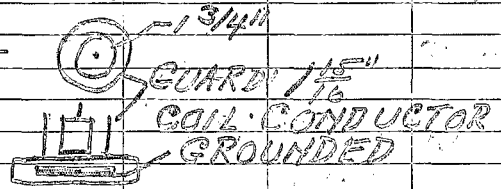
INSULATION RESISTANCE-MAGNET COILS- MAGNETS A-1 & B-1

COIL NO	TEST LOCATION (SEE FIG 1)	SURFACE RES			VOLUME RES		
		1000V	2500V	5000V	1000V	2500V	5000V
A-1 283 NO MICARTA	1A	.4	.4	.3	4.0	2.6	2.7
	2	1.2	.8	.6	2.5	3.7	3.0
	1B	.4	.3	.25	2.0	2.1*	2.4*
	14	60.	7.	3.3	9.0	7.0	5.0*
A-1 300	1A	.5	.3	.2*	2.0	1.7	2.5
	2	.2	.3	.3*	3.0	3.0*	2.7*
	1B	.3	.2	.2*	3.0	2.2	2.5
	14	.4	.35	.25	4.8	3.7*	3.0*

COIL 283

BURNED AREA ABOUT 1" x 3/8" ON TOP EDGE UNDER MICARTA UPSTREAM
 END MICARTA ALSO BURNED (SEE DATA SHEET NO 2) COIL SURFACES
 BROWNED
 A-1 HAD BEEN IN A FORMER RADIATION AREA B-1 NOT A HOT AREA

B-1 COIL SURFACE VERY GOOD NO DISCOLORATION
