**TESTS OF BRACKET AND COIL INSULATION - MAGNETS A-1, B-1,  
G-10, AND G-11 AFTER APRIL 1971 SHUTDOWN**

AGS DIVISION TECHNICAL NOTE

No. 85

TESTS OF BRACKET AND COIL INSULATION - MAGNETS A-1,  
B-1, G-10, AND G-11 AFTER APRIL 1971 SHUTDOWN

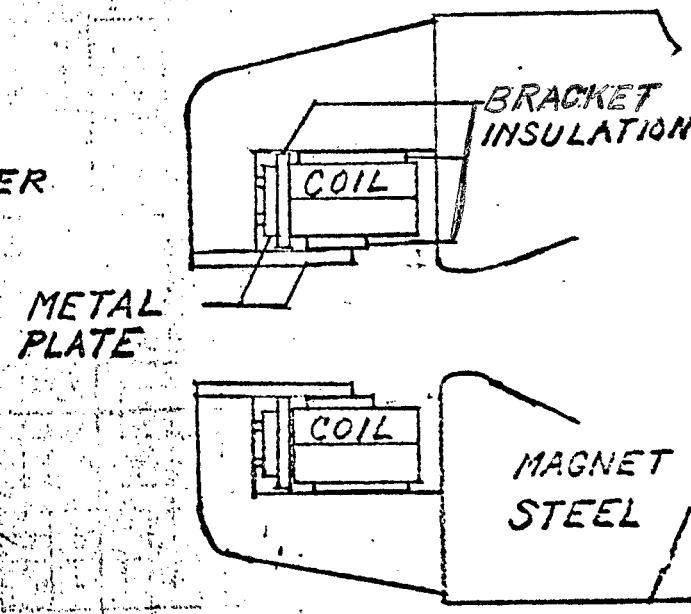
SUBJECT SCHEMATIC COIL MOUNTING - MAIN MAGNET - BRACKET INSULATION SPACERS

TEST LOCATION ①, ① - WHEN COILS ARE ASSEMBLED - TOP SURFACE OF TOP COIL AND TOP SURFACE OF TOP LOWER COIL

- 4) When making up the sandwich, the separate sheets shall be wiped clean and inspected for holes or foreign particles.
- 5) After the coils have been assembled on the magnet, surface and volume insulation resistance tests shall be measured following the procedure on Fig. 2 and Sheet No. 1 in the Appendix. The tests shall be made at locations 1A and B, 2, 5, 8A and B Fig. 1. This will serve as a bench mark for later after service tests.
