SIEMENS POWER SUPPLY MOTOR-GENERATOR SET MOTOR ROTOR FAILURE

AGS DIVISION TECHNICAL NOTE

No. 99

September 29, 1972

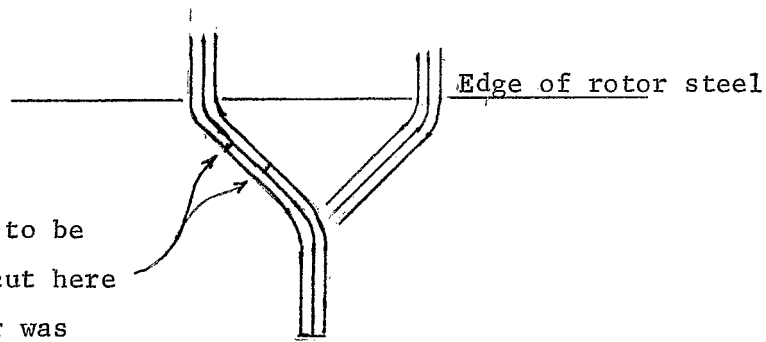
The coil to be repaired was cut here and new copper was

brazed with staggered joints as shown. The brazed joints were then ground to bar size. The repair work on the coil was completed on this day and it is an excellent job.

The repair will be done by brazing using fifteen percent (15%) silver.

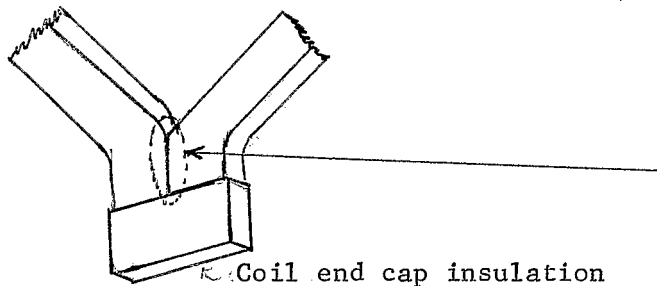
The coil end connection has a small space between coils in this area which allows dirt to collect and shorten the creepage path to conductors.

under the end cap insulation. The major portion of the fault was in this area. All end cap insulation will have this space filled with an epoxy and the complete area will be insulated with glass tape and epoxy.

Siemens "epoxy mica paint" will be used over the glass tape/epoxy insulation between the slip rings.

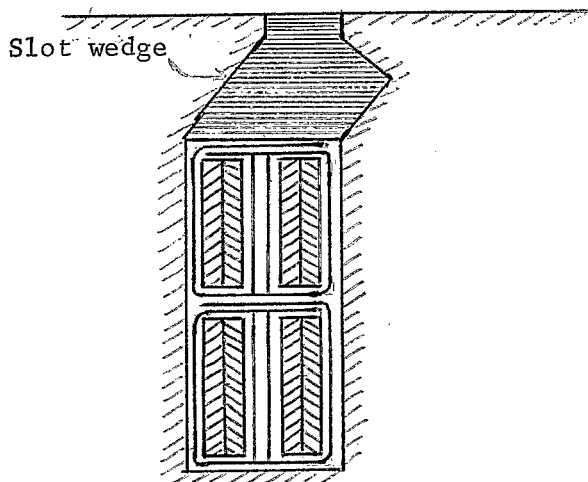
The old slot liner insulation was folded over at the top of the bottom coil and a new U shaped liner insulation was installed with the upper coil.

All coil end cap insulators were filled with epoxy in addition to the space between coils and each connectors. They were then glass taped and epoxyed. The epoxy used to fill the end caps is Astro Chemical Co., Schenectady, New York, "Barco Bond" two part mix equal of each. The glass tape is held in place with Scotch Grip #1300L adhesive.

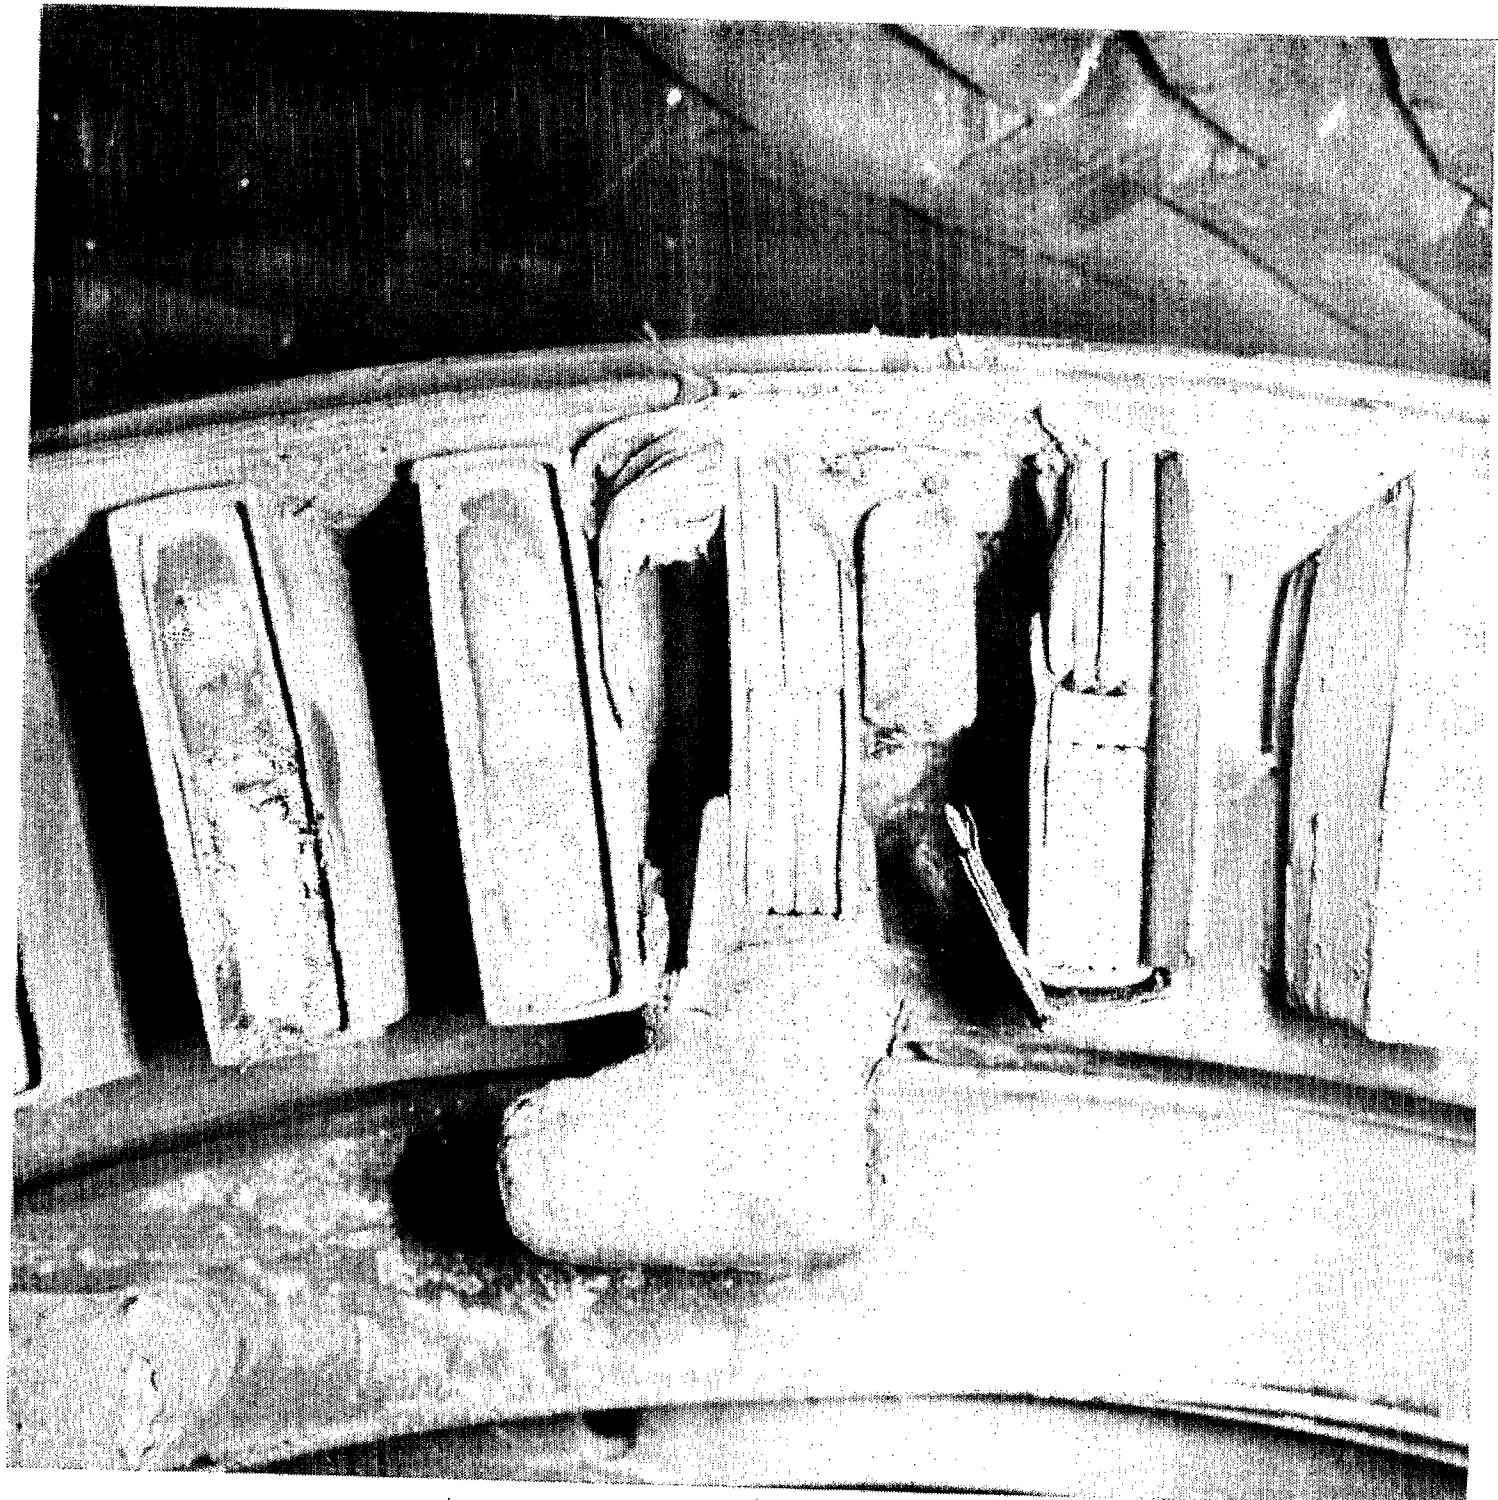
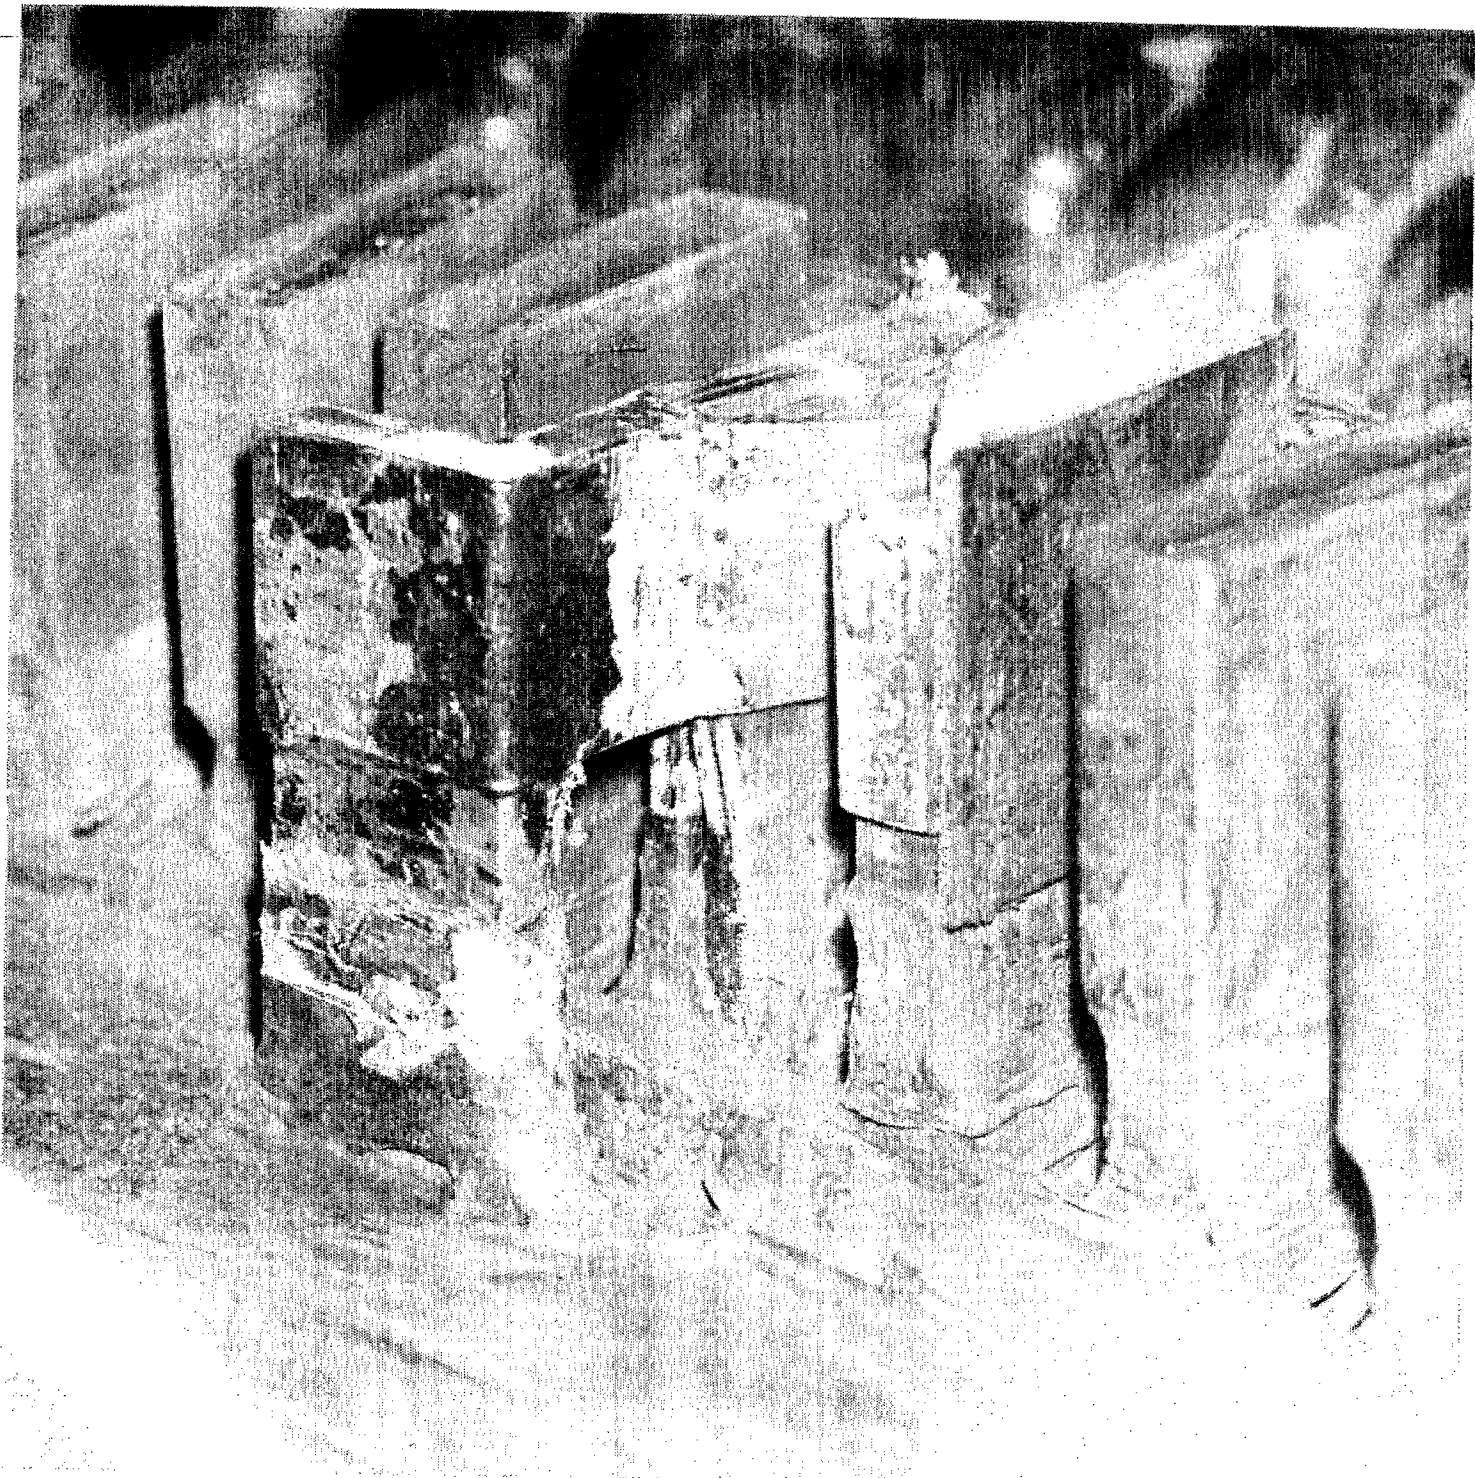
After removing the slip-ring cover and the motor end shields, it was found that one or two rotor winding end connections and the rotor to slip-ring connections were severely burned. Figures 2 to 6 show different views of the external damage at the rotor winding end connections, and Figs. 7 to 9 show the physical damage at the rotor to slip-ring connections.

When the fault occurred, the heat generated by the fault melted the solder which was thrown outward centrifugally on the end turns of the stator coils and inside the motor end shields. No damage was done to the stator coils. Extensive arc erosion took place on one of the rotor half coil ends. The copper evaporated. The fault was phase to phase. The area of the damage is shown circled in red on Siemens drawing number TRA-W 1827/1. At the rotor winding to slip-ring connections, the arc occurred from the bolted joint (rotor winding connection bar to slip-ring bars) to the shaft and slip-ring assembly guard ring which is at the same potential as the shaft. The heat generated by the arc melted the connection solder which was thrown out centrifugally to the inside of the outer motor end shield.

The coil insulation at the slip-ring end of the rotor (where the fault occurred) which is under the retaining ring is extremely dirty with carbon

from the brushes. This is an area that is very difficult to clean and it is evident that the dirt was a major cause of the fault or arc-over between phases.

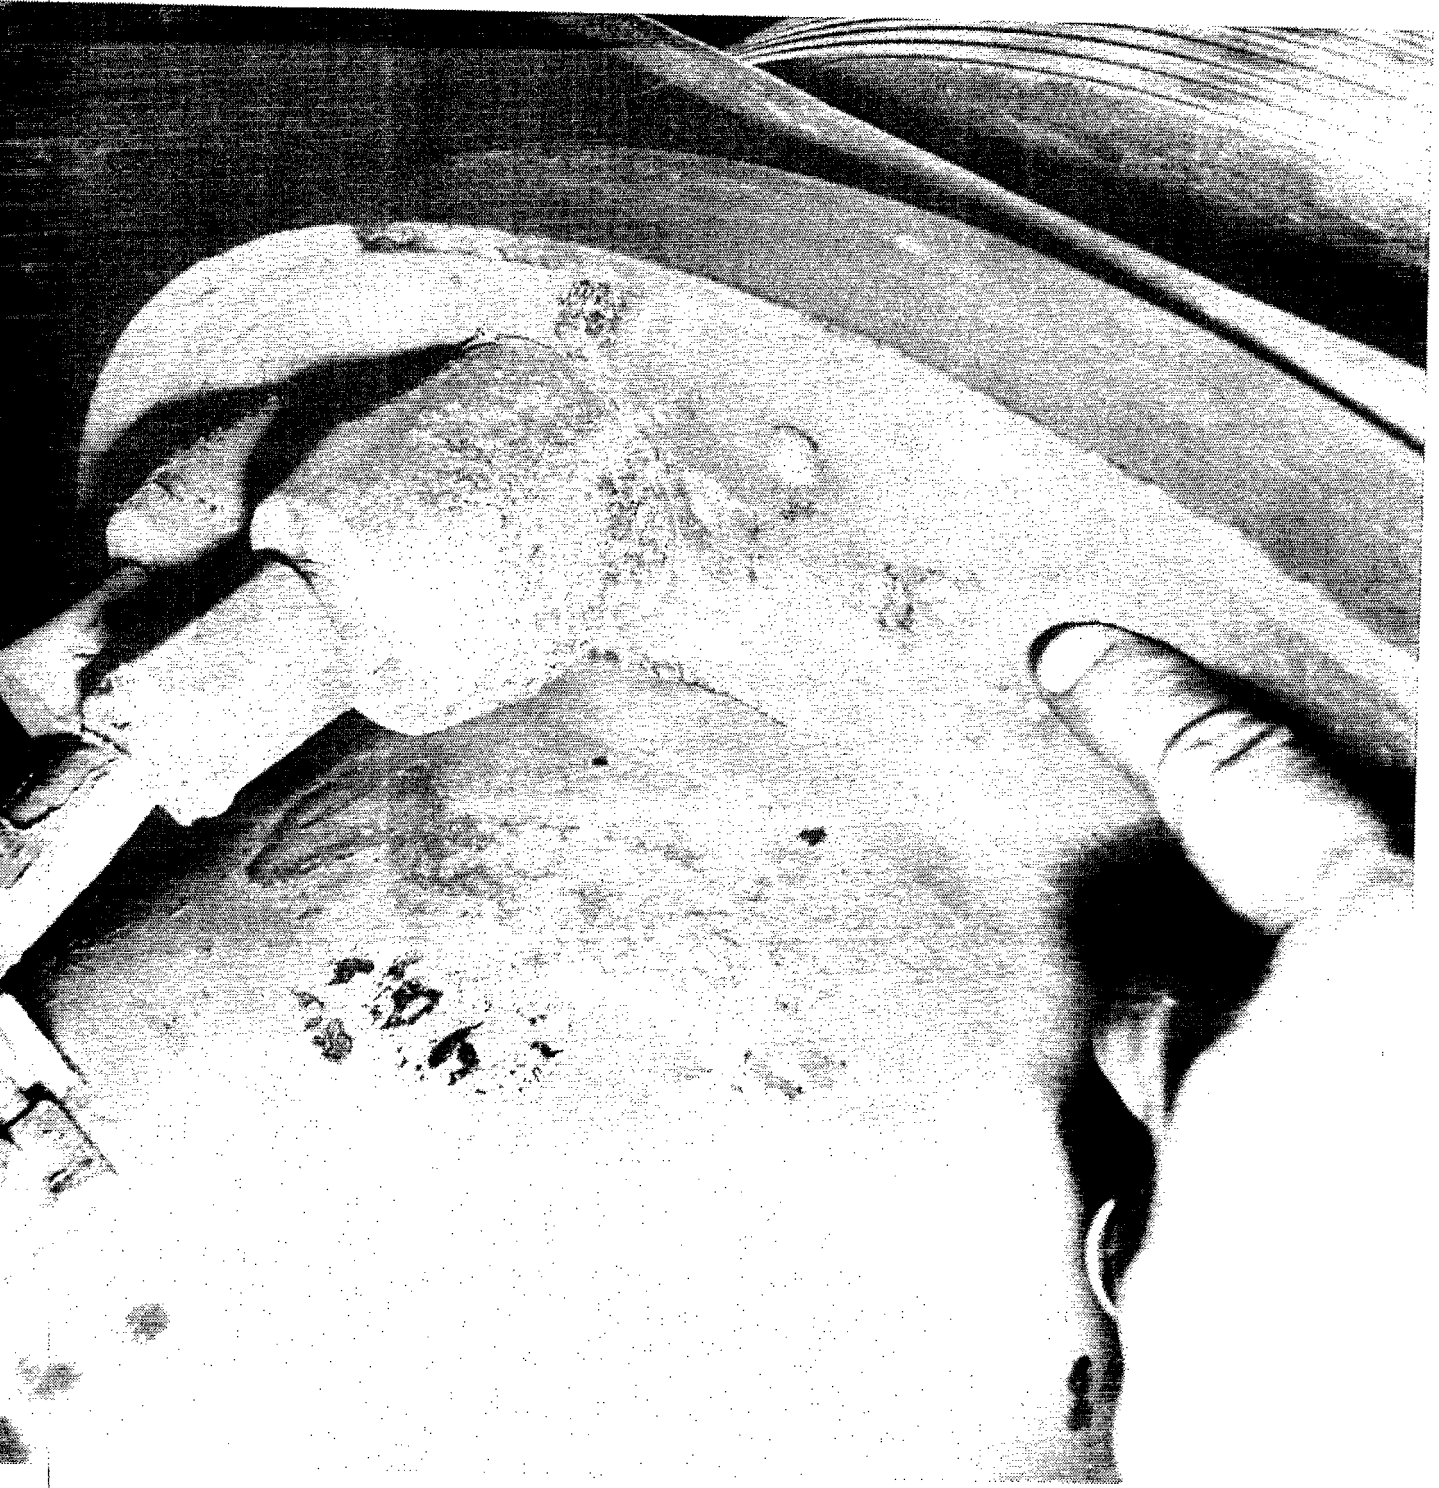
The connector bolts at the connection between the slip-ring bars and the rotor winding connecting strap were too long and thus too close to the shaft. The bolts will be turned around to get more clearance to the shaft and the shaft in this area will be insulated with glass tape and epoxy.

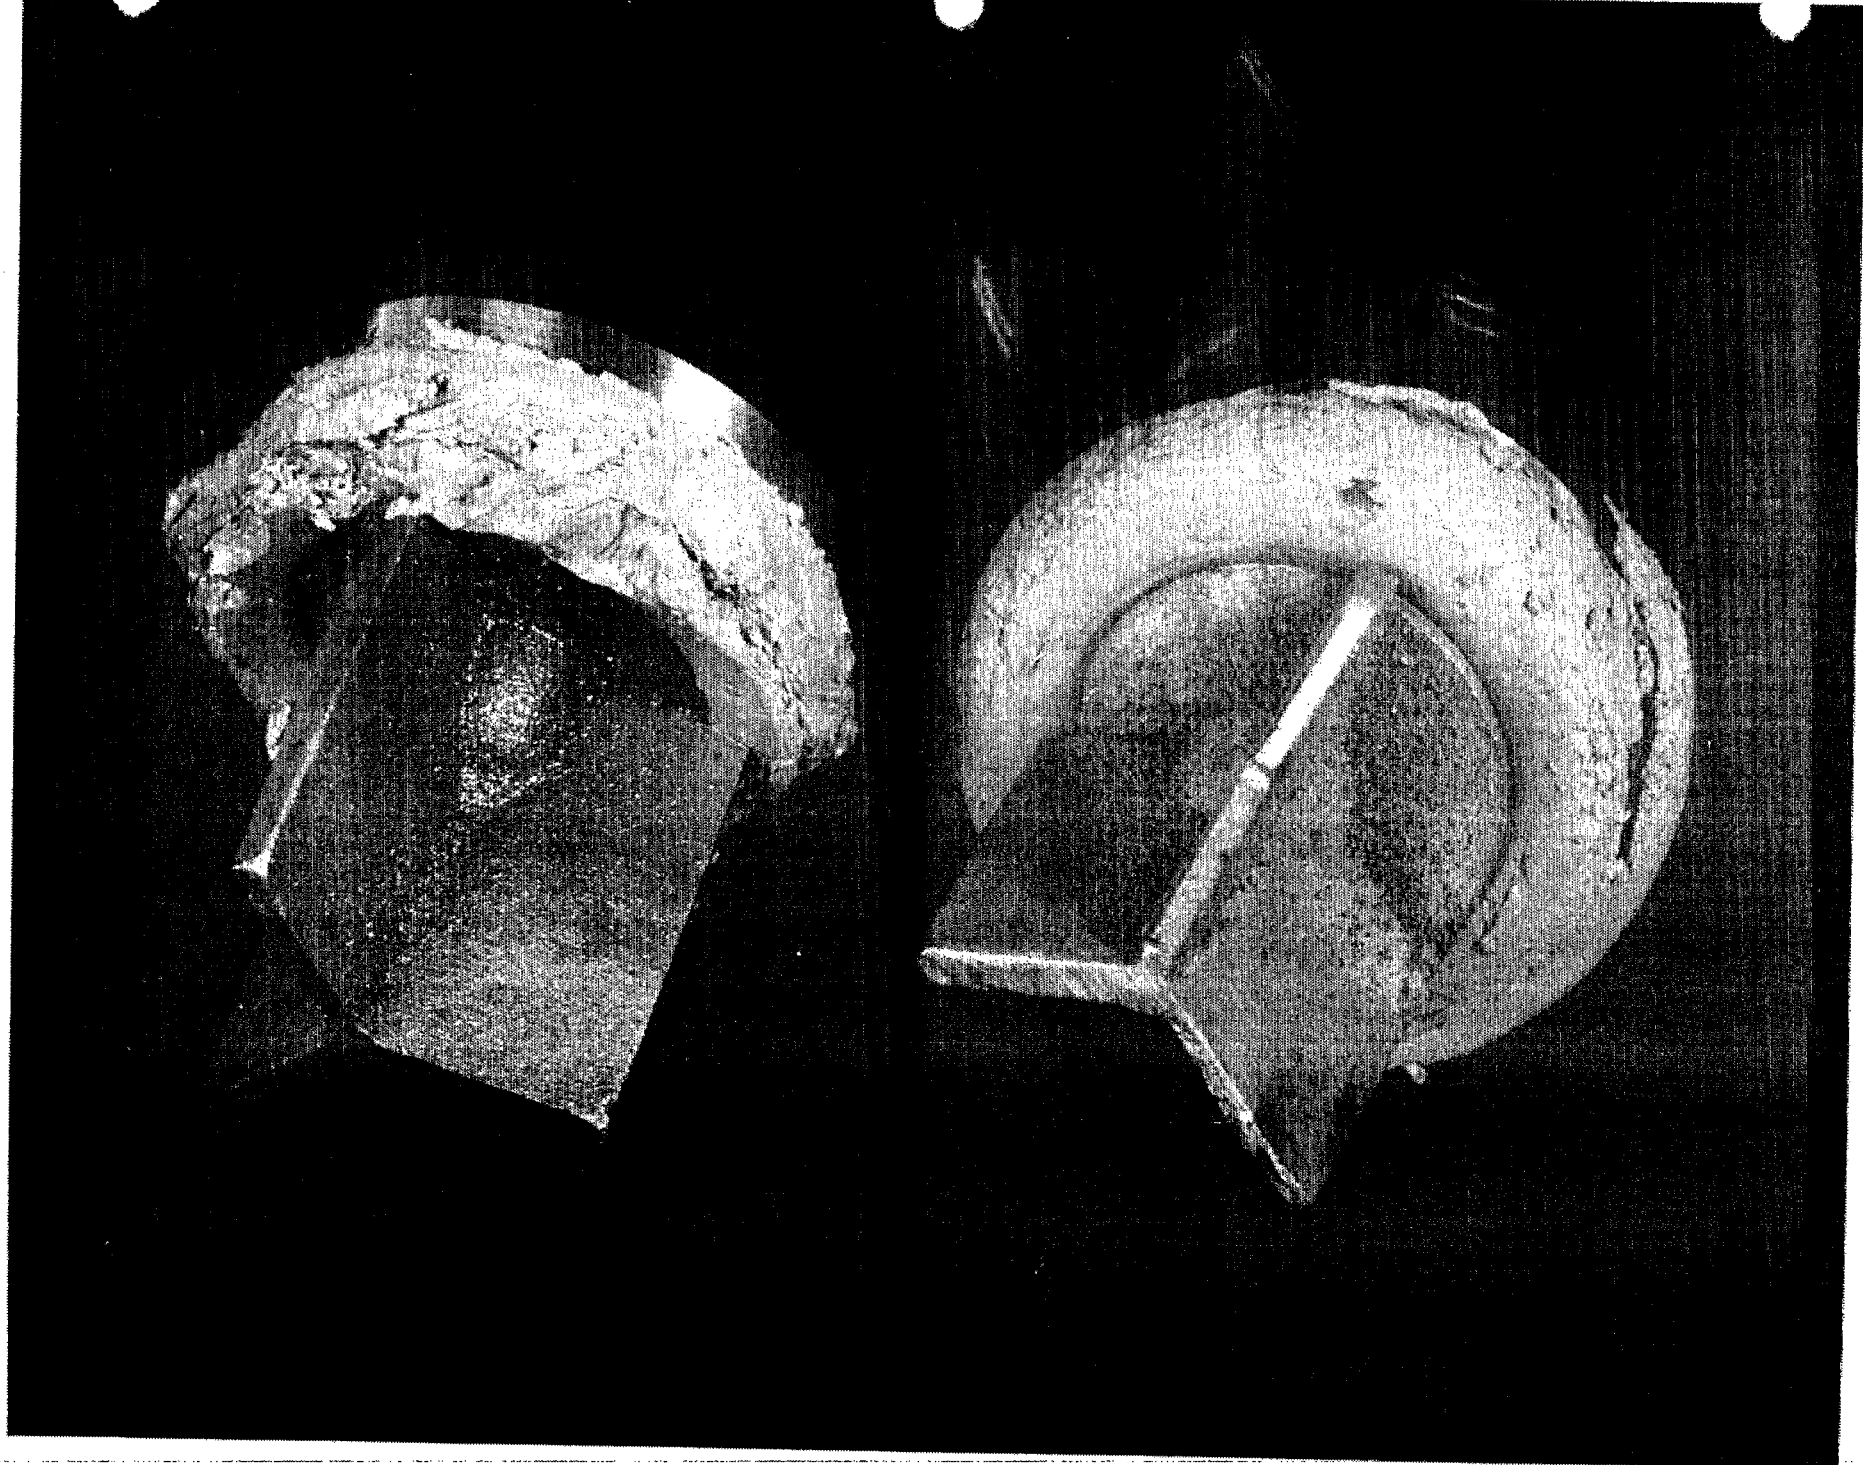
The pumps were disassembled and thoroughly examined for signs of wear or component failures and none could be found. Each pump suction line has a foot valve (check valve) installed at the lower end of the pipe line near the bottom of the oil tank. See Siemens drawing number 2D8.6701-167338 coordinate B5. These check valves were disassembled. It was found that the check mechanism seal had deteriorated. See Figs. 10 and 11. The material used to seal at the valve seat (not shown) was some type of rubber which had become spongy, distorted, and eroded in the case of pump #2 check valve where the flow was not impeded when tested. In the case of pump #1 the seal material was so bloated as to impede the proper operation of the valve and thereby to restrict the normal flow of oil.

Since pump #1 and #2 are well down into the tank, and therefore self-priming, the suction line check valves were completely removed. The check valve at the lower end of the shaft-driven pump suction line exhibited the same problem as the others in that the seal material was spongy and bloated to the point that it seriously restricted the normal flow. The seal material is very evidently not compatible with the lubricating oil. This oil is Mobil DTE medium grade oil without any inhibitors. Since this check valve must hold

fifteen feet of oil to prevent the loss of charge of oil for the shaft-driven pump, it was repaired using Buna-N synthetic rubber material to replace the defective seal material.
