SIEMENS POWER SUPPLY MOTOR-GENERATOR SET MOTOR ROTOR FAILURE

Collider Accelerator Department
Brookhaven National Laboratory

AGS DIVISION TECHNICAL NOTE

No. 99

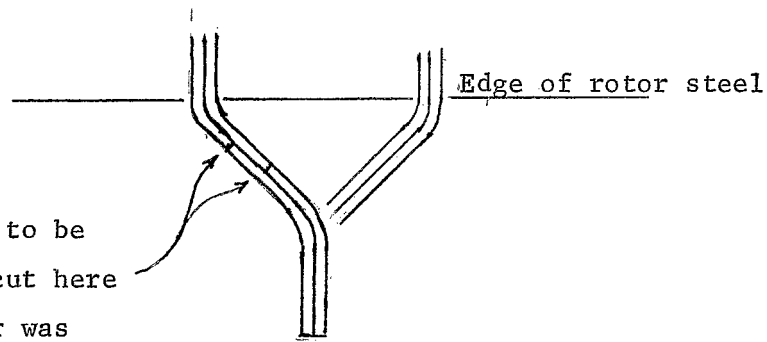
The coil to be repaired was cut here and new copper was

brazed with staggered joints as shown. The brazed joints were then ground to bar size. The repair work on the coil was completed on this day and it is an excellent job.

The repair will be done by brazing using fifteen percent (15%) silver.

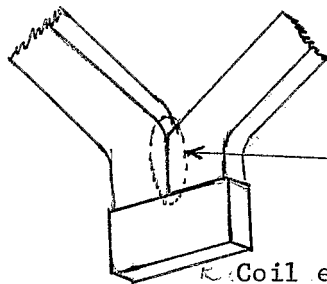
Coil end cap insulation

The coil end connection has a small space between coils in this area which allows dirt to collect and shorten the creepage path to conductors.

under the end cap insulation. The major portion of the fault was in this area. All end cap insulation will have this space filled with an epoxy and the complete area will be insulated with glass tape and epoxy.

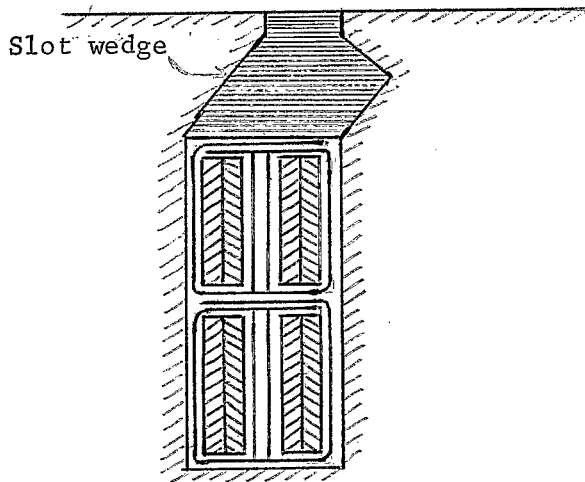
The old slot liner insulation was folded over at the top of the bottom coil and a new U shaped liner insulation was installed with the upper coil.

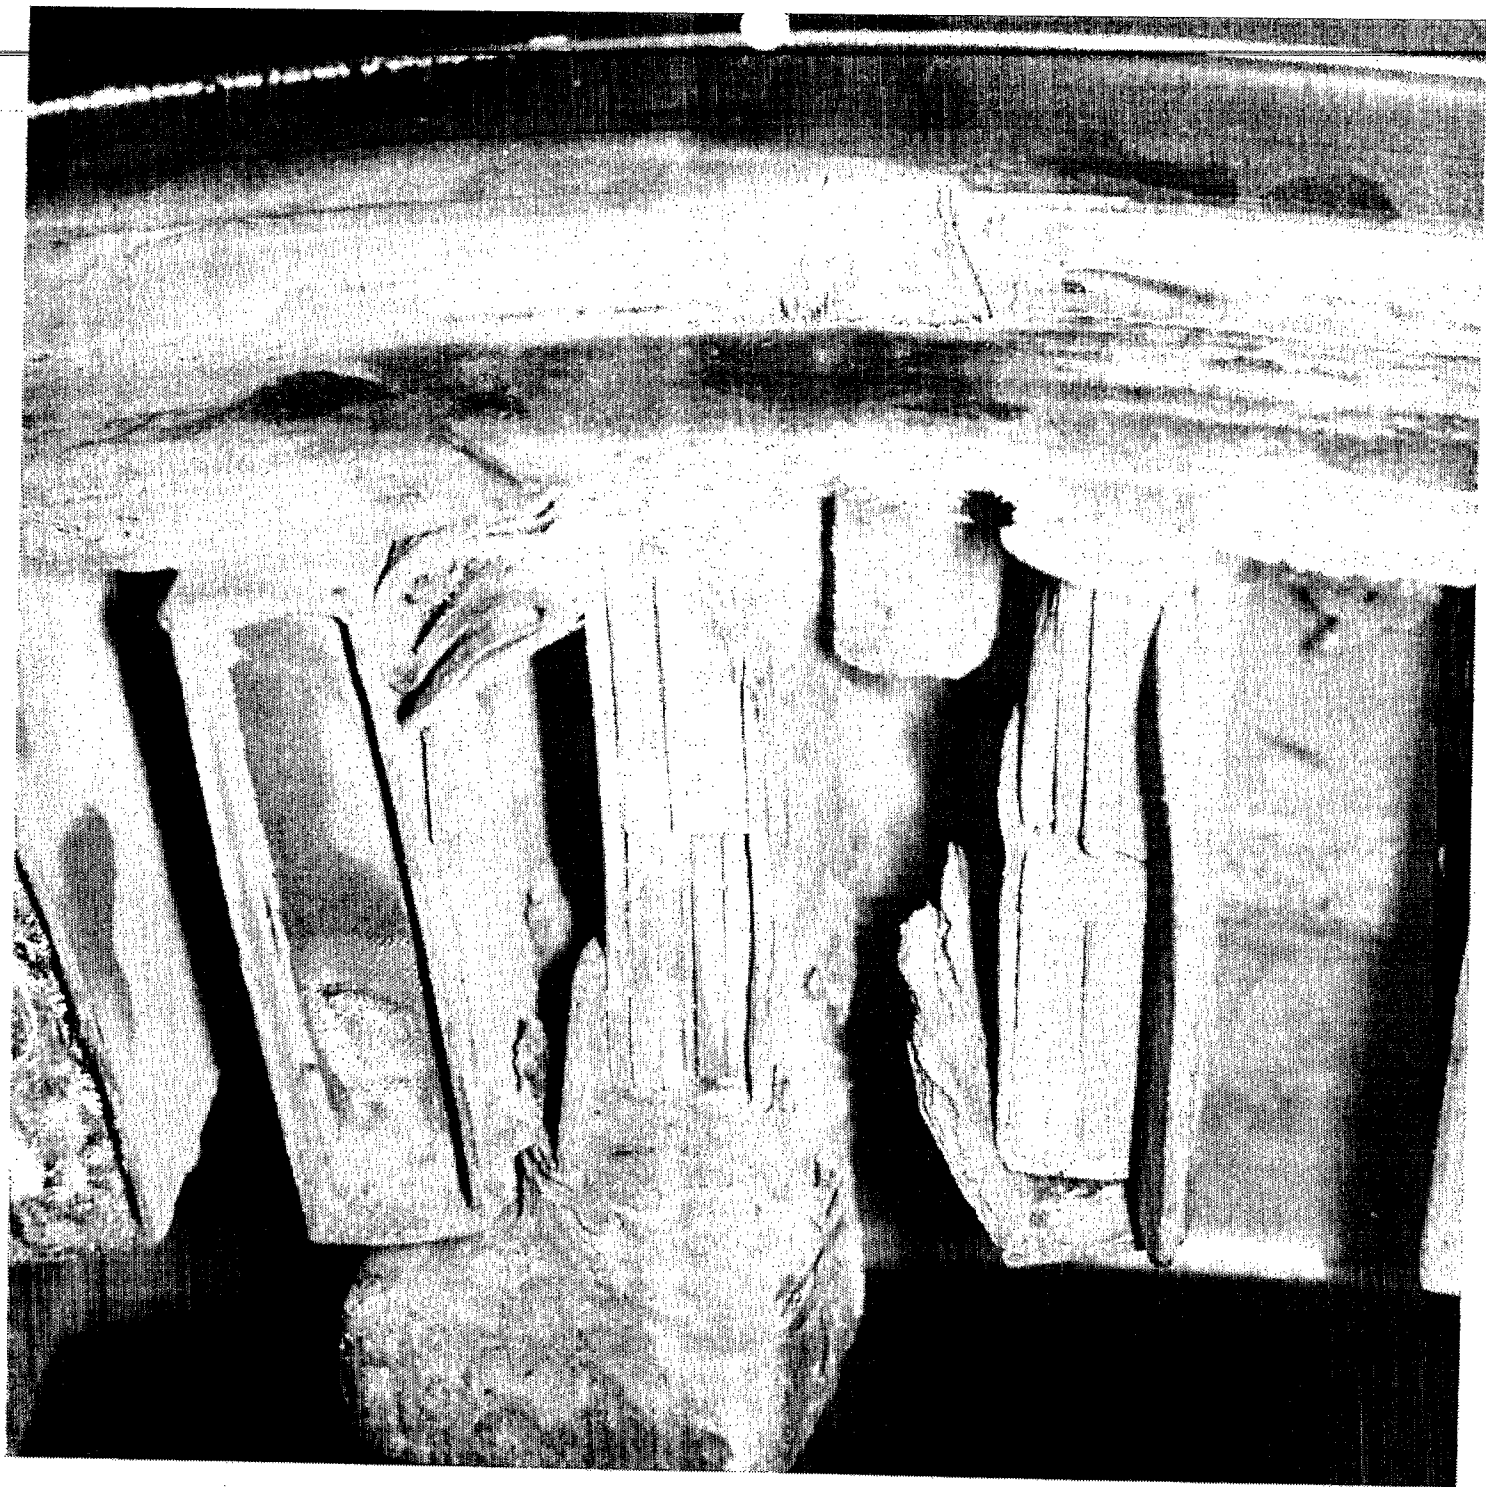
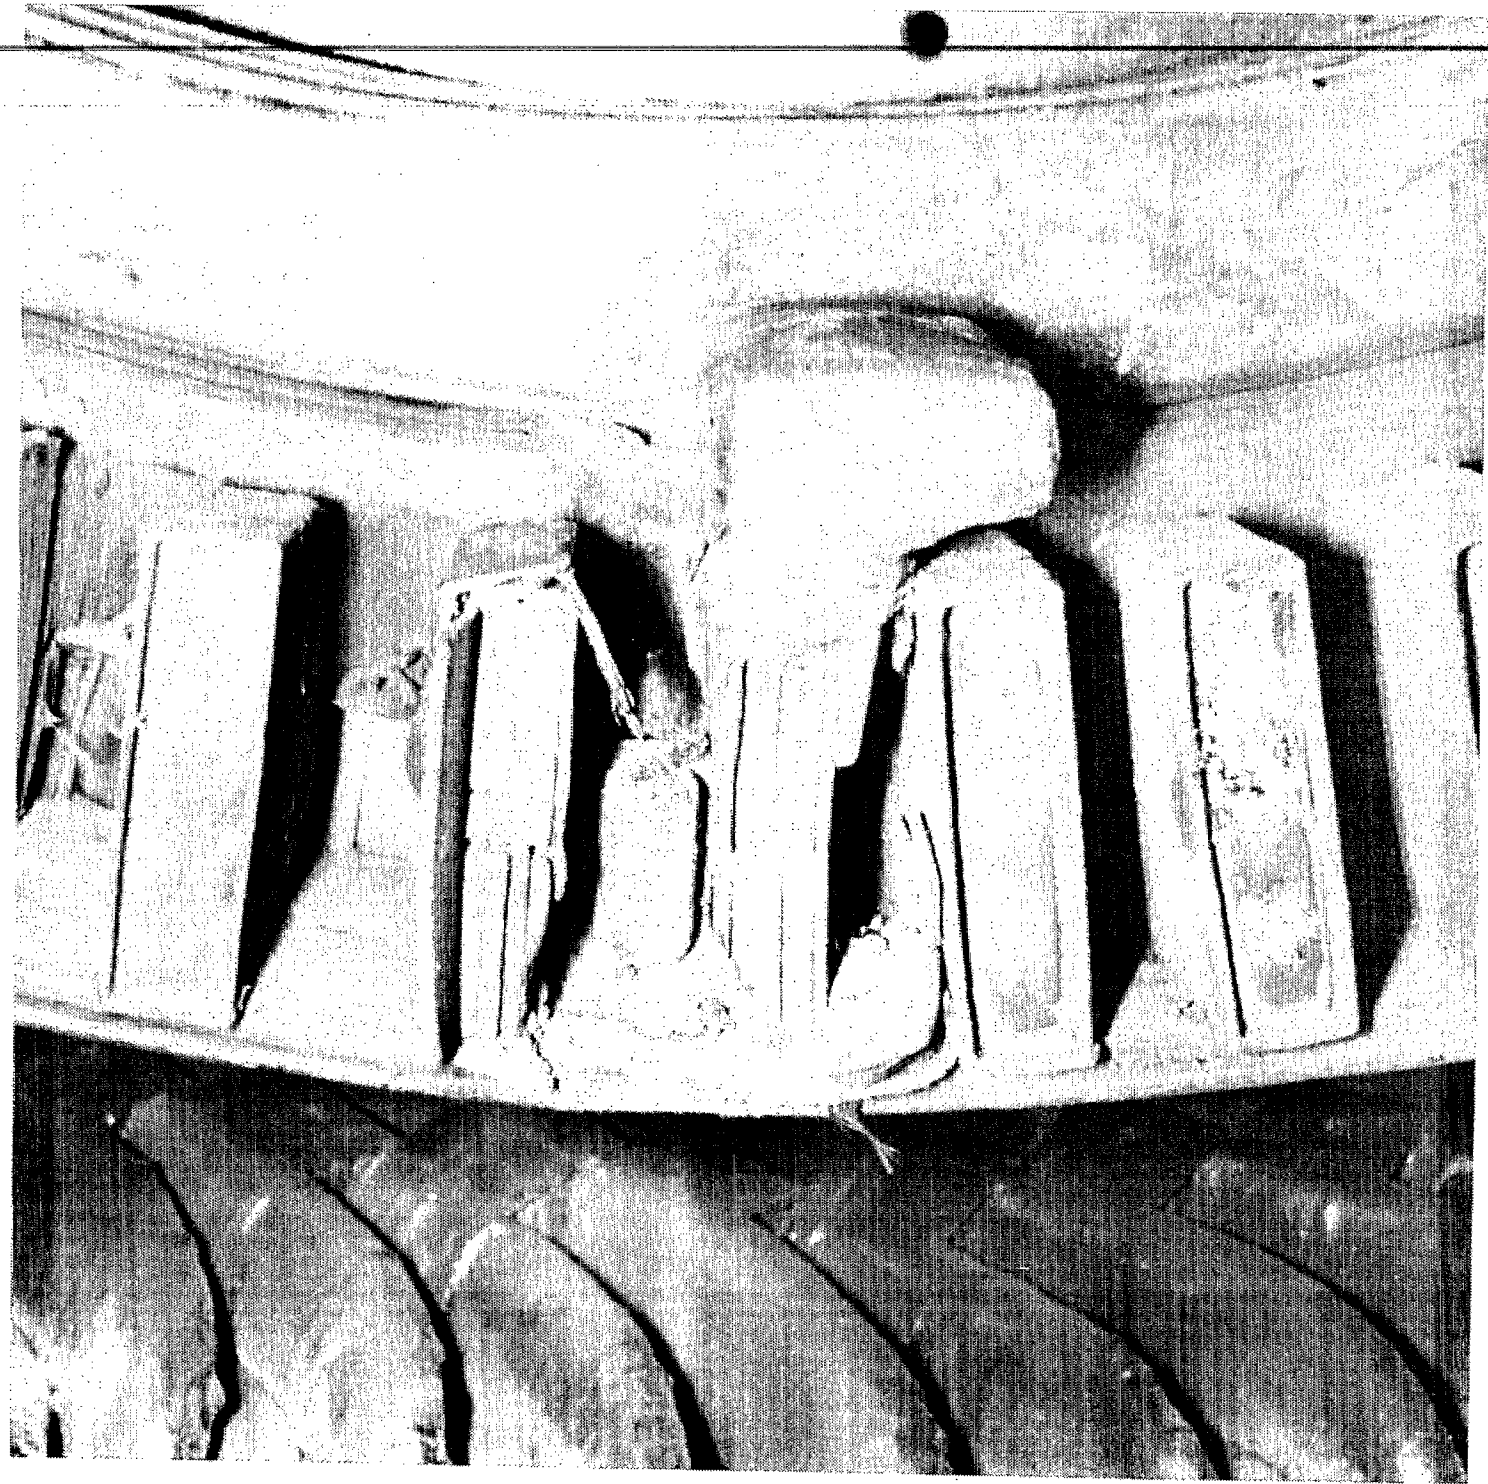
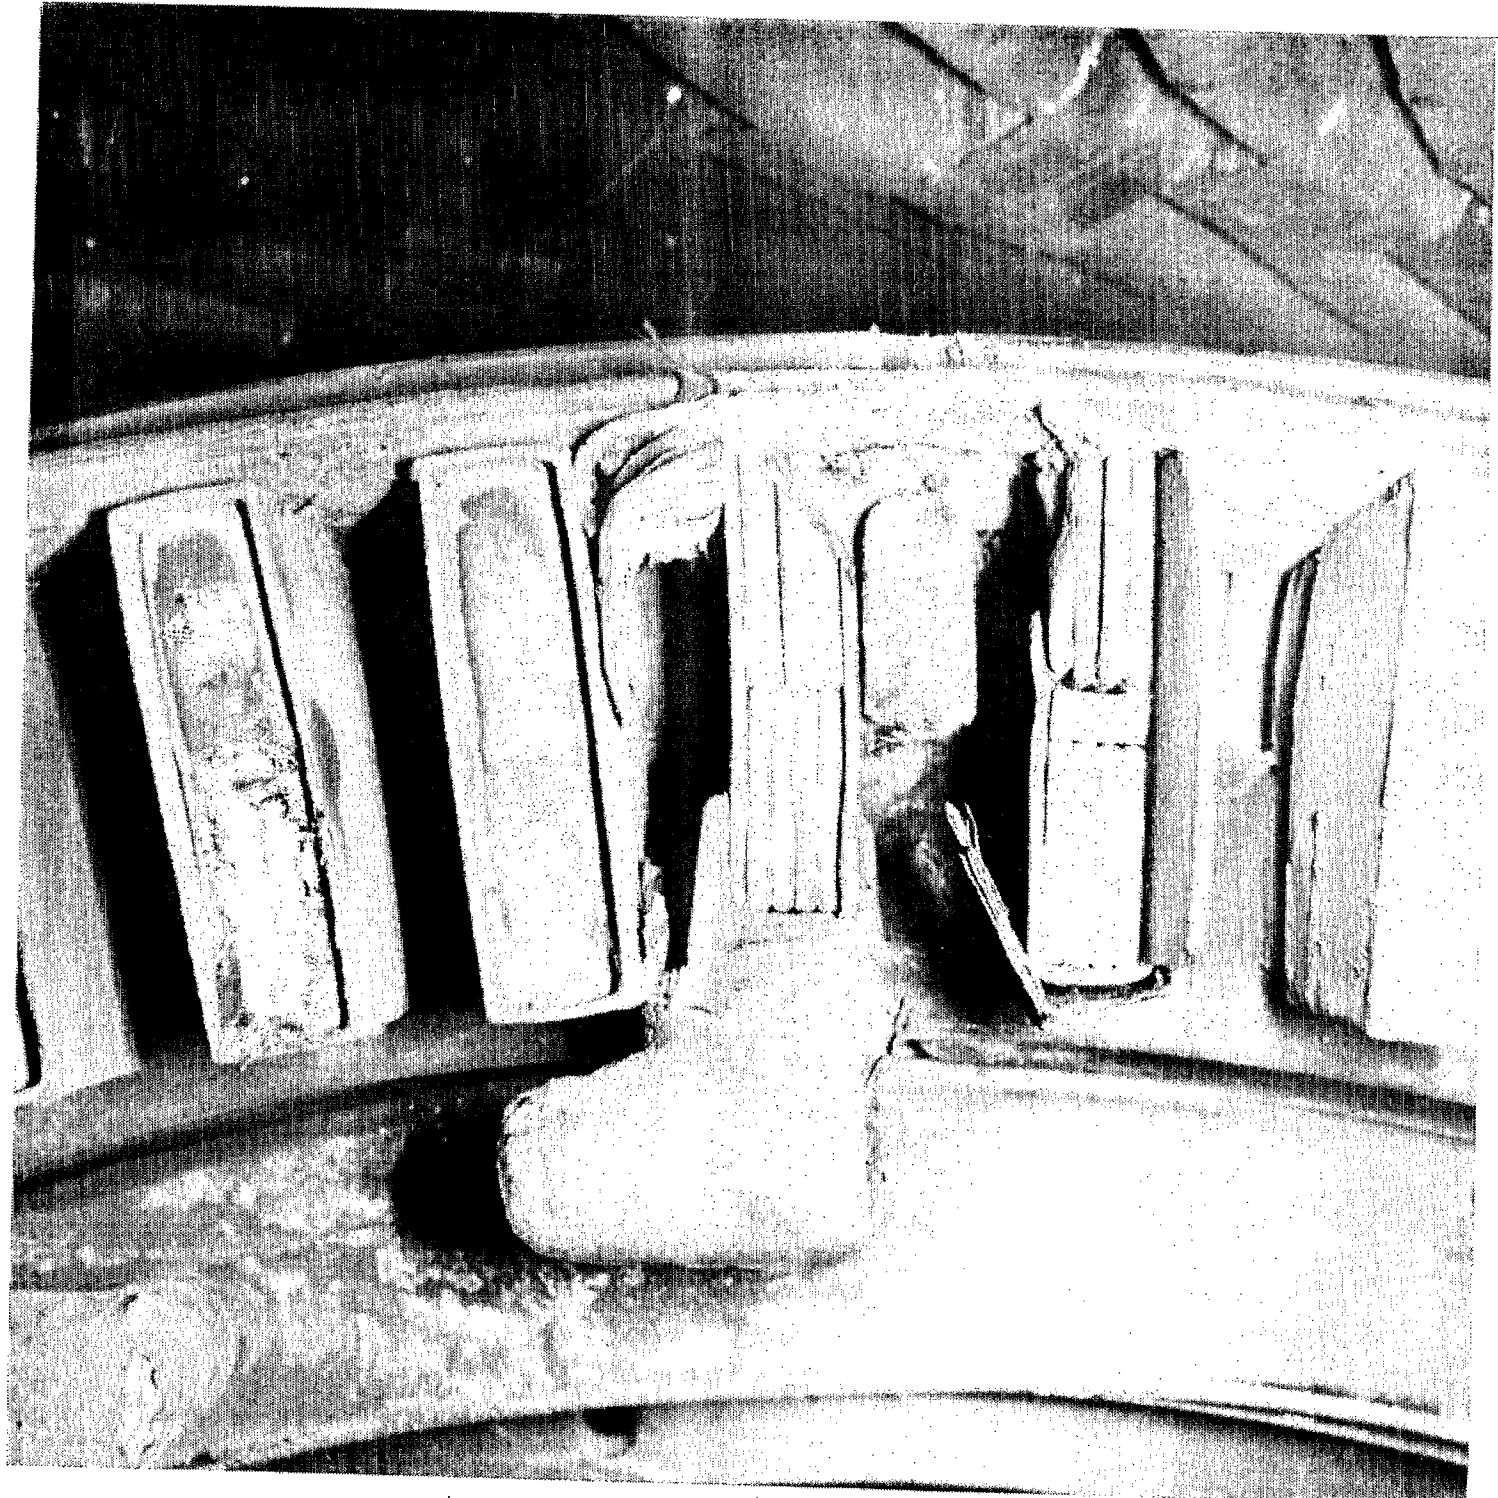
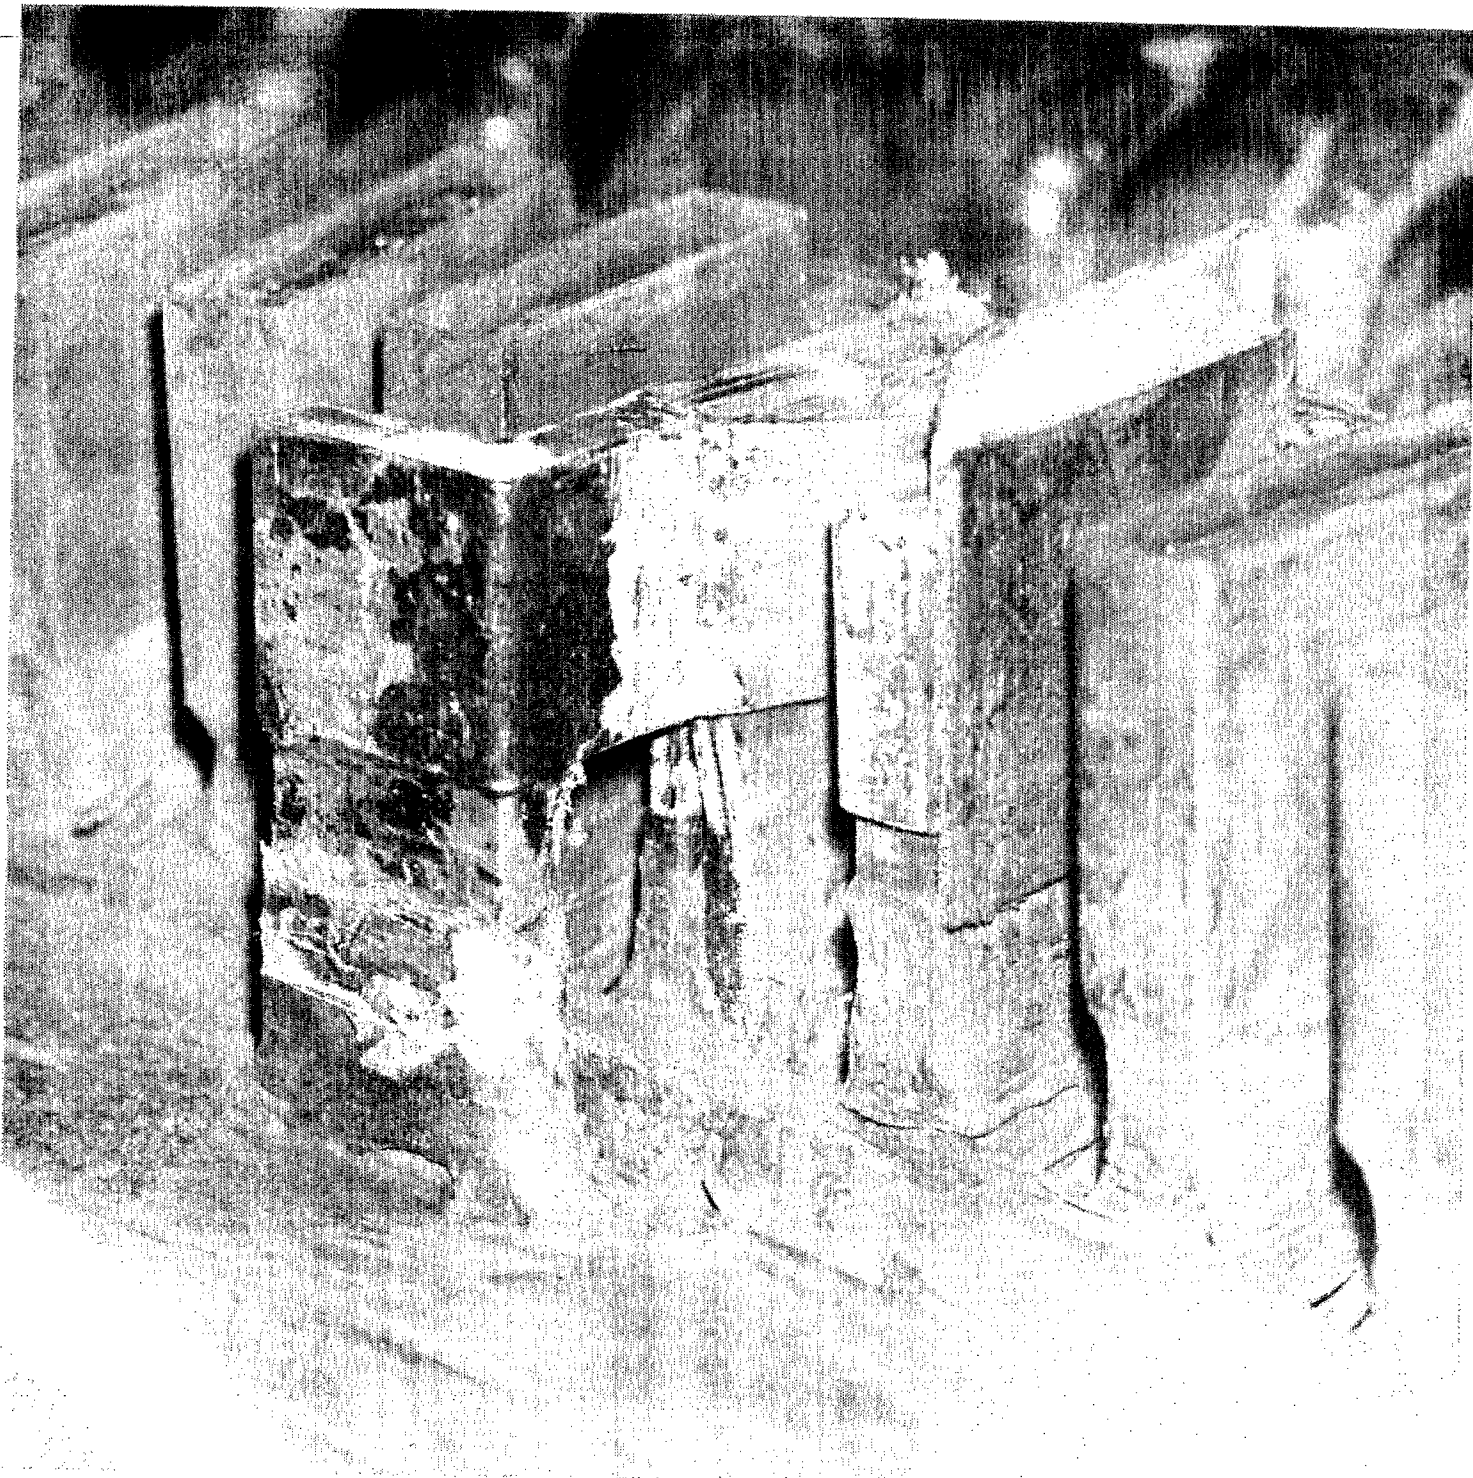
After removing the slip-ring cover and the motor end shields, it was found that one or two rotor winding end connections and the rotor to slip-ring connections were severely burned. Figures 2 to 6 show different views of the external damage at the rotor winding end connections, and Figs. 7 to 9 show the physical damage at the rotor to slip-ring connections.

When the fault occurred, the heat generated by the fault melted the solder which was thrown outward centrifugally on the end turns of the stator coils and inside the motor end shields. No damage was done to the stator coils. Extensive arc erosion took place on one of the rotor half coil ends. The copper evaporated. The fault was phase to phase. The area of the damage is shown circled in red on Siemens drawing number TRA-W 1827/1. At the rotor winding to slip-ring connections, the arc occurred from the bolted joint (rotor winding connection bar to slip-ring bars) to the shaft and slip-ring assembly guard ring which is at the same potential as the shaft. The heat generated by the arc melted the connection solder which was thrown out centrifugally to the inside of the outer motor end shield.

The coil insulation at the slip-ring end of the rotor (where the fault occurred) which is under the retaining ring is extremely dirty with carbon

from the brushes. This is an area that is very difficult to clean and it is evident that the dirt was a major cause of the fault or arc-over between phases.

All coil end cap insulators were filled with epoxy in addition to the space between coils and each connectors. They were then glass taped and epoxyed. The epoxy used to fill the end caps is Astro Chemical Co., Schenectady, New York, "Barco Bond" two part mix equal of each. The glass tape is held in place with Scotch Grip #1300L adhesive.

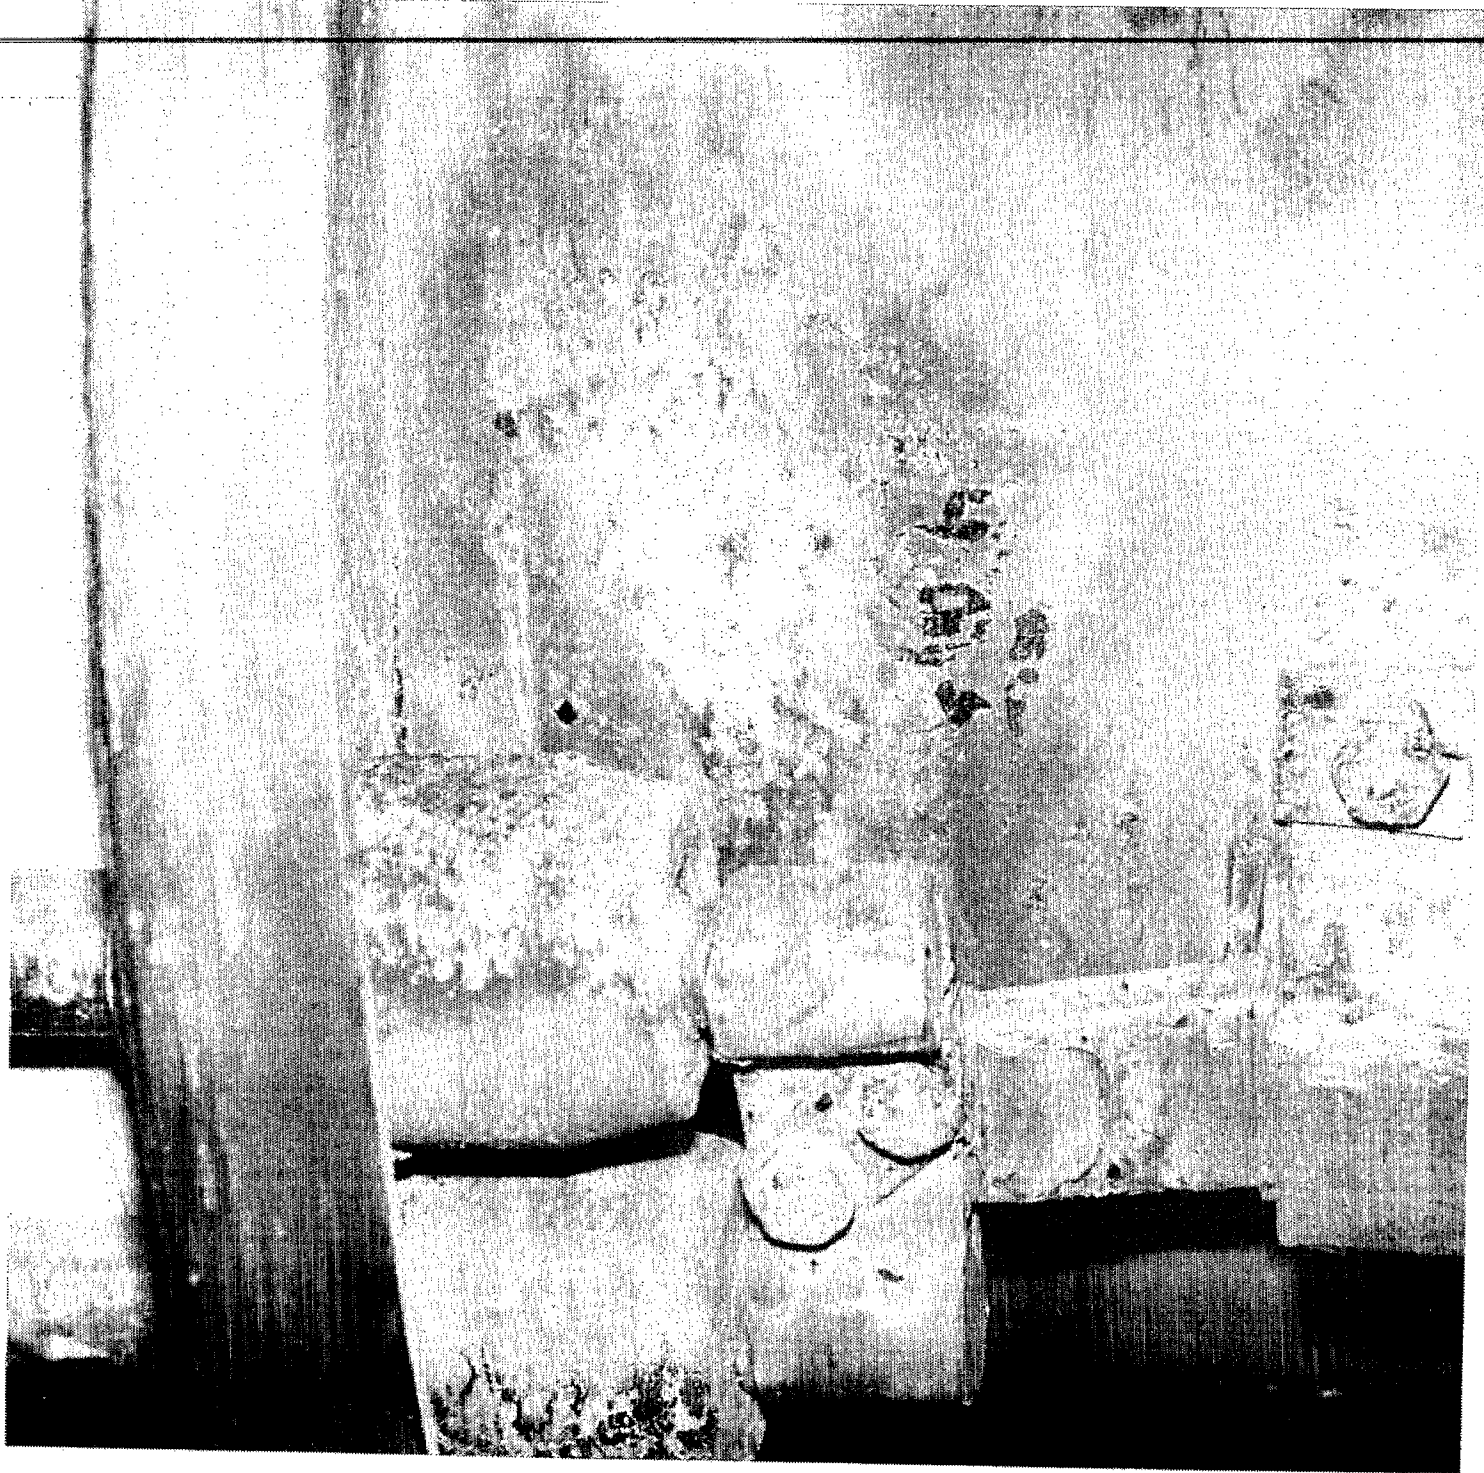
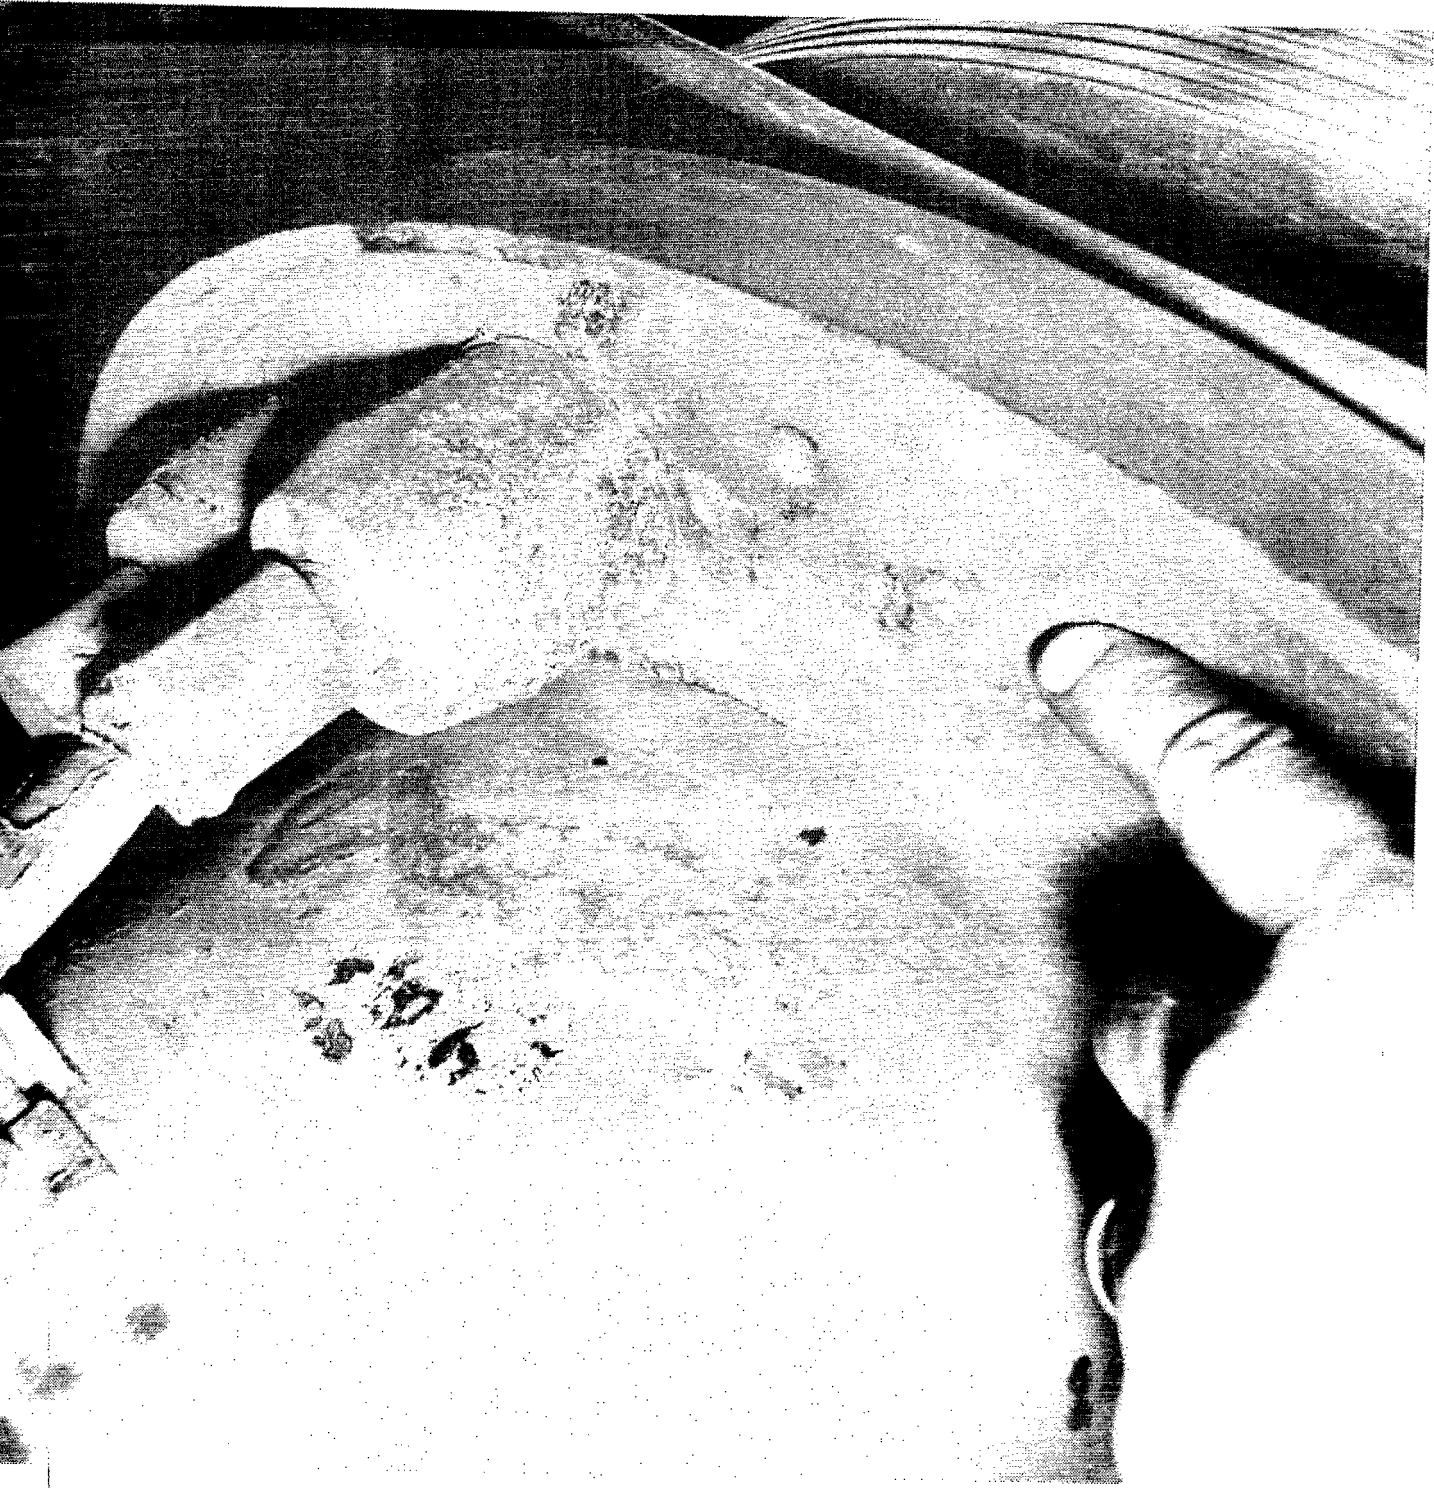
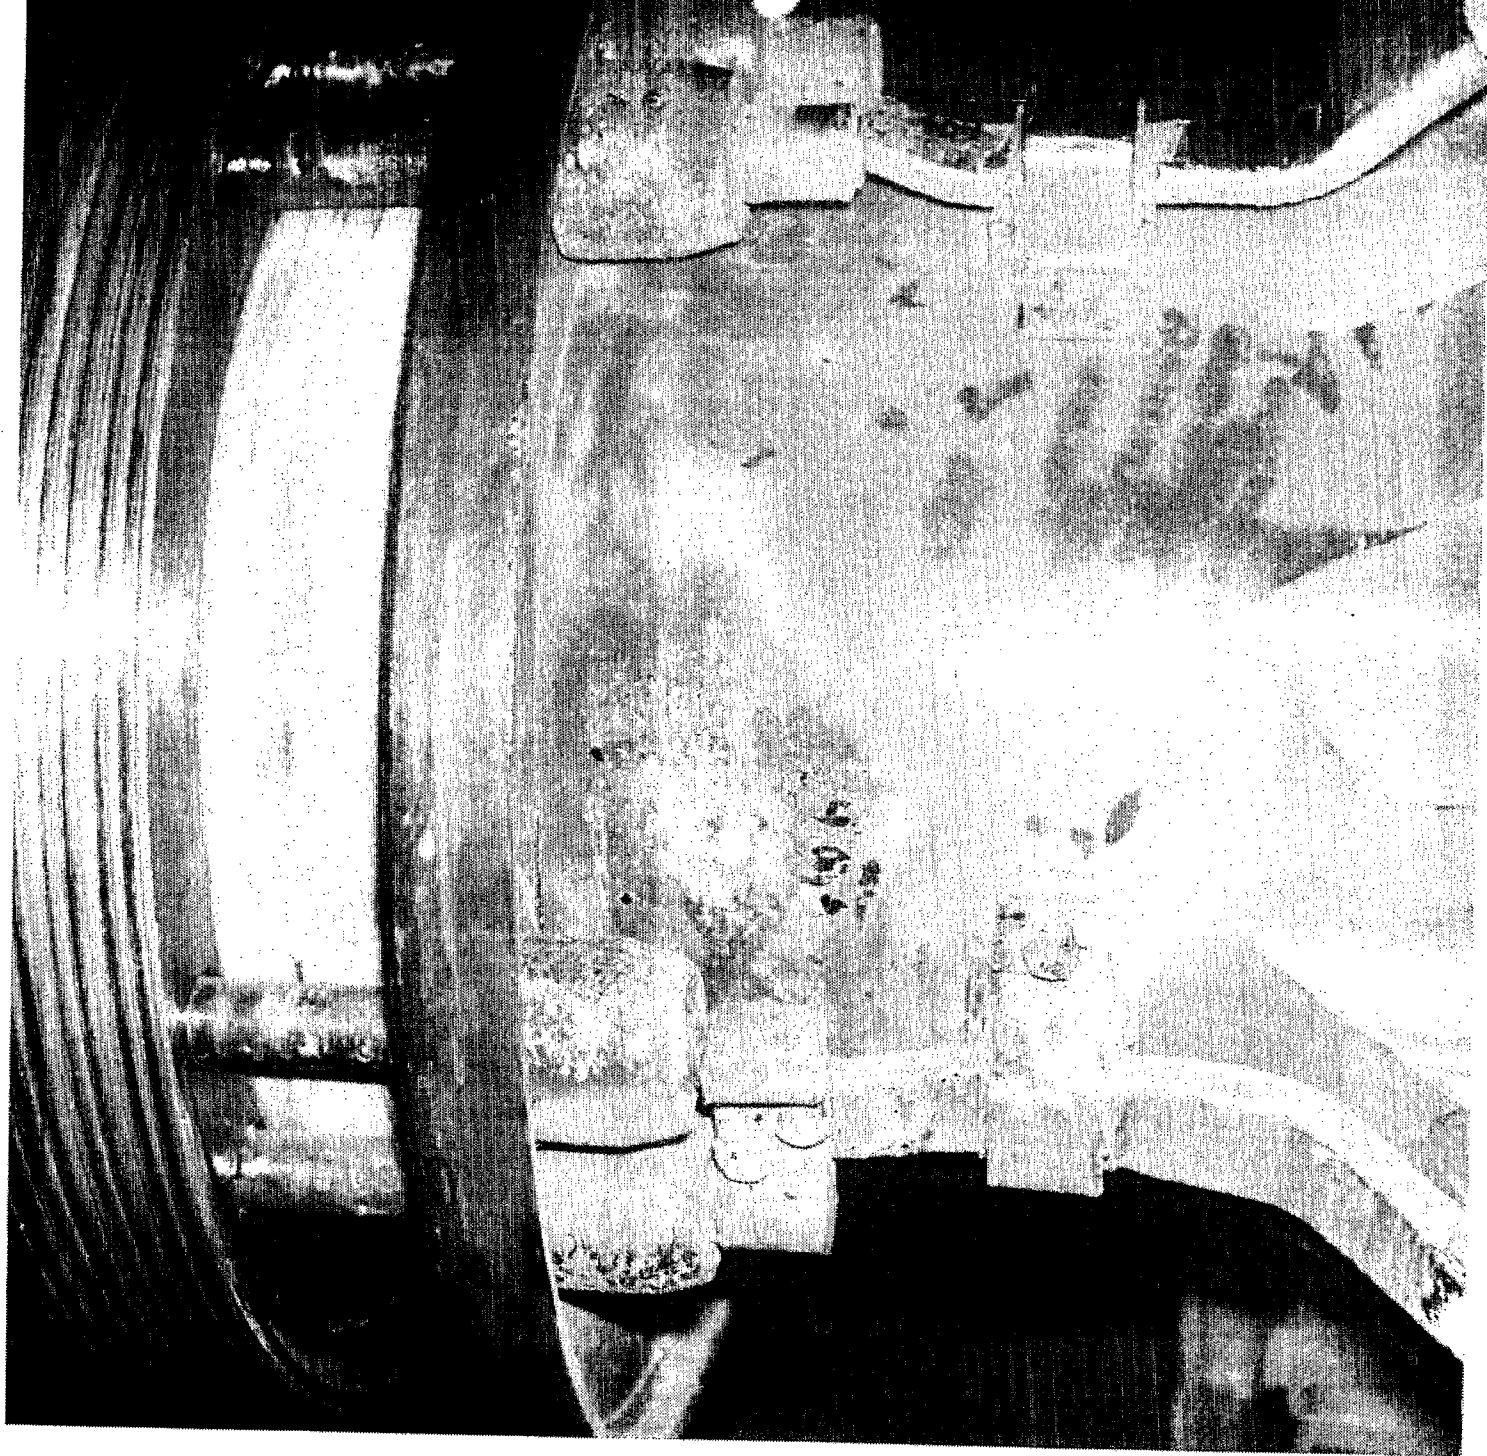
The connector bolts at the connection between the slip-ring bars and the rotor winding connecting strap were too long and thus too close to the shaft. The bolts will be turned around to get more clearance to the shaft and the shaft in this area will be insulated with glass tape and epoxy.

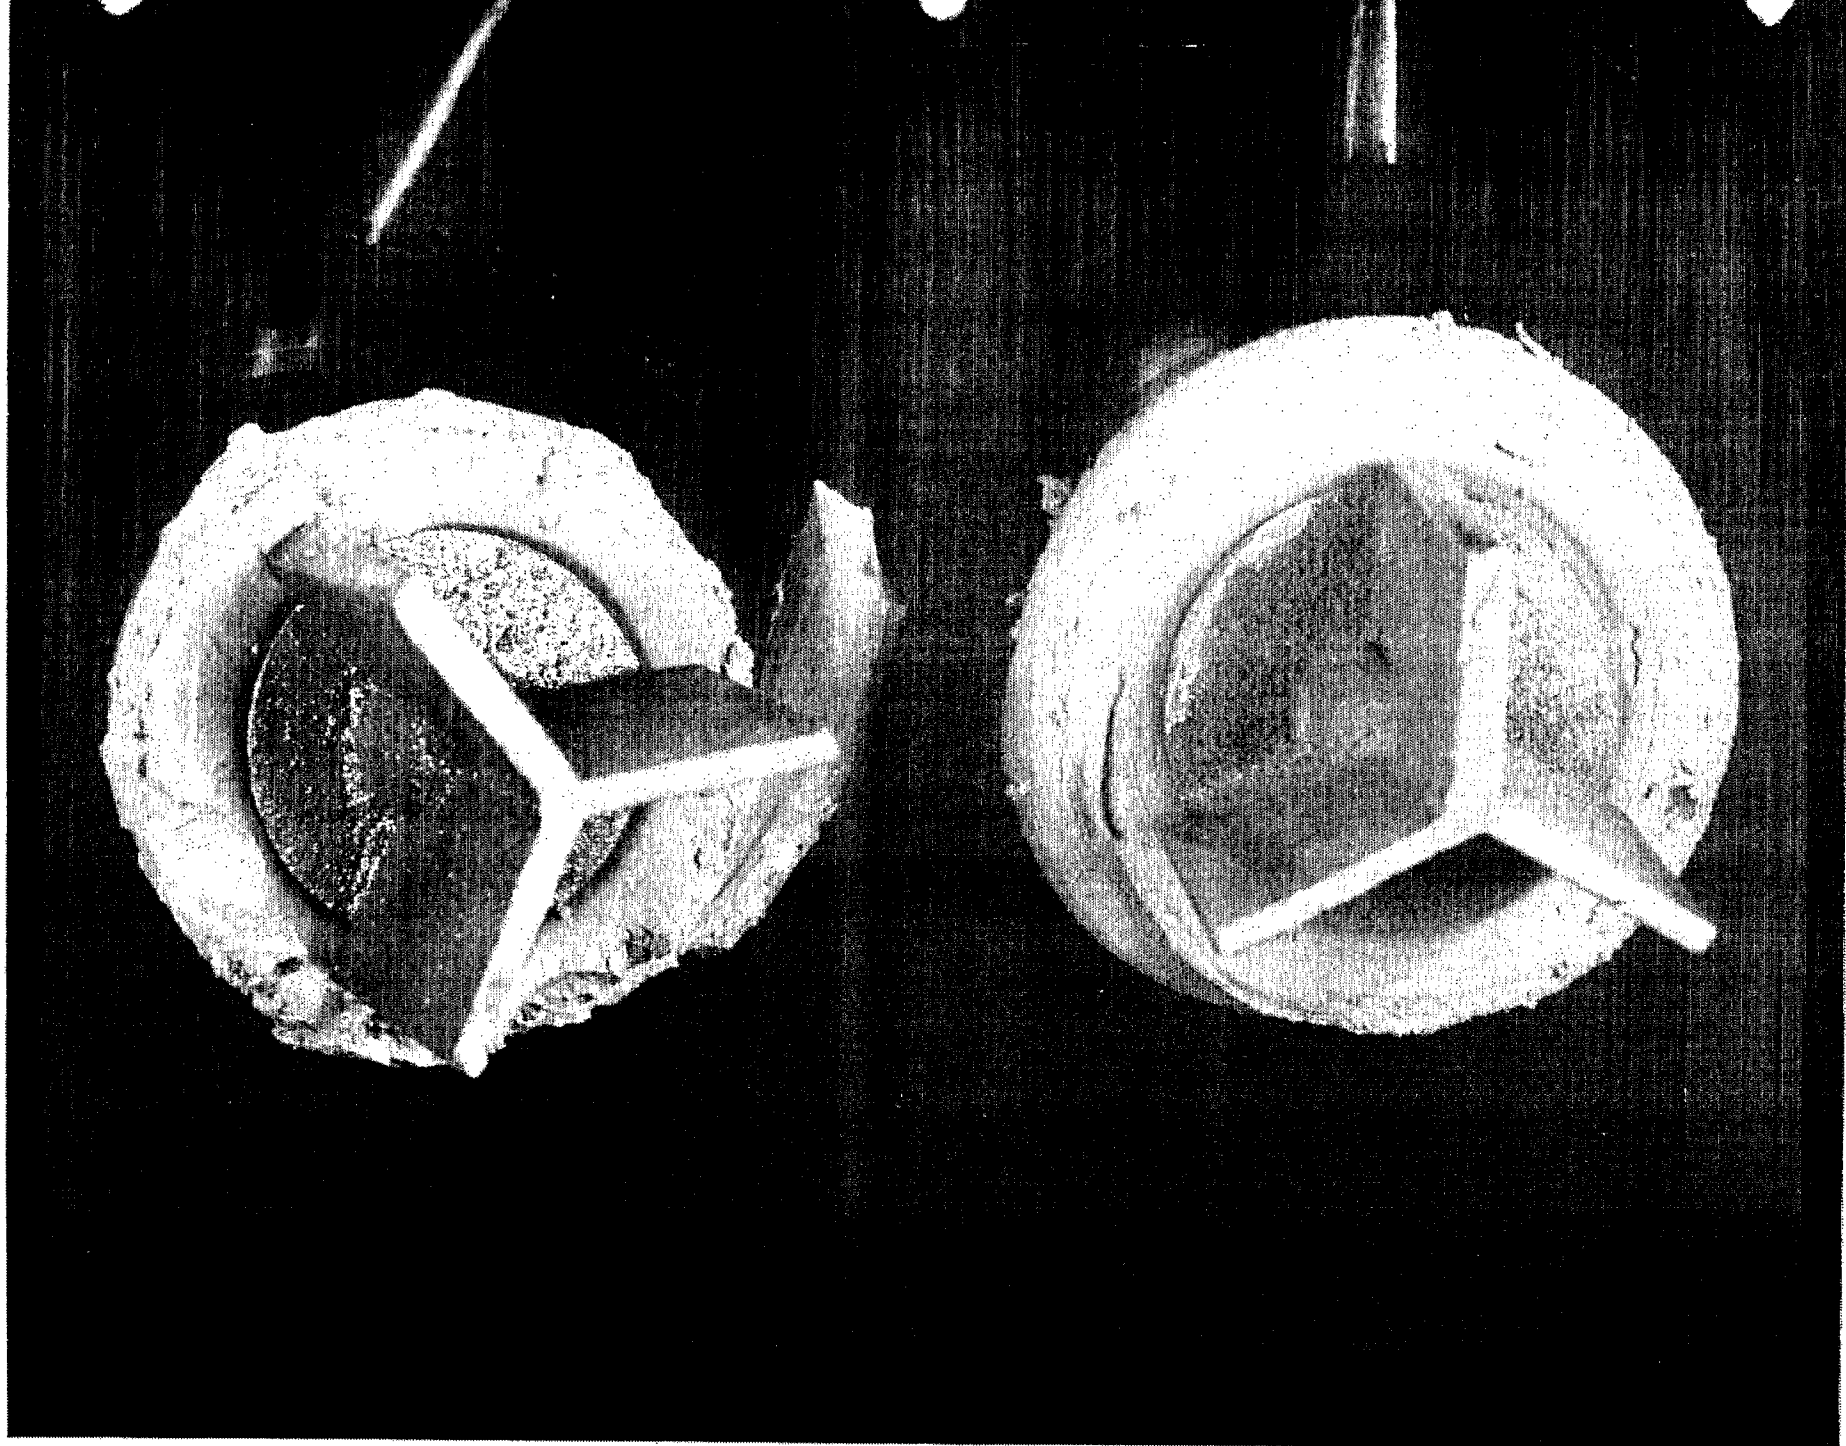
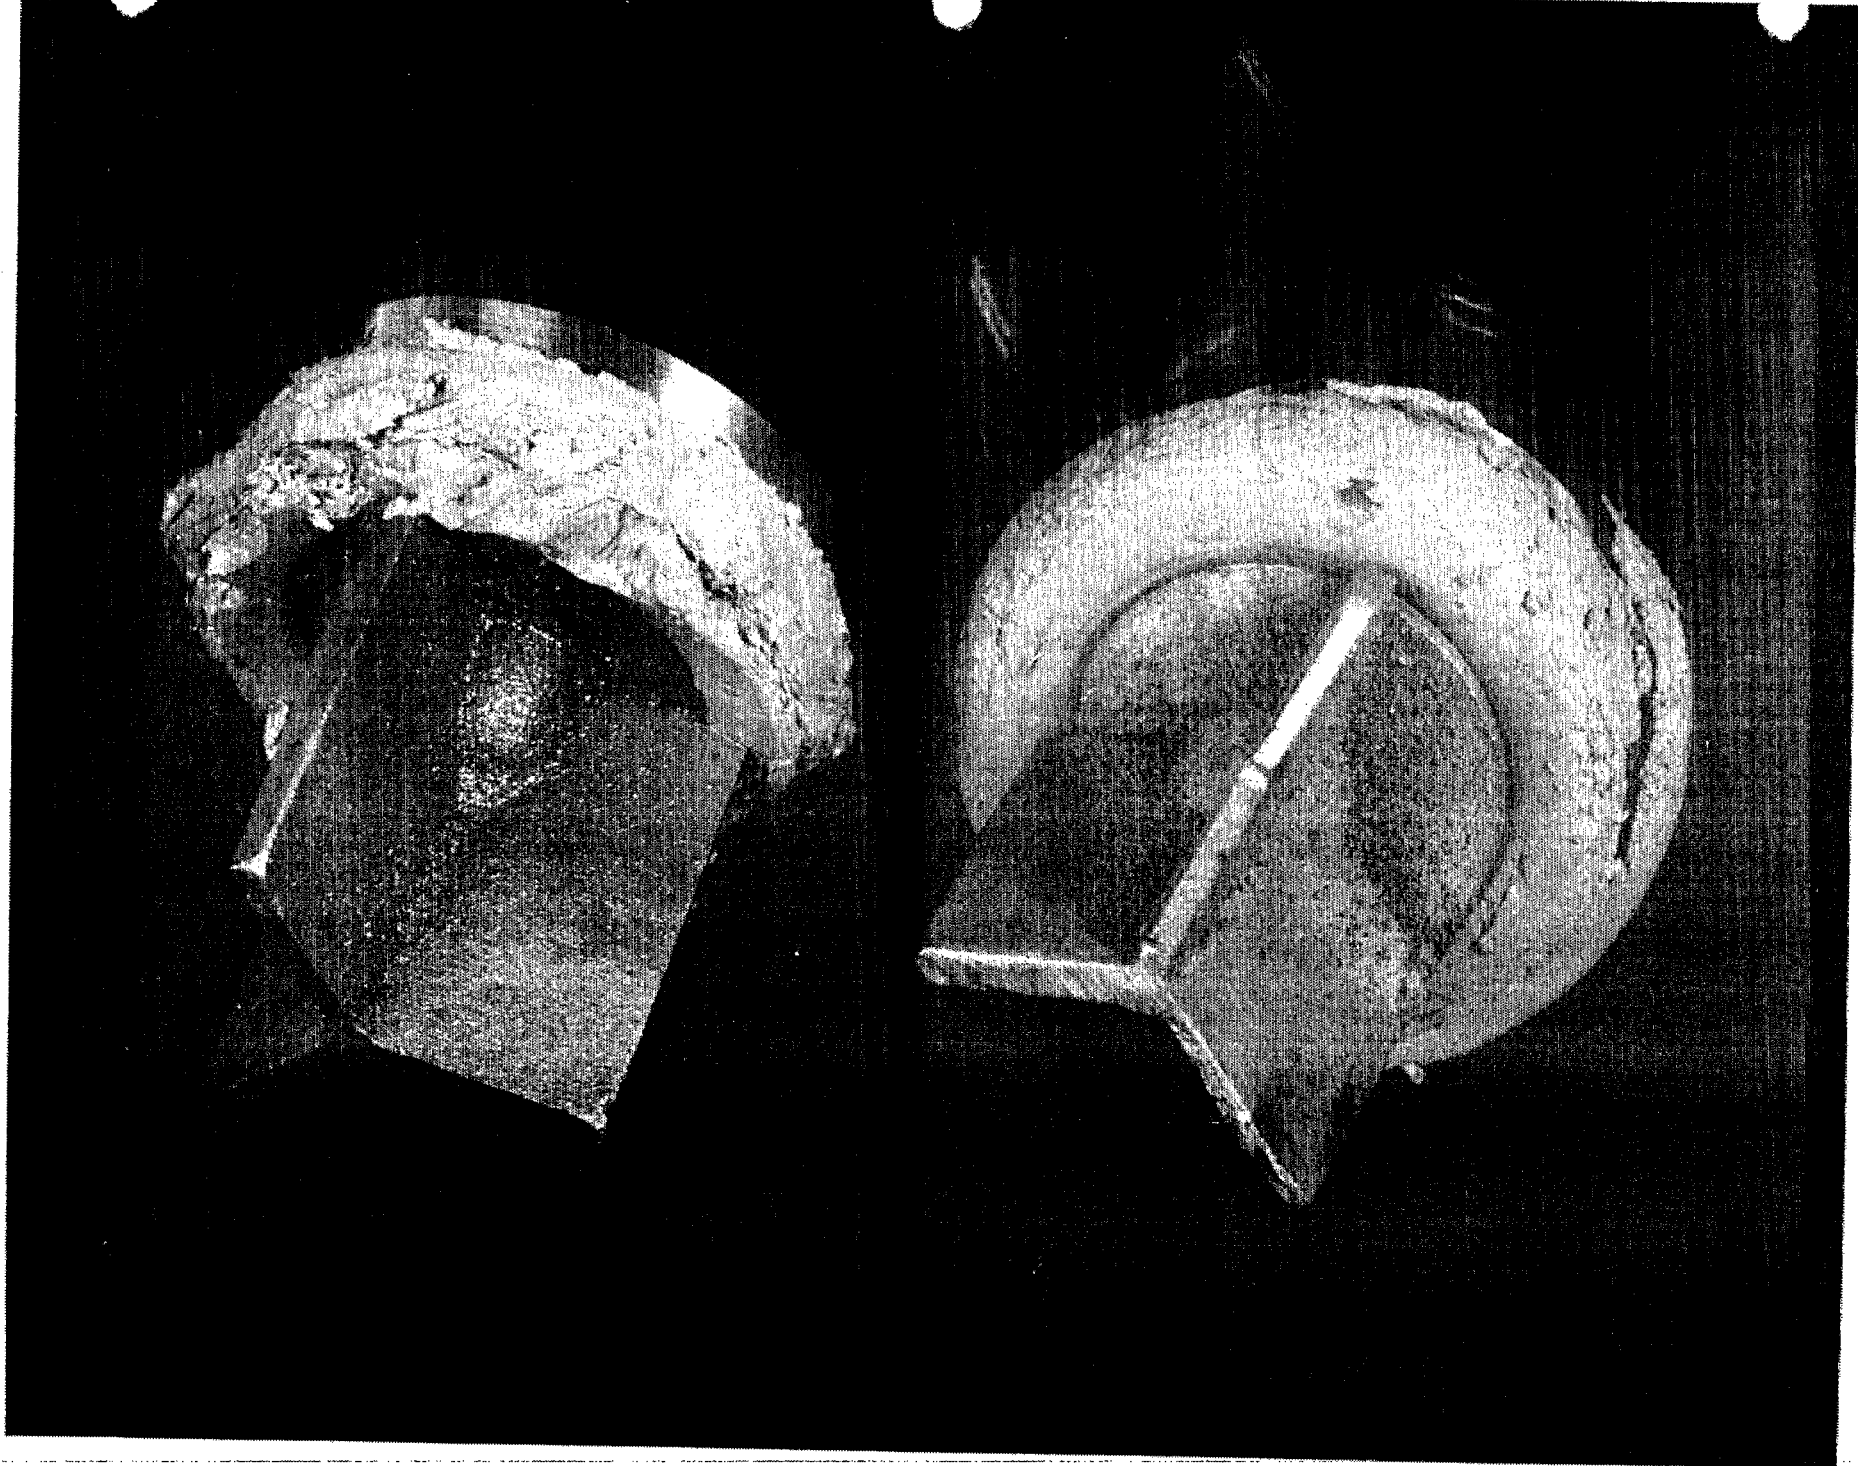
The pumps were disassembled and thoroughly examined for signs of wear or component failures and none could be found. Each pump suction line has a foot valve (check valve) installed at the lower end of the pipe line near the bottom of the oil tank. See Siemens drawing number 2D8.6701-167338 coordinate B5. These check valves were disassembled. It was found that the check mechanism seal had deteriorated. See Figs. 10 and 11. The material used to seal at the valve seat (not shown) was some type of rubber which had become spongy, distorted, and eroded in the case of pump #2 check valve where the flow was not impeded when tested. In the case of pump #1 the seal material was so bloated as to impede the proper operation of the valve and thereby to restrict the normal flow of oil.

Since pump #1 and #2 are well down into the tank, and therefore self-priming, the suction line check valves were completely removed. The check valve at the lower end of the shaft-driven pump suction line exhibited the same problem as the others in that the seal material was spongy and bloated to the point that it seriously restricted the normal flow. The seal material is very evidently not compatible with the lubricating oil. This oil is Mobil DTE medium grade oil without any inhibitors. Since this check valve must hold

fifteen feet of oil to prevent the loss of charge of oil for the shaft-driven pump, it was repaired using Buna-N synthetic rubber material to replace the defective seal material.
