SIEMENS POWER SUPPLY MOTOR-GENERATOR SET MOTOR ROTOR FAILURE

Collider Accelerator Department
Brookhaven National Laboratory

AGS DIVISION TECHNICAL NOTE

No. 99

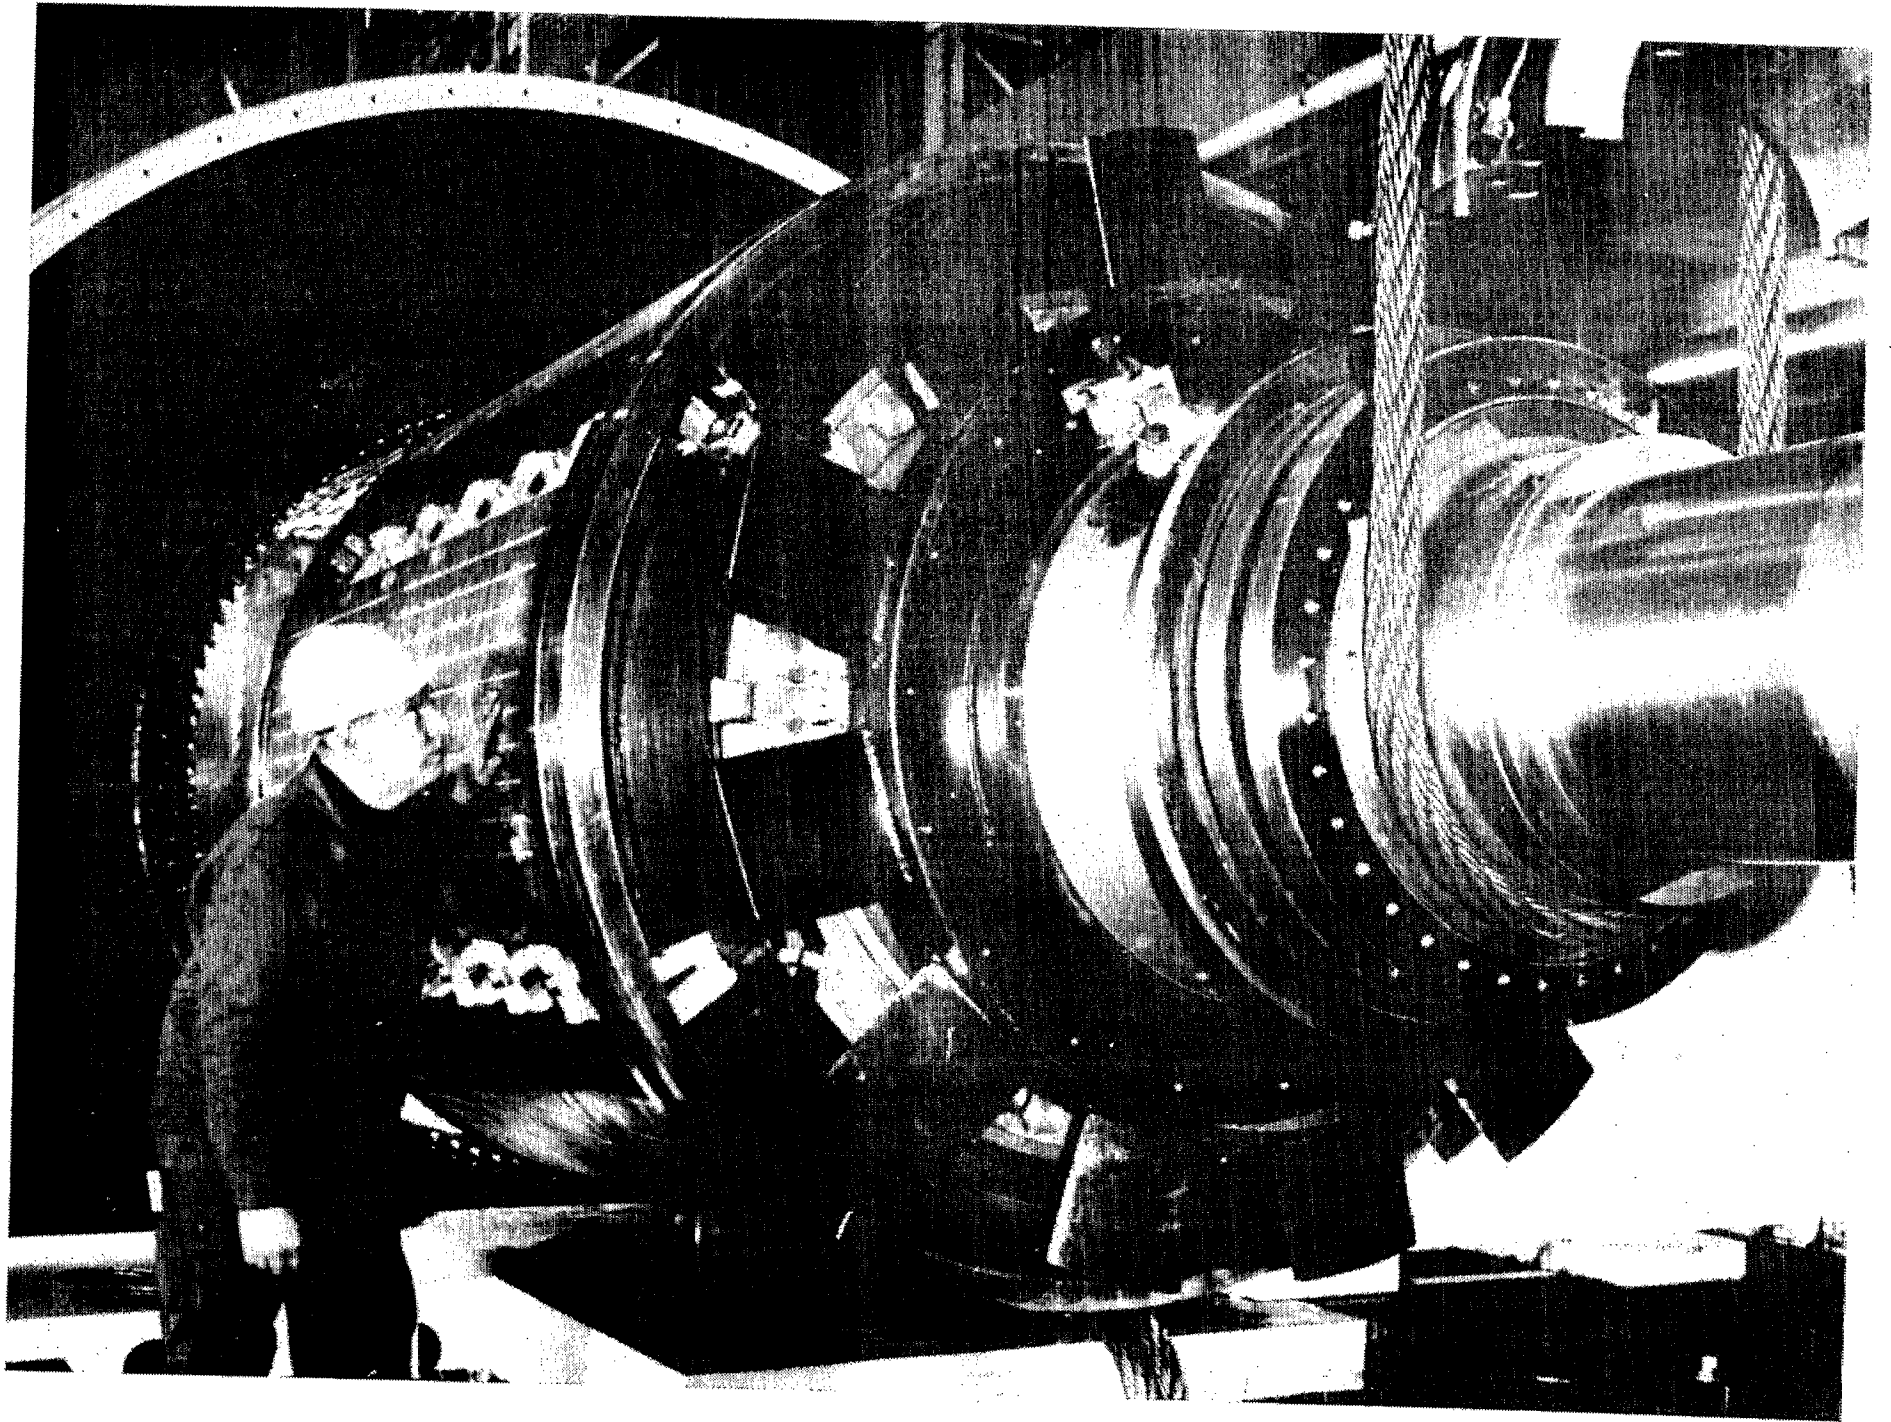
Fig. 12

During the time when the motor rotor was in the General Electric Service Shop, the generator rotor was rigged out of its stator onto the floor of the motor-generator set room. The Siemens Instruction and Maintenance Manual recommends yearly inspection of the rotors of both the motor and generator. The GERN laboratory of Geneva, Switzerland who also owns a Siemens power supply with an identical generator and a six megawatt motor turning at 1000 rpm have pulled out their rotors two times since the power supply went into operation. At both times the generator rotor had to be serviced. The field coil brace retaining bolts had become loose and needed retightening.

Inspection of the AGS generator rotor showed the same condition. See Fig. 12, generator rotor, and Siemens drawing number 1D1.1384-156656, field coil brace. In the photograph, the field coil braces (light color) are shown between the poles. There are six braces between each of the six poles. As shown on the field coil brace drawing, one bolt retains the brace. The bolt head is locked by a lock plate to prevent it from turning. In turn the brace compresses insulation blocks onto the field coils.

During normal operation, the poles expand thermally due to the field pole current and elastically due to the high centrifugal force. These compress the insulation blocks at the field coil braces. With continuous operation, the insulation blocks become thinner requiring the tightening of the field coil brace retaining bolts periodically. Since these retaining bolts are not easily accessible while the rotor is inside the stator, the rotor must be pulled out to accomplish the tightening.

The field coil brace were tightened down and the retaining bolts were

torqued to 150 foot-pounds. The generator rotor was rigged back into the stator and completed Wednesday, September 20.
