Collider Accelerator Department
Brookhaven National Laboratory

AGS DIVISION TECHNICAL NOTE

No. 99

SIEMENS POWER SUPPLY MOTOR-GENERATOR SET
MOTOR ROTOR FAILURE

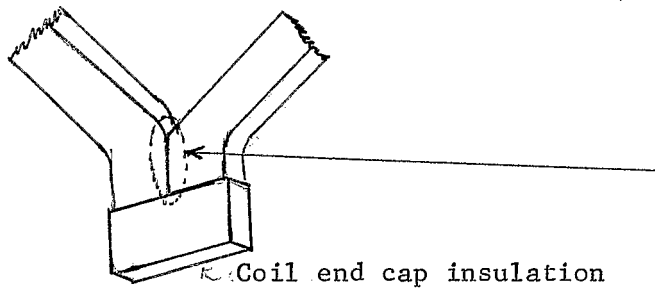
The coil end connection has a small space between coils in this area which allows dirt to collect and shorten the creepage path to conductors.

under the end cap insulation. The major portion of the fault was in this area. All end cap insulation will have this space filled with an epoxy and the complete area will be insulated with glass tape and epoxy.
