SIEMENS POWER SUPPLY MOTOR-GENERATOR SET MOTOR ROTOR FAILURE

AGS DIVISION TECHNICAL NOTE

No. 99

September 29, 1972

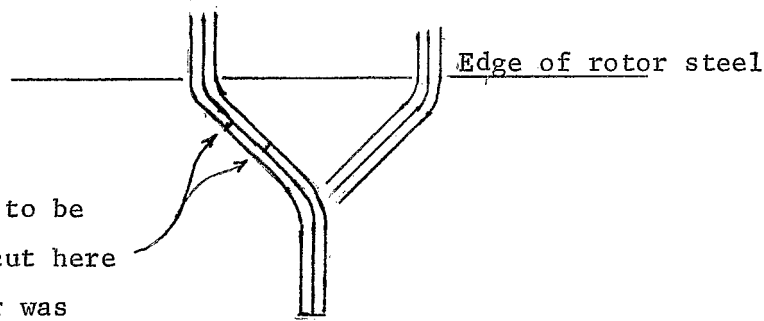
The coil to be repaired was cut here and new copper was

brazed with staggered joints as shown. The brazed joints were then ground to bar size. The repair work on the coil was completed on this day and it is an excellent job.

The coil end connection has a small space between coils in this area which allows dirt to collect and shorten the creepage path to conductors.

under the end cap insulation. The major portion of the fault was in this area. All end cap insulation will have this space filled with an epoxy and the complete area will be insulated with glass tape and epoxy.

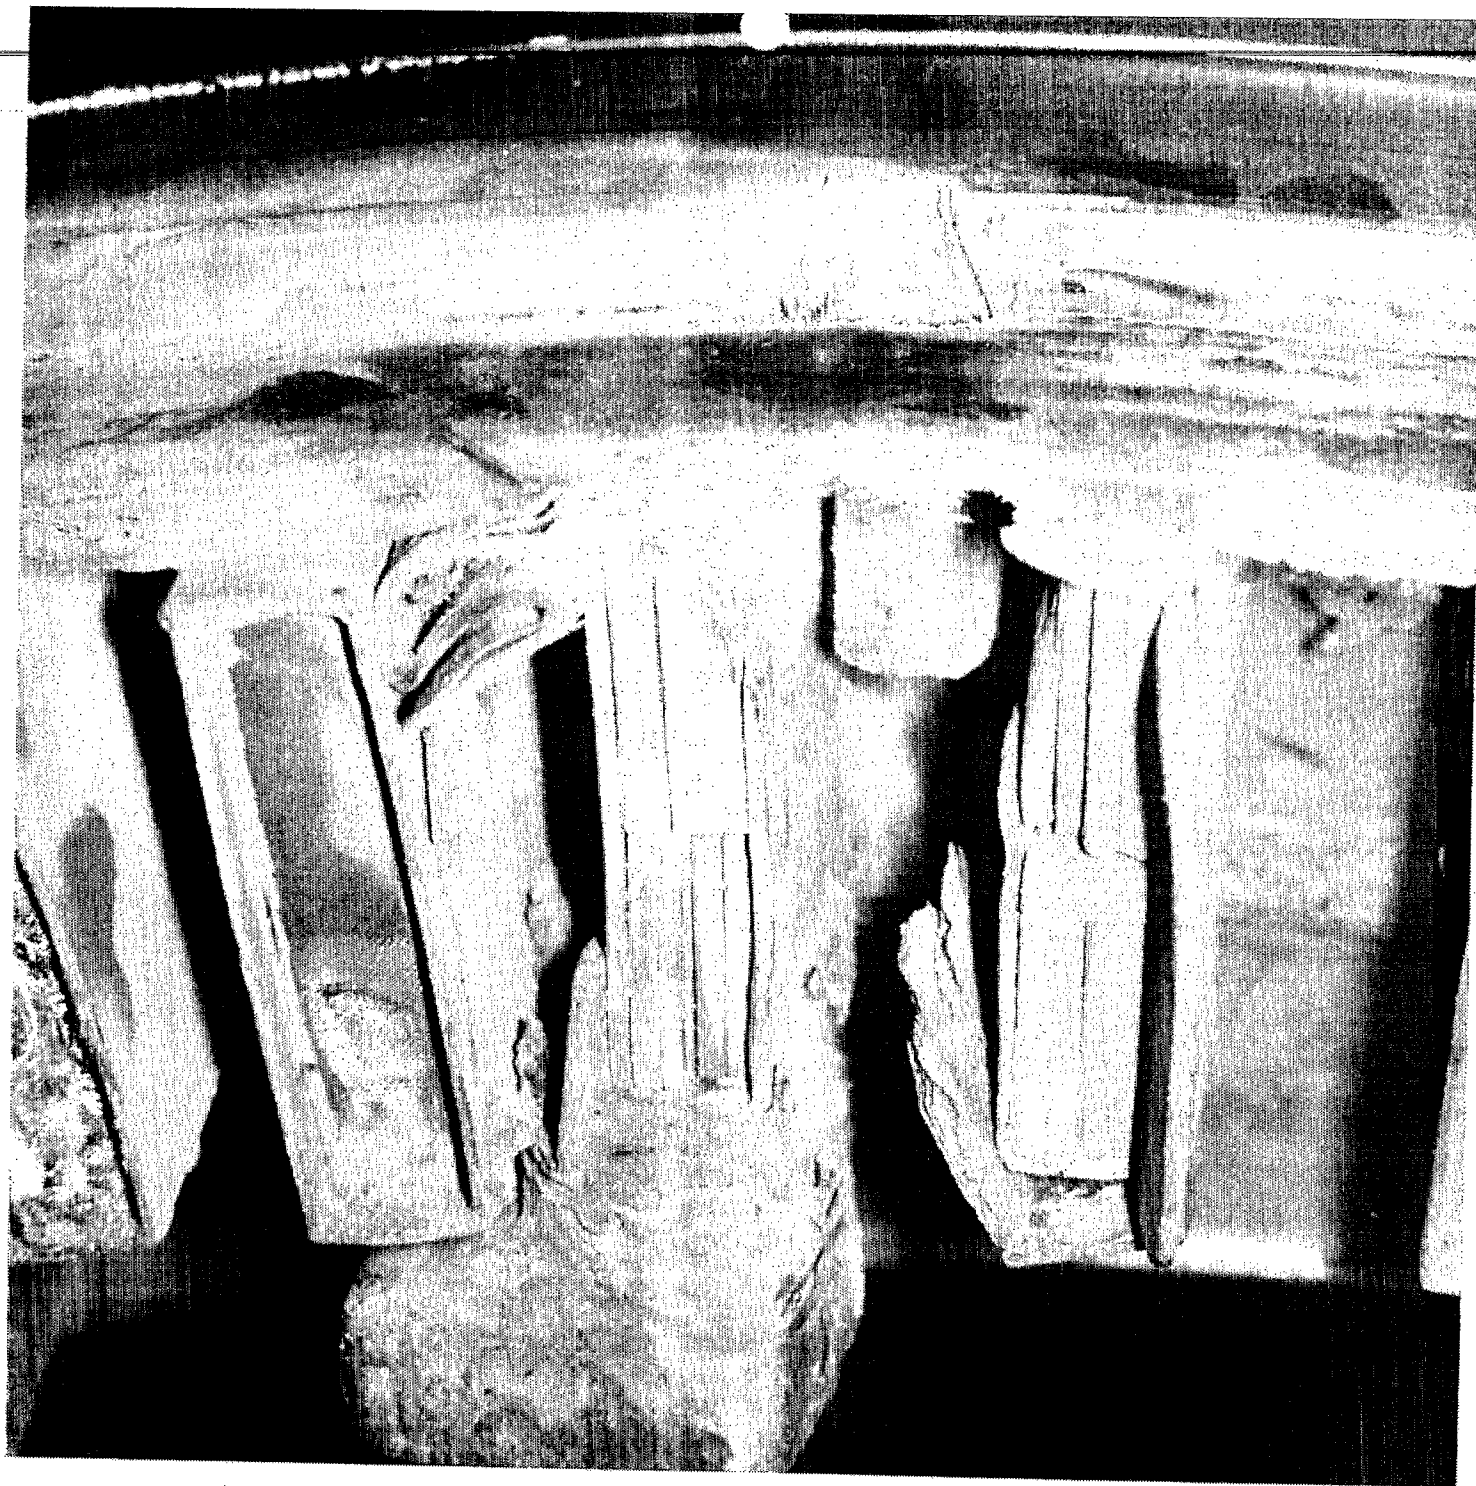
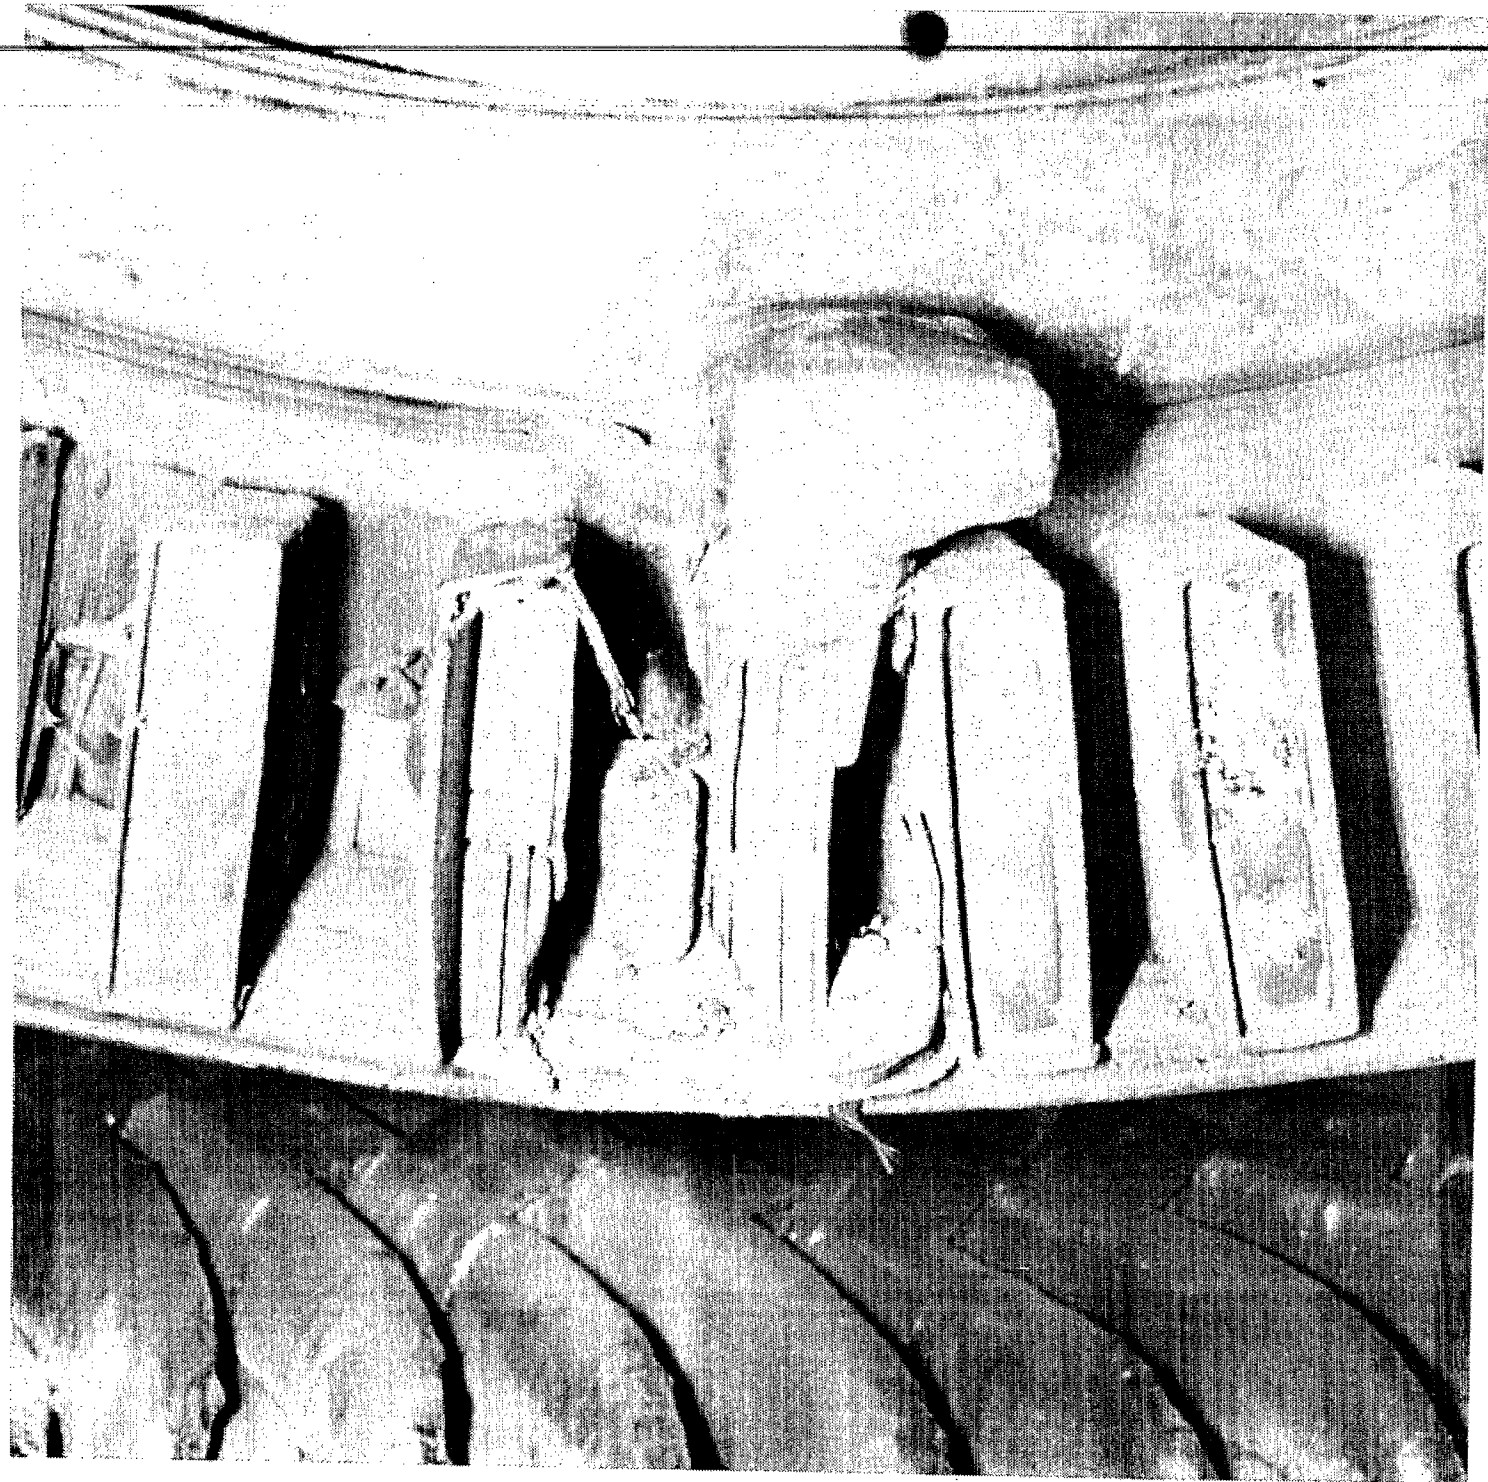
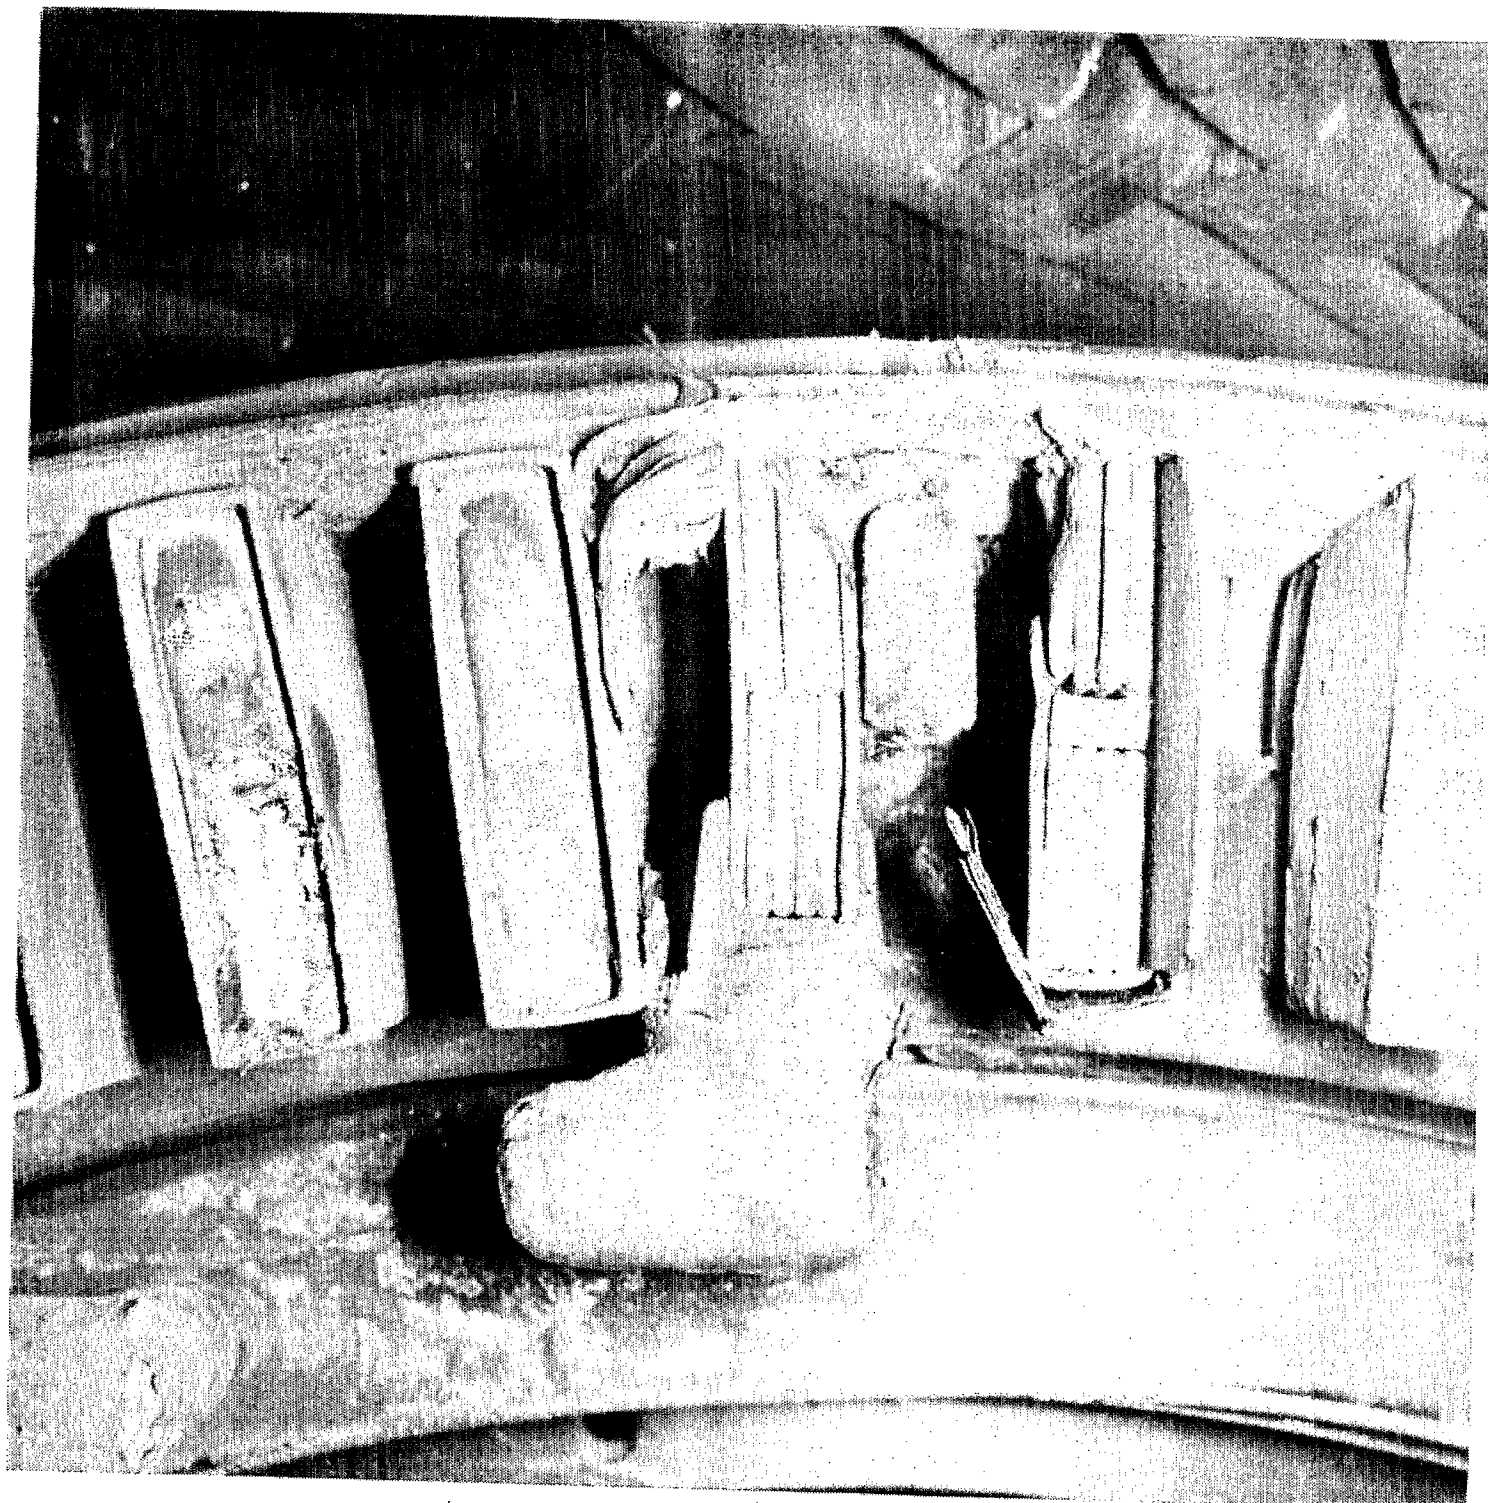
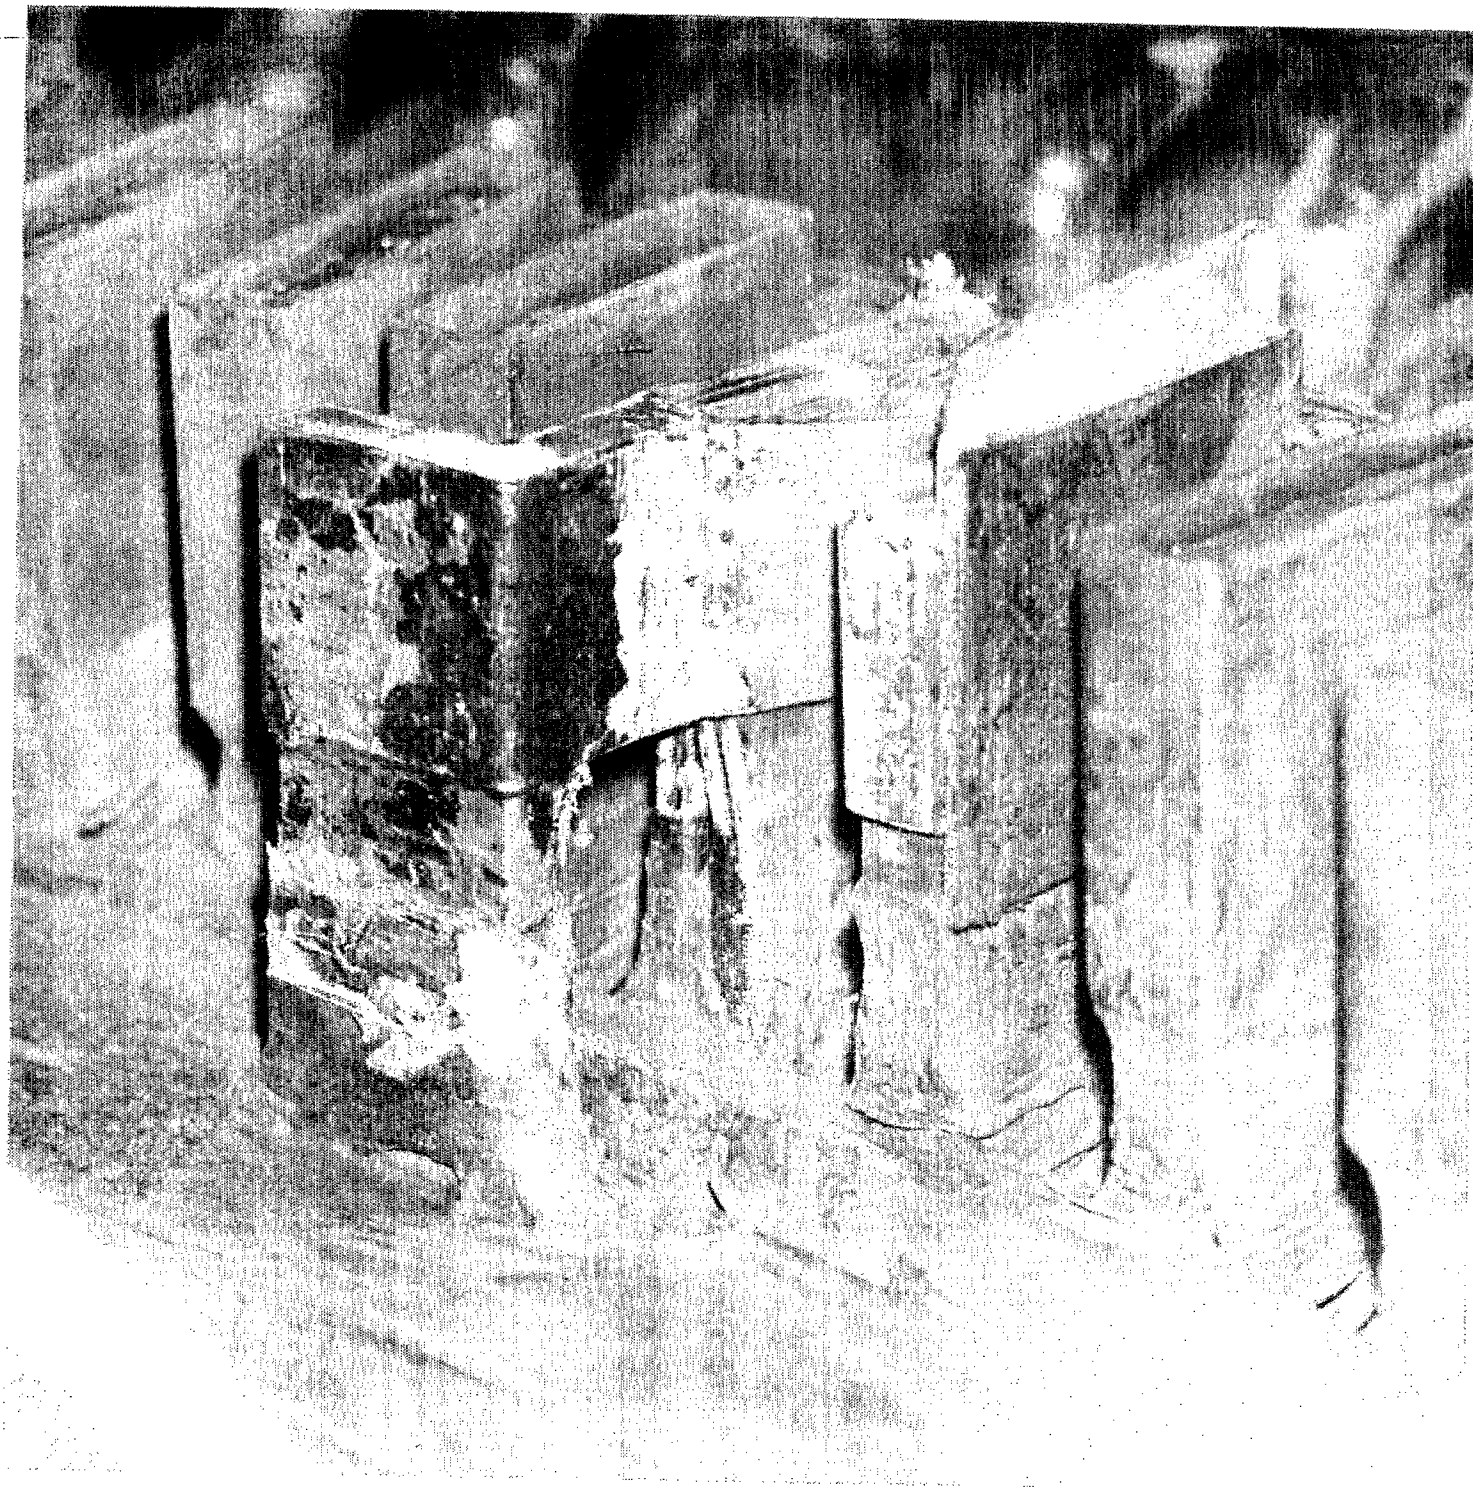
Fig. 2

After removing the slip-ring cover and the motor end shields, it was found that one or two rotor winding end connections and the rotor to slip-ring connections were severely burned. Figures 2 to 6 show different views of the external damage at the rotor winding end connections, and Figs. 7 to 9 show the physical damage at the rotor to slip-ring connections.

When the fault occurred, the heat generated by the fault melted the solder which was thrown outward centrifugally on the end turns of the stator coils and inside the motor end shields. No damage was done to the stator coils. Extensive arc erosion took place on one of the rotor half coil ends. The copper evaporated. The fault was phase to phase. The area of the damage is shown circled in red on Siemens drawing number TRA-W 1827/1. At the rotor winding to slip-ring connections, the arc occurred from the bolted joint (rotor winding connection bar to slip-ring bars) to the shaft and slip-ring assembly guard ring which is at the same potential as the shaft. The heat generated by the arc melted the connection solder which was thrown out centrifugally to the inside of the outer motor end shield.

The coil insulation at the slip-ring end of the rotor (where the fault occurred) which is under the retaining ring is extremely dirty with carbon

from the brushes. This is an area that is very difficult to clean and it is evident that the dirt was a major cause of the fault or arc-over between phases.

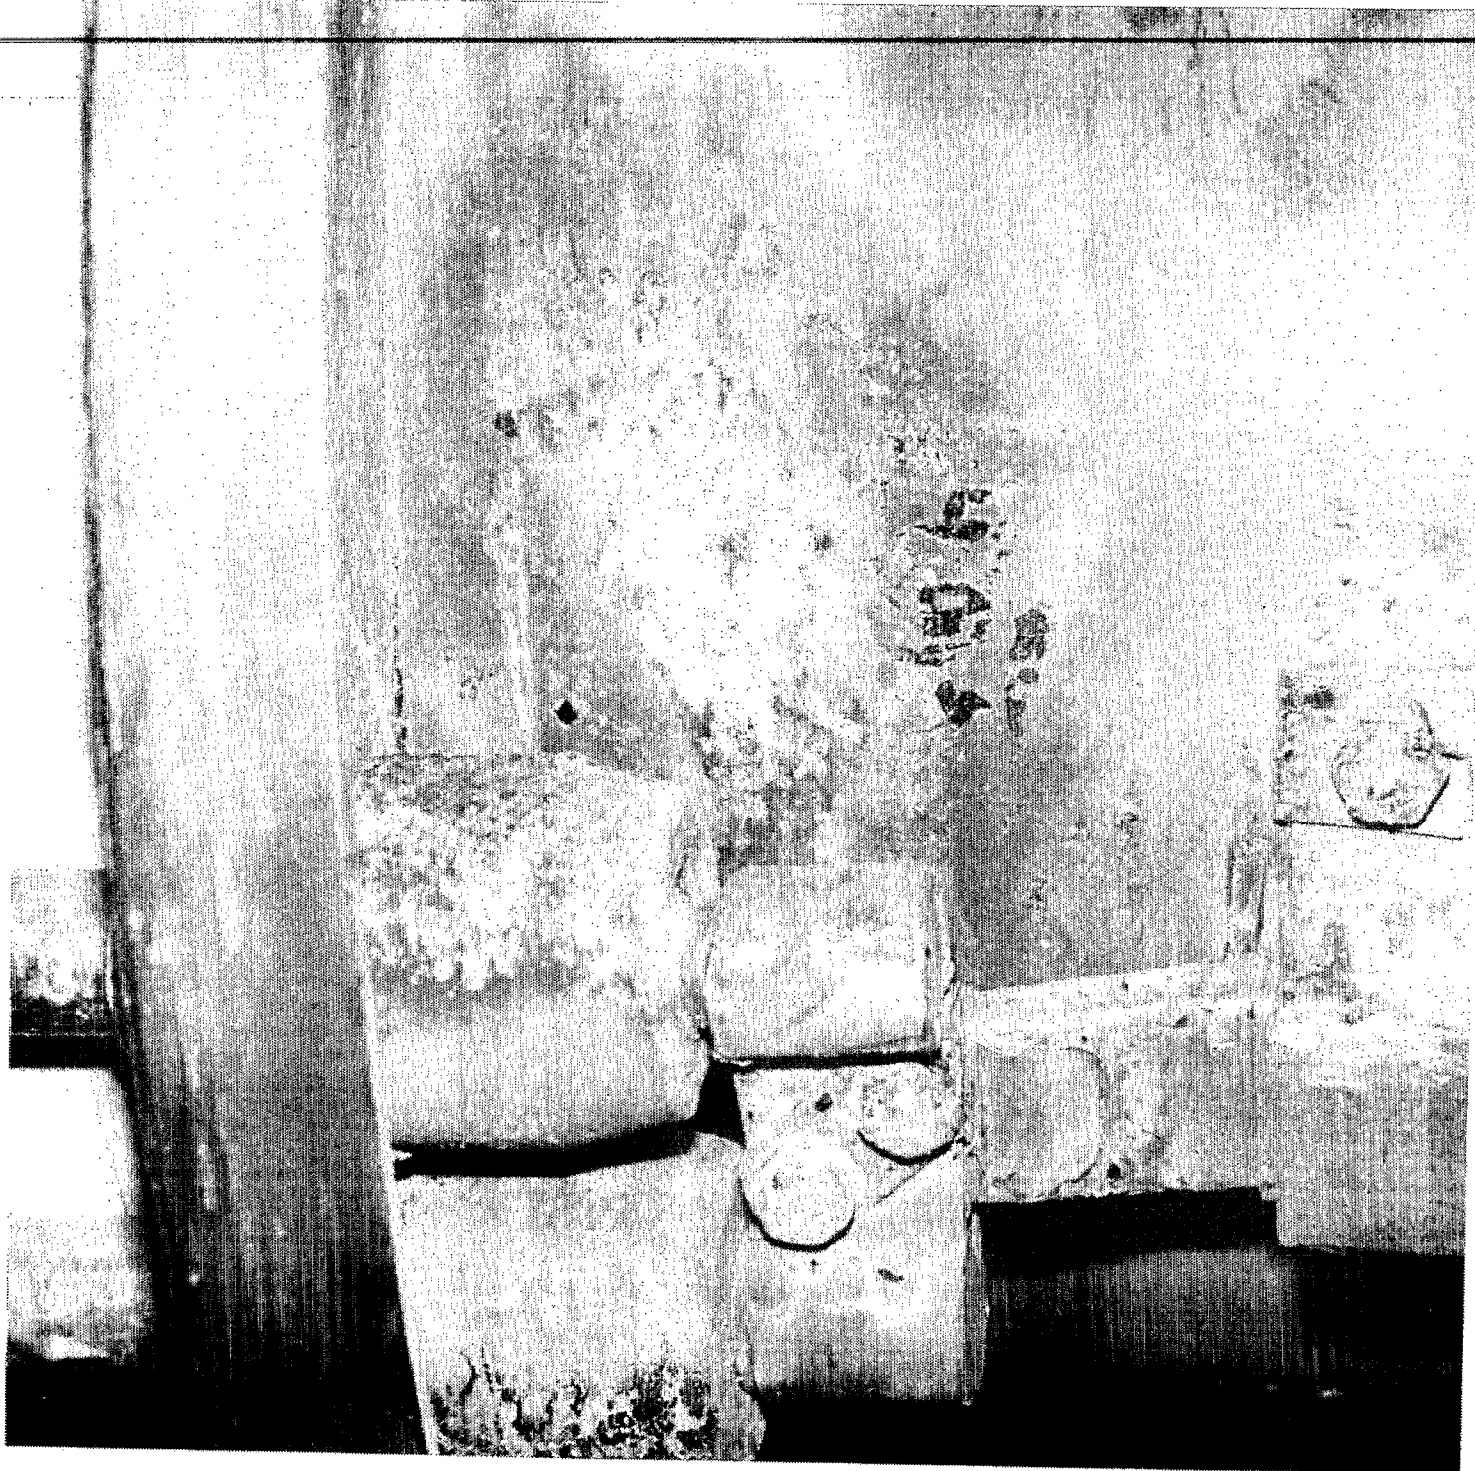
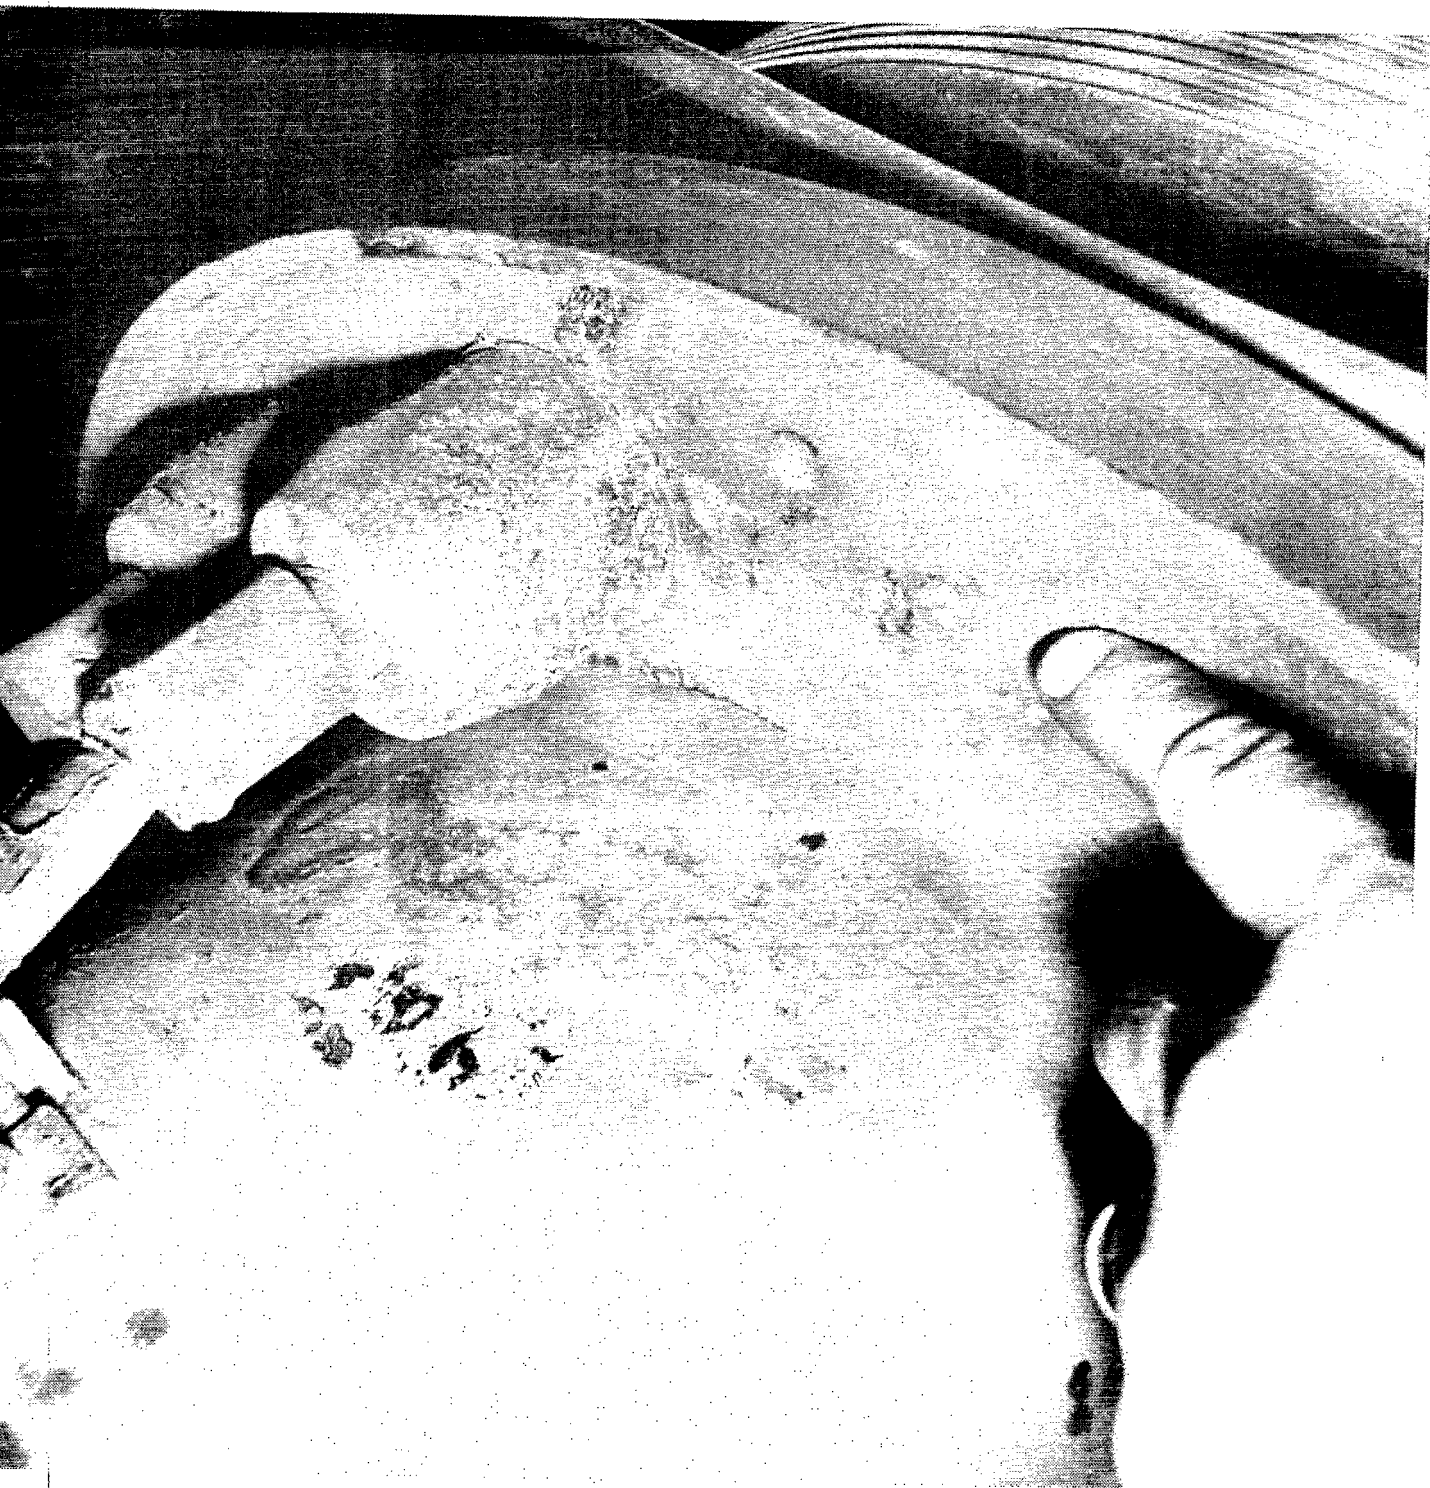
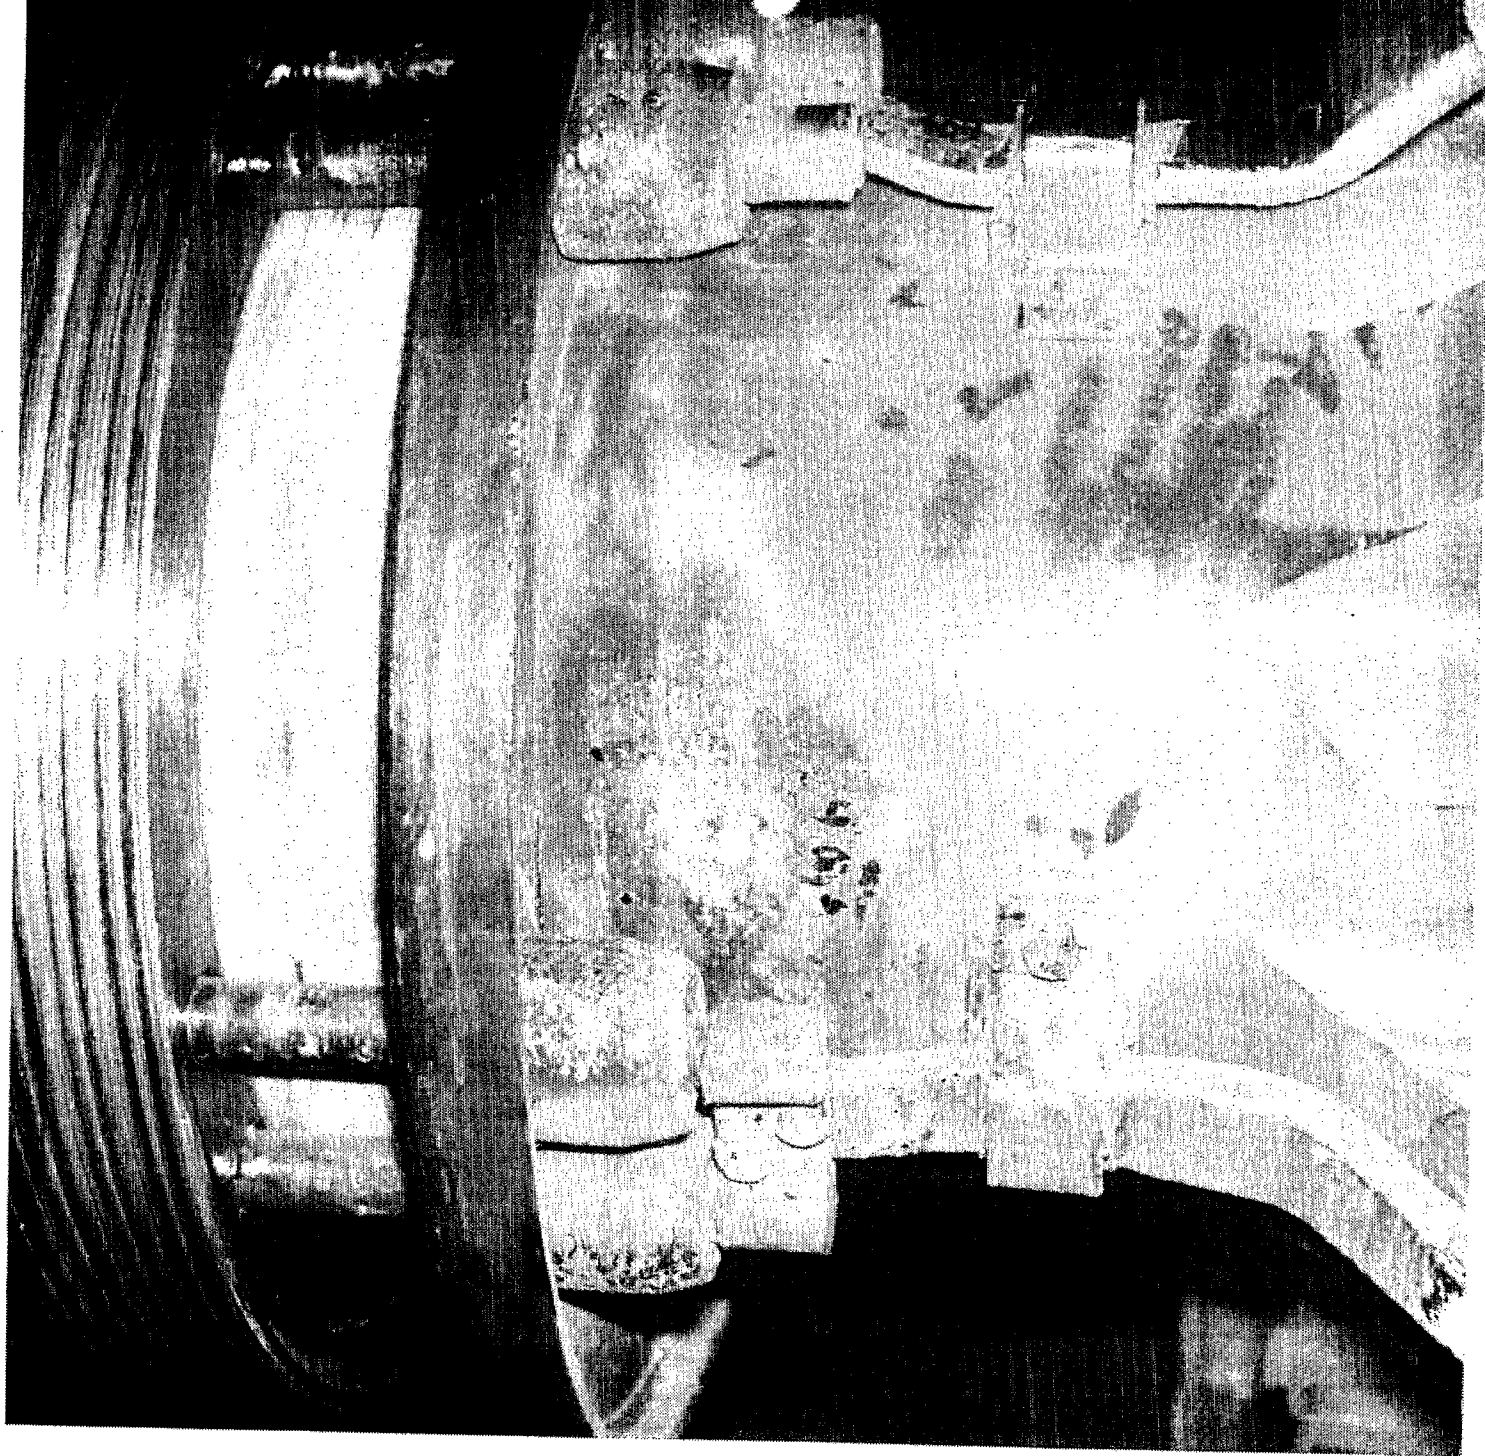
Fig. 7

The connector bolts at the connection between the slip-ring bars and the rotor winding connecting strap were too long and thus too close to the shaft. The bolts will be turned around to get more clearance to the shaft and the shaft in this area will be insulated with glass tape and epoxy.

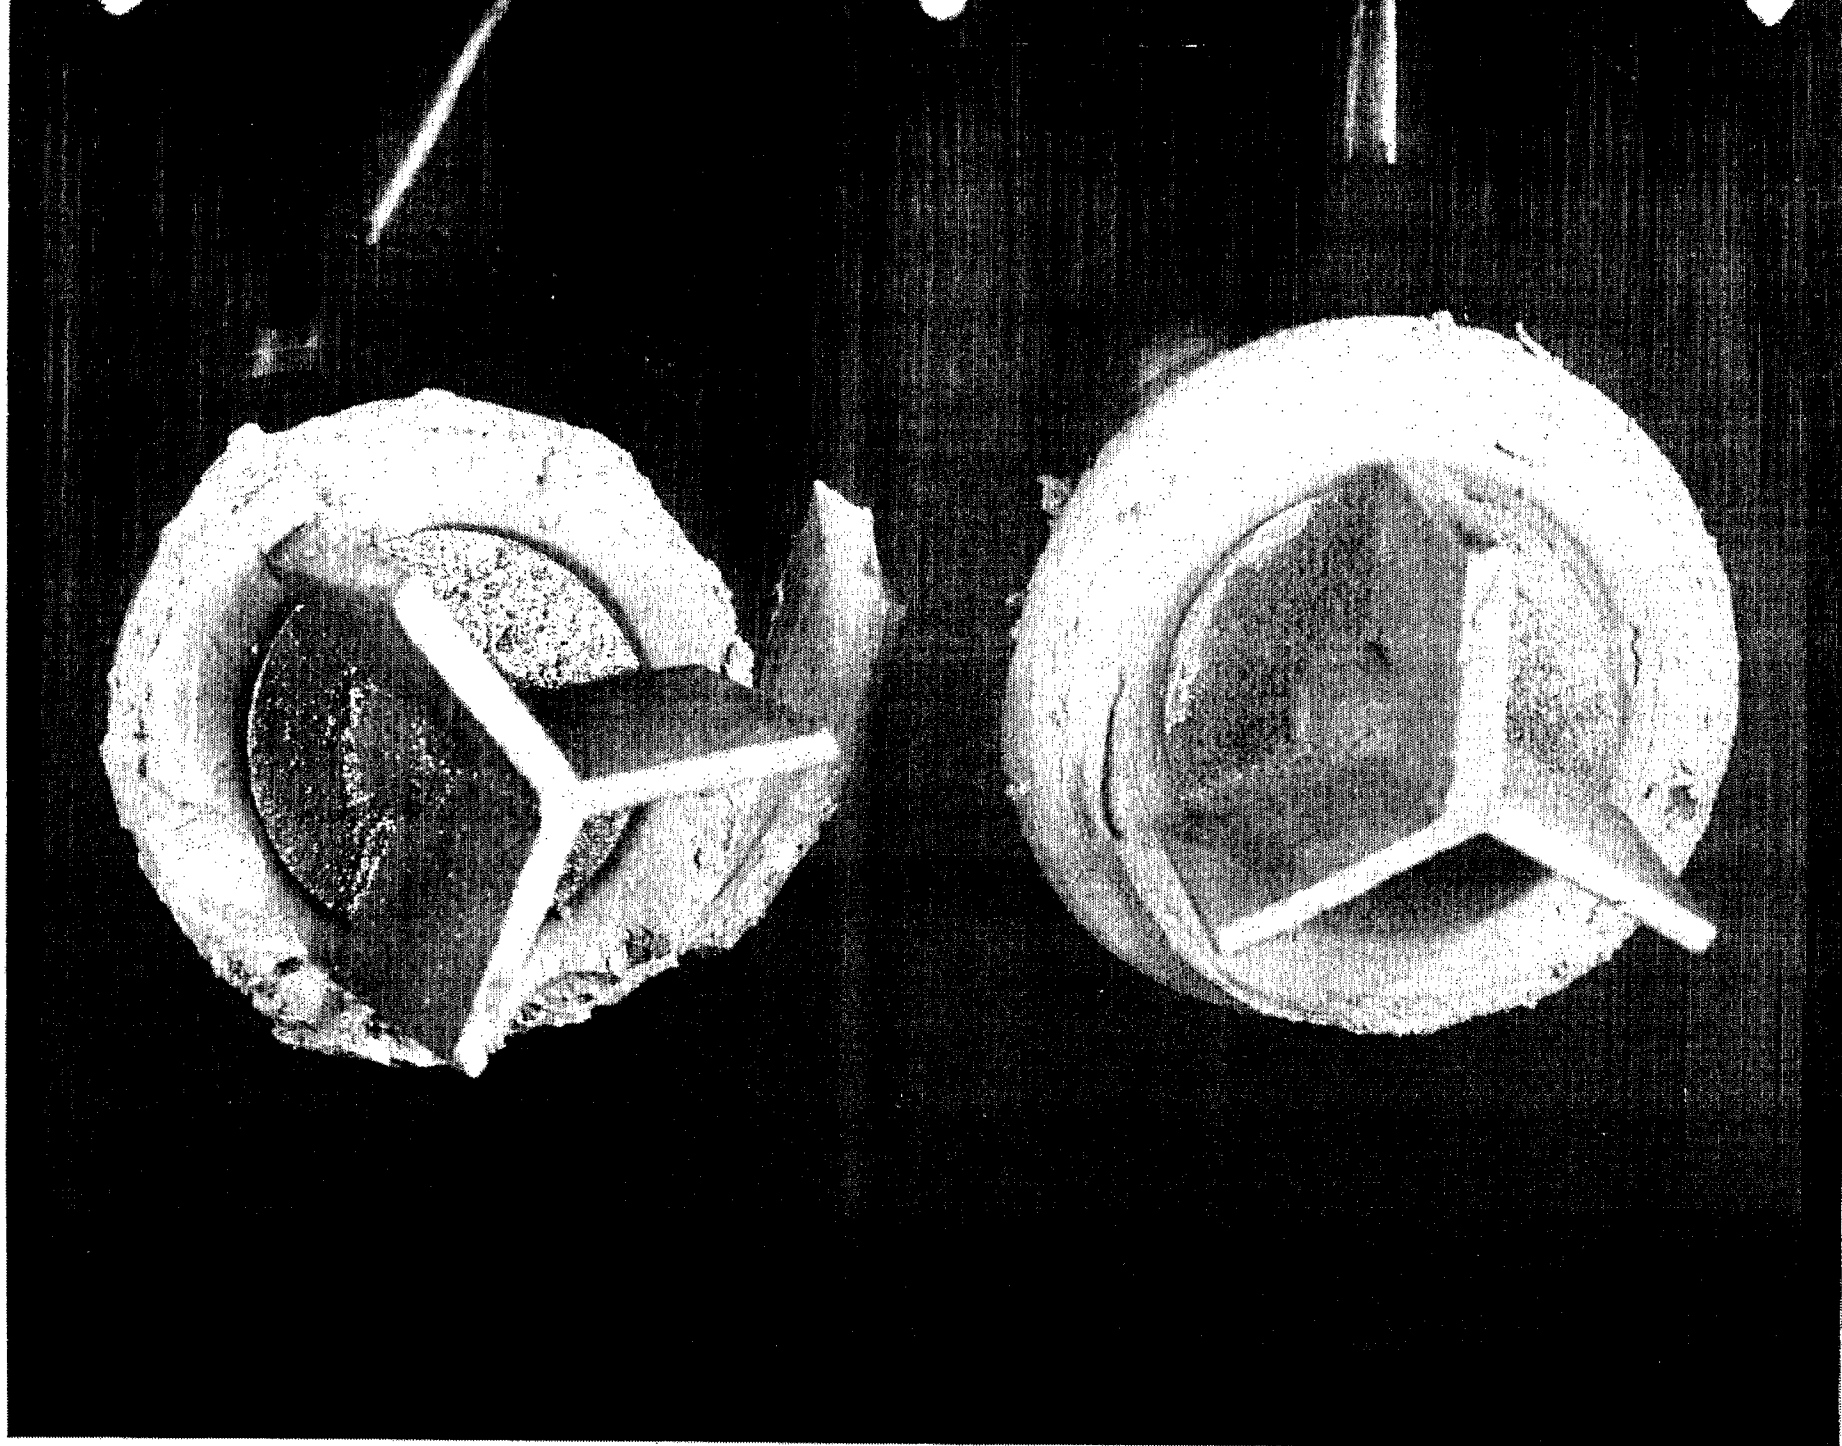
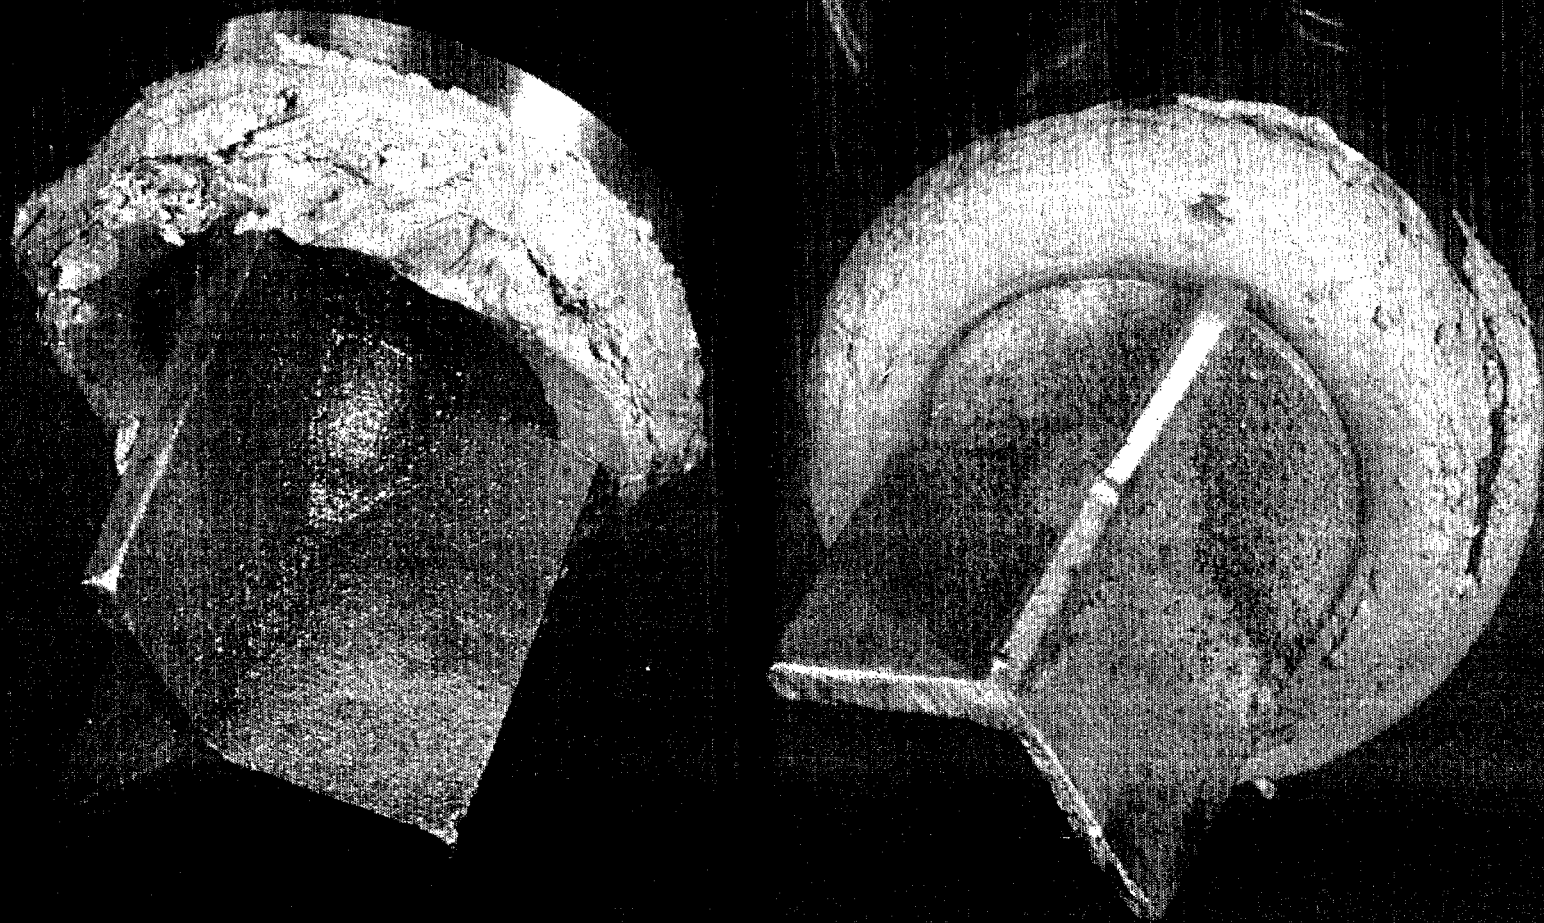
Fig. 10

The pumps were disassembled and thoroughly examined for signs of wear or component failures and none could be found. Each pump suction line has a foot valve (check valve) installed at the lower end of the pipe line near the bottom of the oil tank. See Siemens drawing number 2D8.6701-167338 coordinate B5. These check valves were disassembled. It was found that the check mechanism seal had deteriorated. See Figs. 10 and 11. The material used to seal at the valve seat (not shown) was some type of rubber which had become spongy, distorted, and eroded in the case of pump #2 check valve where the flow was not impeded when tested. In the case of pump #1 the seal material was so bloated as to impede the proper operation of the valve and thereby to restrict the normal flow of oil.

Since pump #1 and #2 are well down into the tank, and therefore self-priming, the suction line check valves were completely removed. The check valve at the lower end of the shaft-driven pump suction line exhibited the same problem as the others in that the seal material was spongy and bloated to the point that it seriously restricted the normal flow. The seal material is very evidently not compatible with the lubricating oil. This oil is Mobil DTE medium grade oil without any inhibitors. Since this check valve must hold

fifteen feet of oil to prevent the loss of charge of oil for the shaft-driven pump, it was repaired using Buna-N synthetic rubber material to replace the defective seal material.
