SIEMENS POWER SUPPLY MOTOR-GENERATOR SET MOTOR ROTOR FAILURE

AGS DIVISION TECHNICAL NOTE

No. 99

September 29, 1972

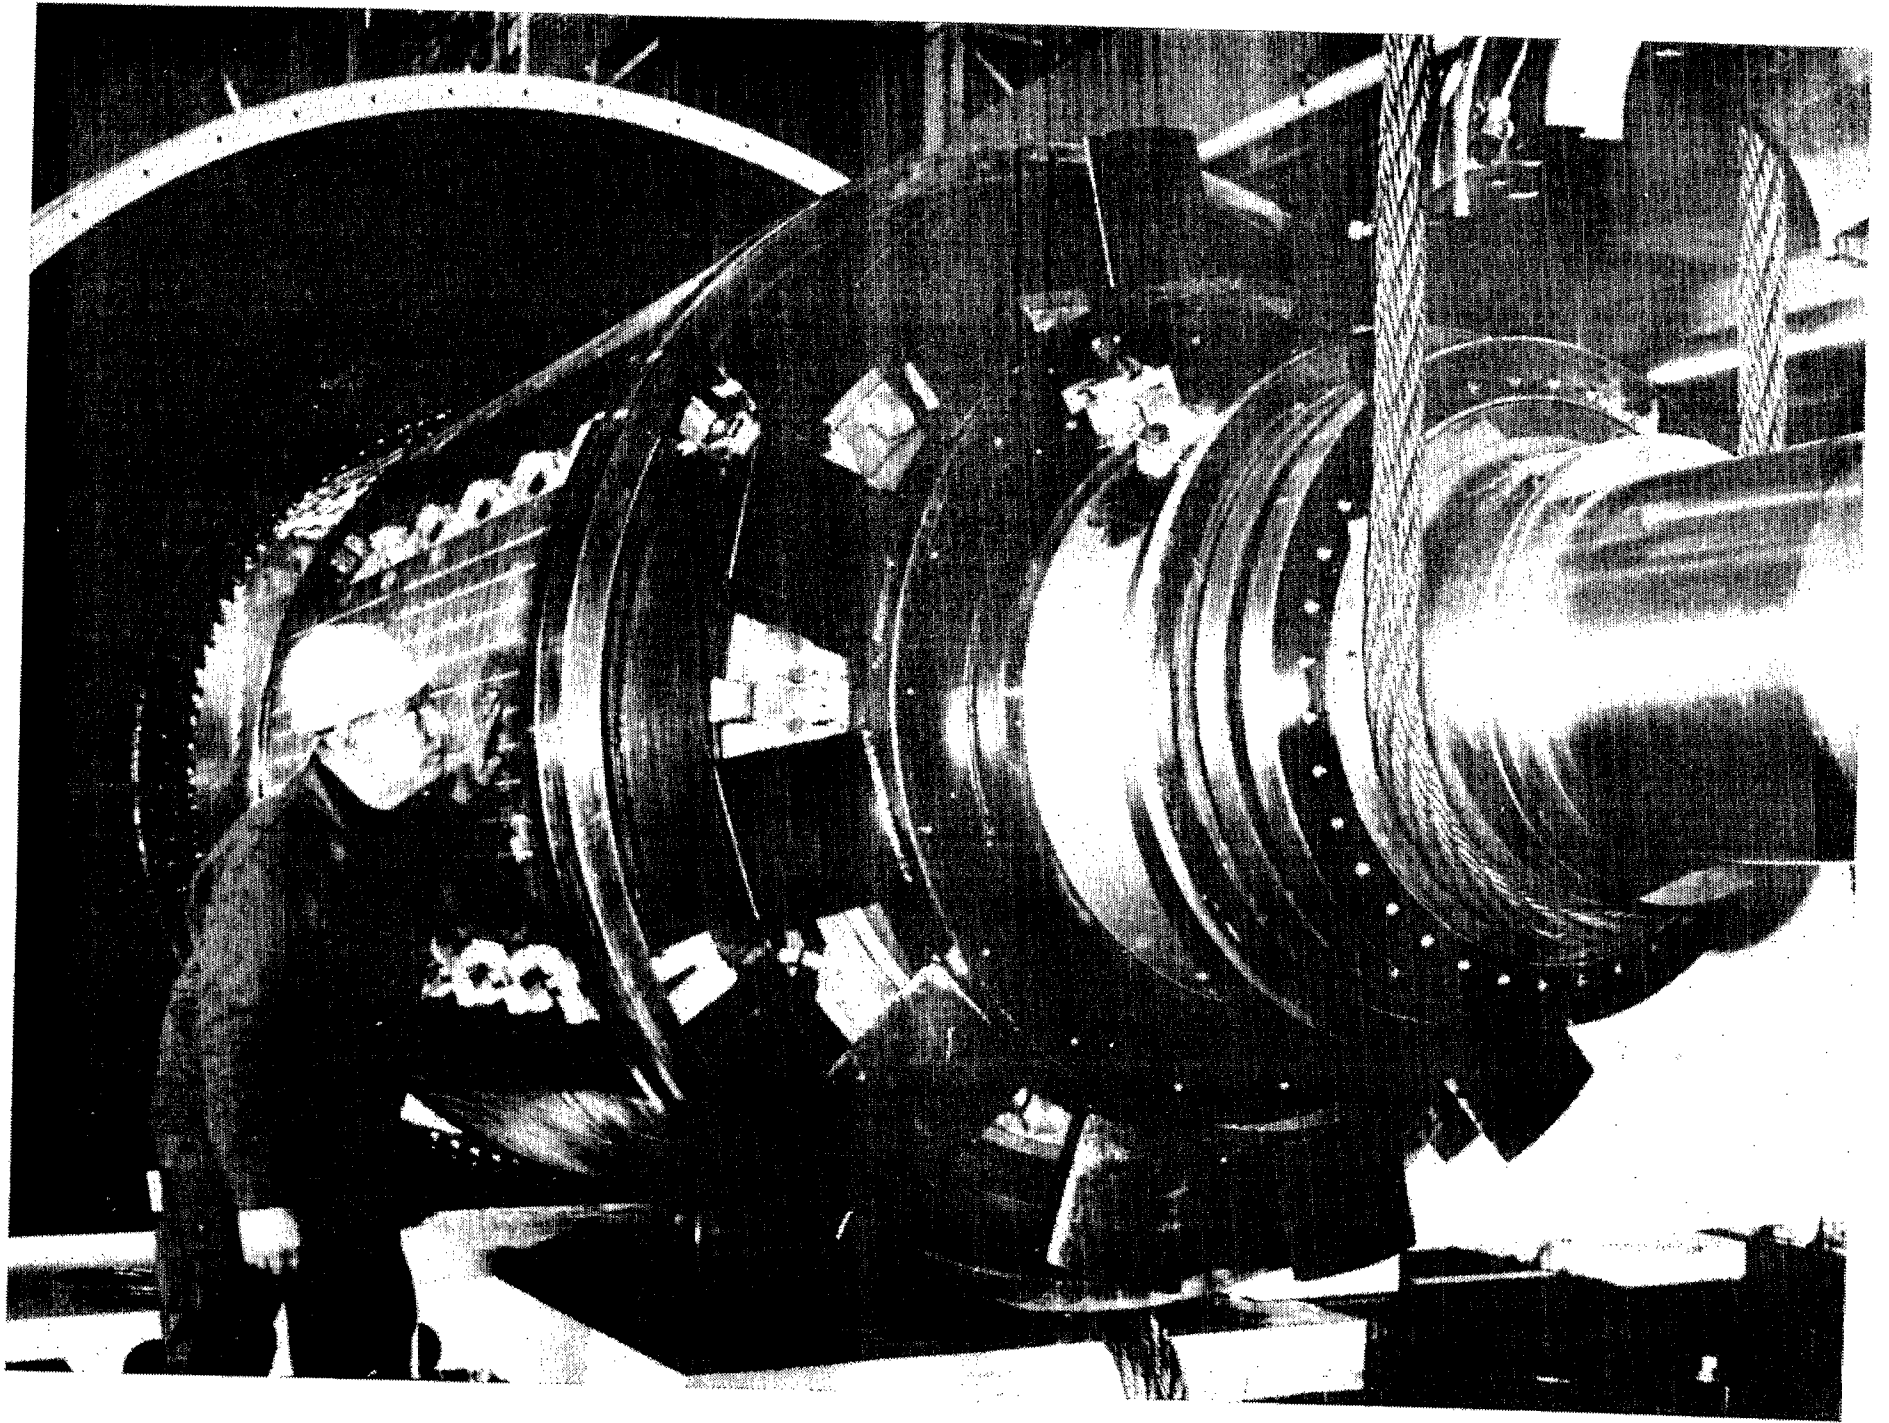
Fig. 12

Inspection of the AGS generator rotor showed the same condition. See Fig. 12, generator rotor, and Siemens drawing number 1D1.1384-156656, field coil brace. In the photograph, the field coil braces (light color) are shown between the poles. There are six braces between each of the six poles. As shown on the field coil brace drawing, one bolt retains the brace. The bolt head is locked by a lock plate to prevent it from turning. In turn the brace compresses insulation blocks onto the field coils.

During normal operation, the poles expand thermally due to the field pole current and elastically due to the high centrifugal force. These compress the insulation blocks at the field coil braces. With continuous operation, the insulation blocks become thinner requiring the tightening of the field coil brace retaining bolts periodically. Since these retaining bolts are not easily accessible while the rotor is inside the stator, the rotor must be pulled out to accomplish the tightening.

The field coil brace were tightened down and the retaining bolts were

torqued to 150 foot-pounds. The generator rotor was rigged back into the stator and completed Wednesday, September 20.
