AGS/AD/Tech Note No. 144;BNL-104573-2014-IR

## VIDEO SPLATTER ON VERSATEC HARD COPY

W. Frey

February 1978

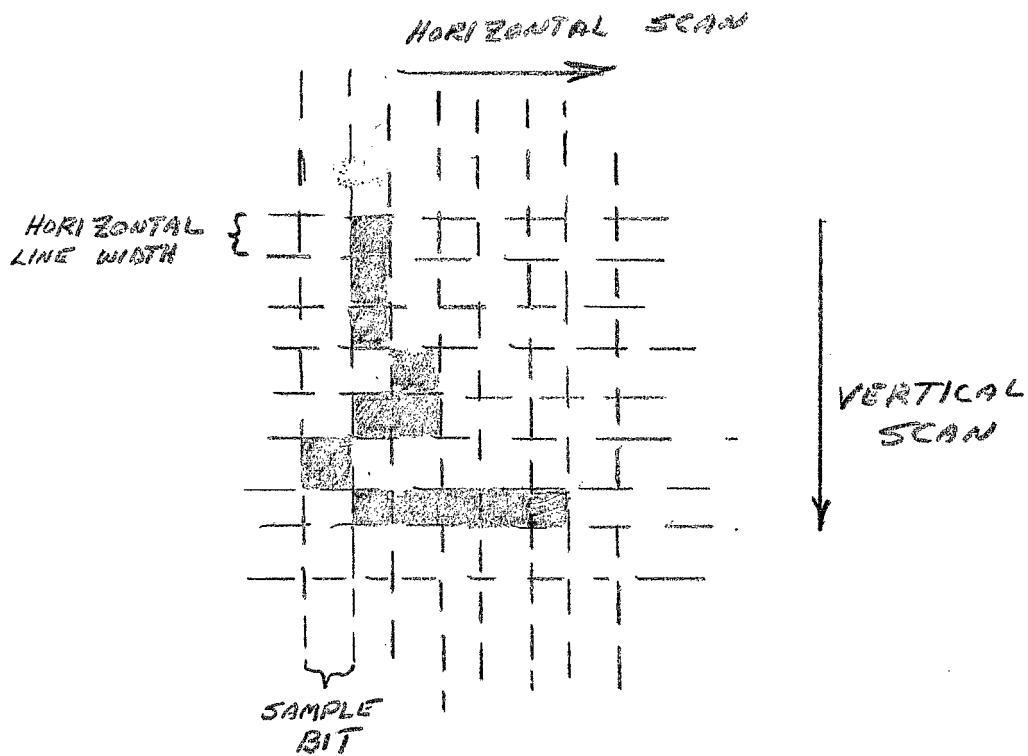
Noise on the signal and possible bandwidth limitations on the signal will effect the transition time at the threshold circuit to cause the character width to jump between sample periods resulting in breakup of a vertical stroke as successive video lines are printed (see Fig. 2).

Fig. 2 Video splatter resulting in breakup of the letter L due to shift of video information on vertical line of letter.

Thus, it seems that there is no simple solution to the printout problem. Each input to the Controller will have to be optimized and the Controller internal adjustment optimized for overall system performance.
