# VIDEO SPLATTER ON VERSATEC HARD COPY

AGS DIVISION TECHNICAL NOTE

No. 144

February 14, 1978

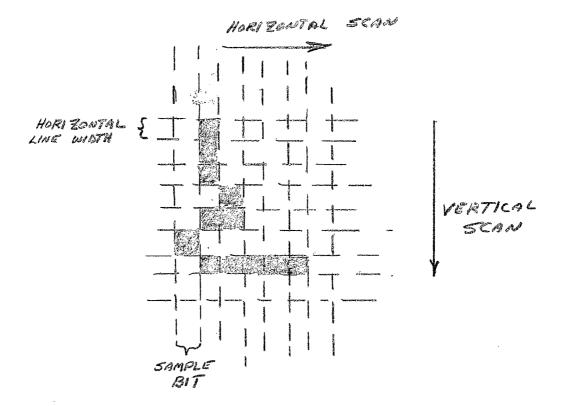
Noise on the signal and possible bandwidth limitations on the signal will effect the transition time at the threshold circuit to cause the character width to jump between sample periods resulting in breakup of a vertical stroke as successive video lines are printed (see Fig. 2).

Fig. 2 Video splatter resulting in breakup of the letter L due to shift of video information on vertical line of letter.
