**AGS/EP&S/Tech. Note No. 132**

May 24, 1989

*W.J. Leonhardt*

**Shielding Block Lug Failures**

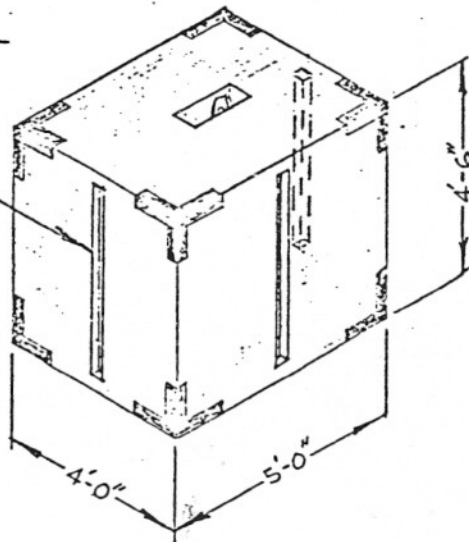
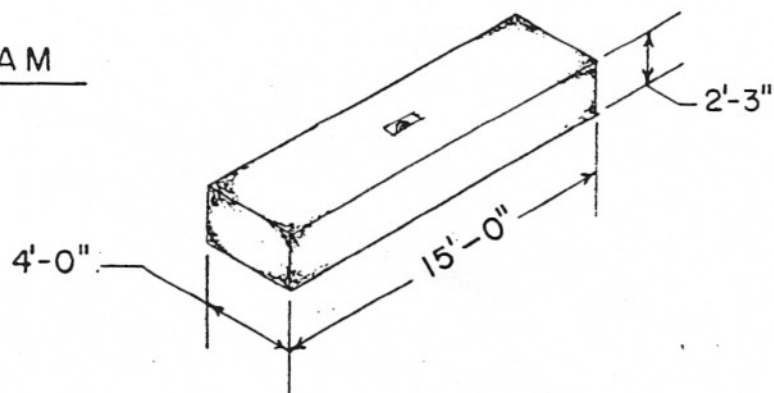
The first failure occurred in the Target Building while lifting a B-block over the AGS ring. The block was raised to virtually the highest point possible with the crane and then a horizontal traverse was begun. At this point, the lug failed causing the block to fall onto the AGS roof.

The second failure occurred over the B cave in EEBA. Fifteen-foot roof beams were being lifted to expose the cave below. One beam was wedged between adjacent beams and, when lifting was attempted, became stuck with a tilted orientation. Further attempts to free the beam resulted in the lug breaking.

Fig. 1. Blocks that failed.

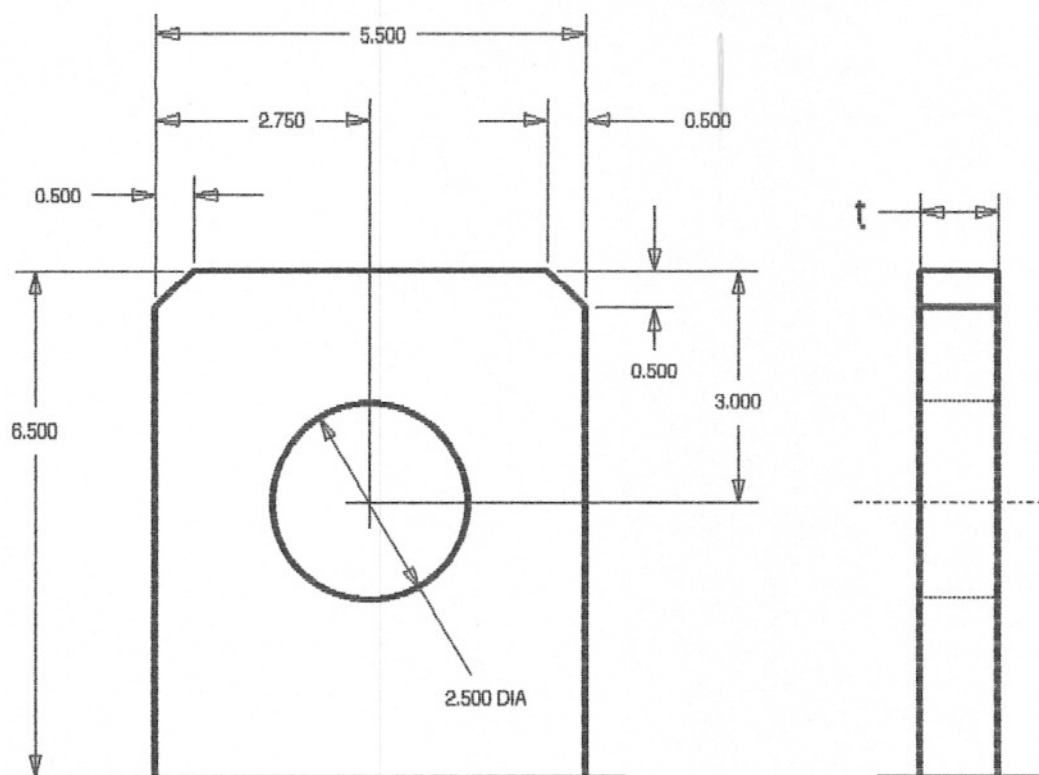
The results of the tests indicates that the failed lug material was very similar to ordinary mild carbon steel (tensile strength ~ 68000 psi, yield strength ~ 35000 psi) with one important exception: the notch toughness determined by the Charpy Impact test was unusually low. This indicates that the material has a high ductile-to-brittle transition temperature which means that at temperatures normally encountered by AGS shielding blocks, the lug may behave in a brittle fashion.

The results of the qualitative spectrographic and quantitative chemical analysis indicated that the material possesses an extremely low silicon and aluminum content indicating the material to be a rimmed (non-killed) steel. Non-killed steels inherently

exhibit little or no toughness and this is consistent with the fact that a visual examination by metallurgical experts determined that the two lugs in question experienced a classical brittle failure.

Fig. 2. Shielding block lifting lug.

The third item deals with modifying the shielding block lugs themselves. Metallurgists have determined that there are no metallurgical processes which will strengthen the existing lug material. In addition, reinforcing the lugs by welding additional material to them was tried but this solution was rejected when it was determined that the reinforced blocks were, in many cases, less strong than those blocks which were not reinforced. It is judged that reinforcement is not necessary, however, since the other solutions described above are adequate to assure safe block handling.

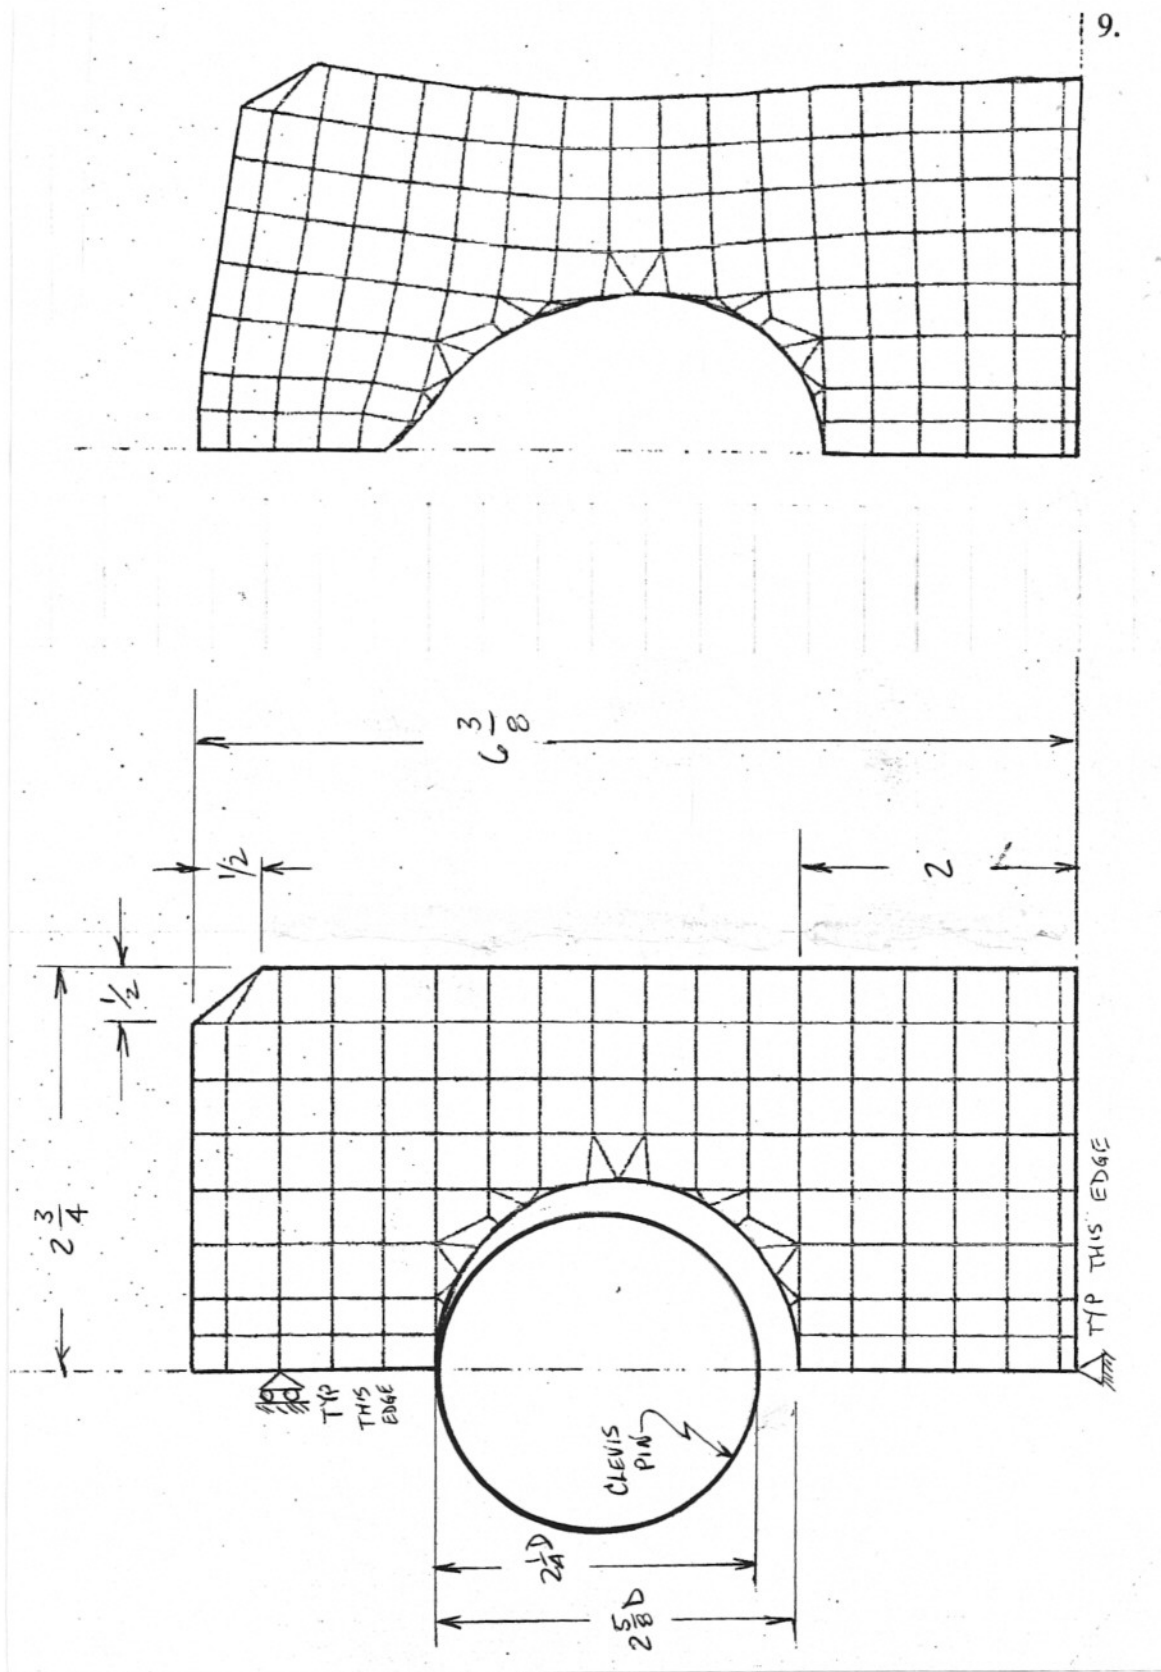
a generous safety margin either. A finite element computer code called MESS (Mechanical Engineer's Stress) was used to analyze a two-dimensional model of the B-block lug. A representative view of the model and its exaggerated shape under loading is shown in Fig. 3. The results of this analysis showed the von Mises' (total) stresses in the lug at the point of failure were about 25,500 psi which is close to the hand calculated values.

Fig. 3. Finite Element Model of lug and exaggerated model distortion under loading.

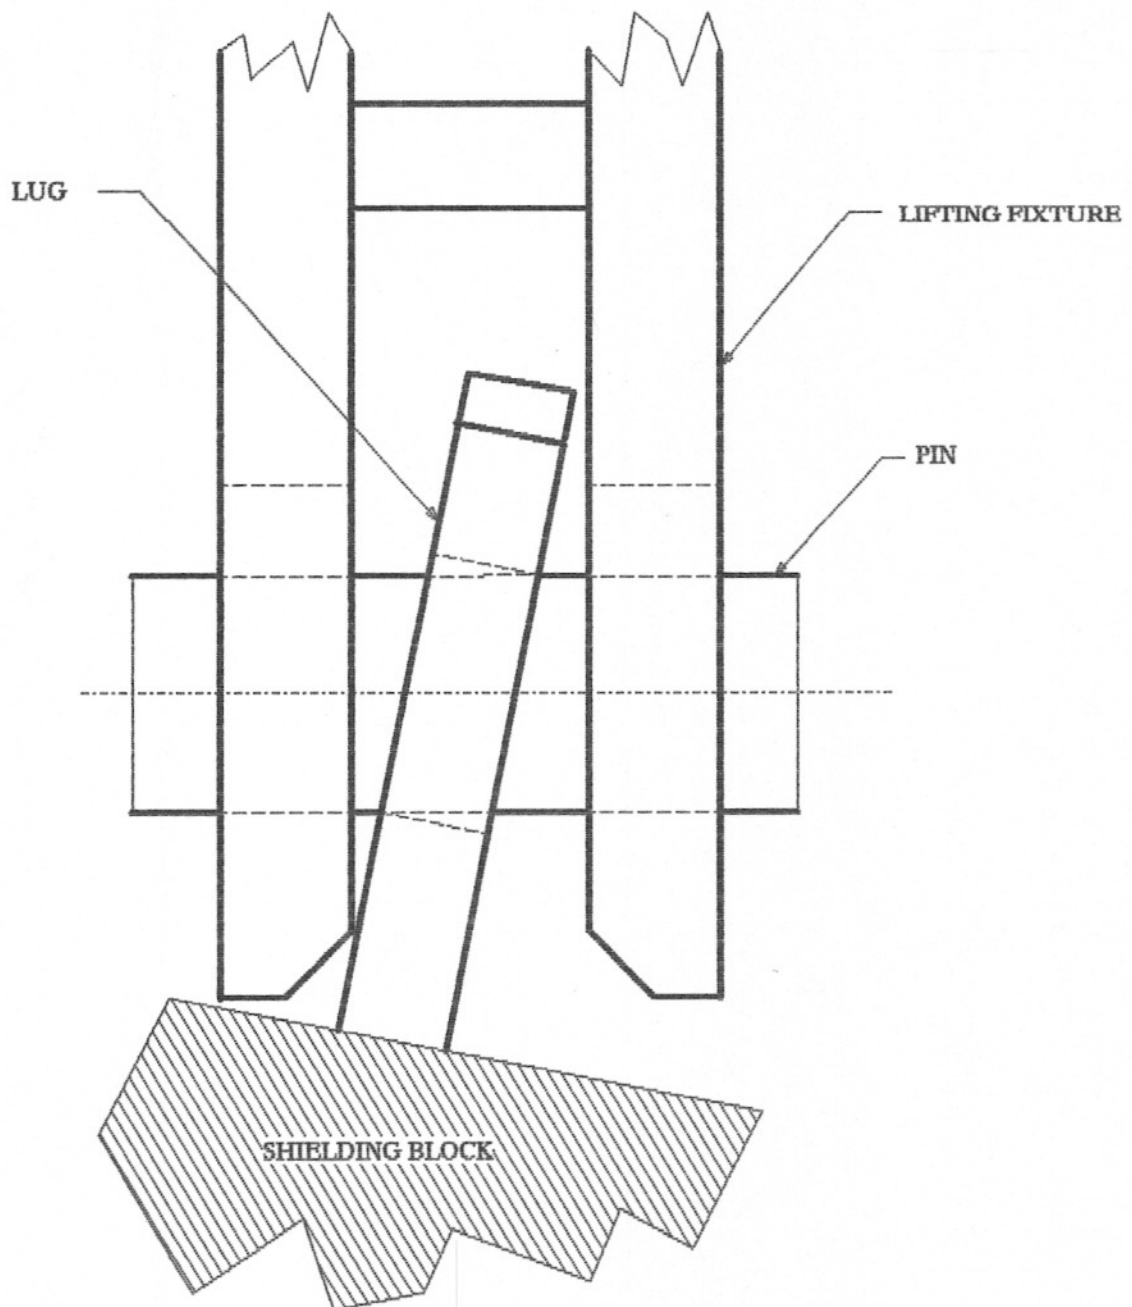
Inspection of the lifting equipment following the B-block failure showed that a large clearance existed between the lug and the lifting fixture used and between the lug and the pin, which can be seen in Fig. 4. The figure shows how these large clearances permitted the lifting fixture to impose large bending forces on the lug during horizontal accelerations. Analysis showed that bending stresses of over 56000 psi could be imposed by an acceleration of only 1 ft/sec<sup>2</sup>. These stresses are extremely high and could result in lug failure.

Fig. 4. Old style lifting fixture showing lug in bending.

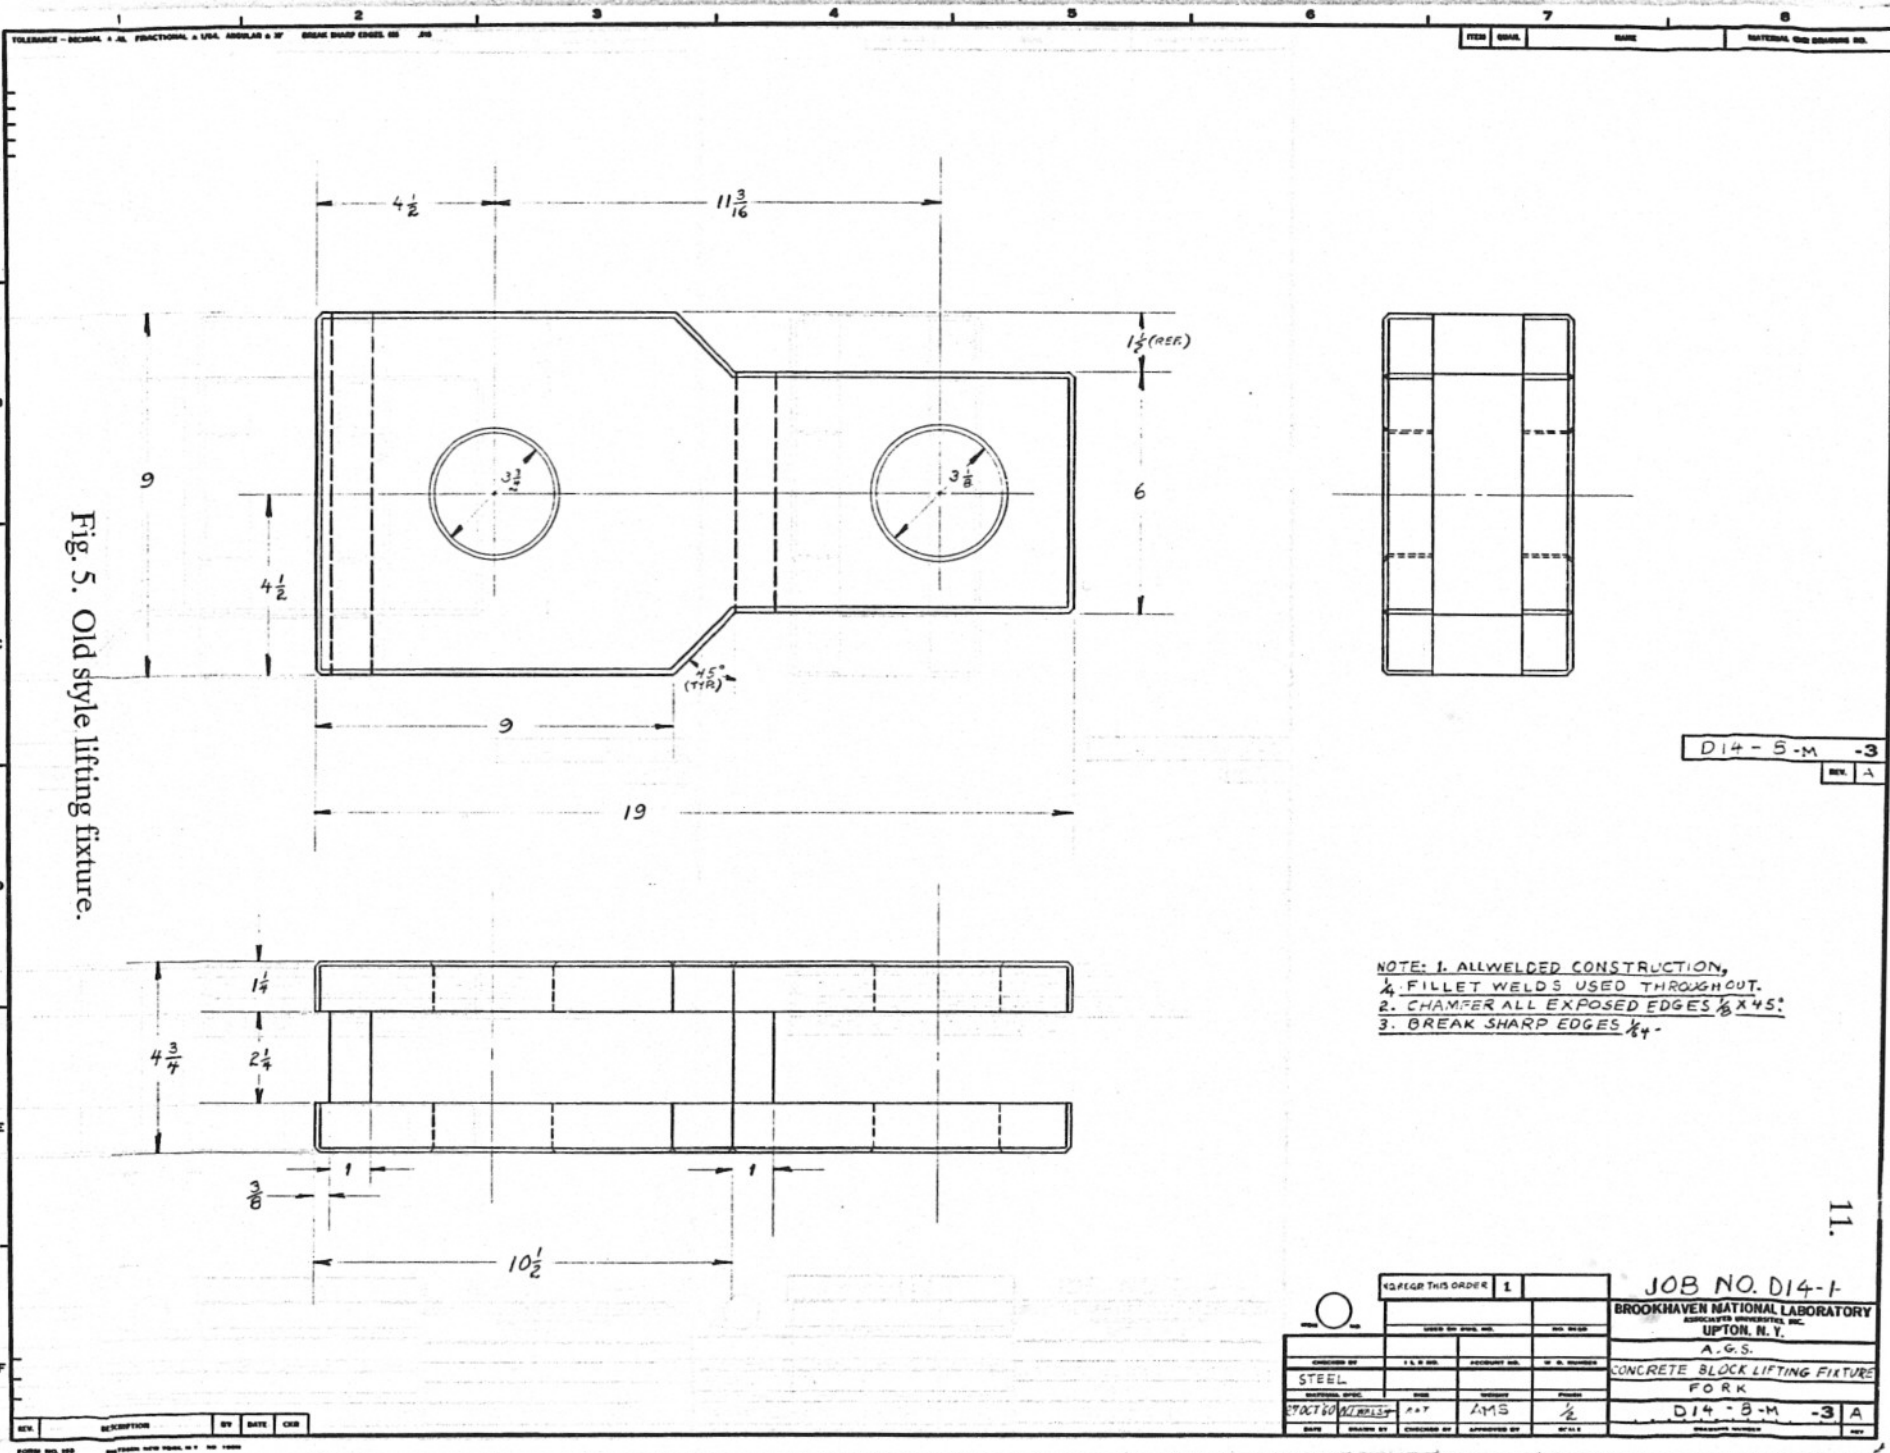
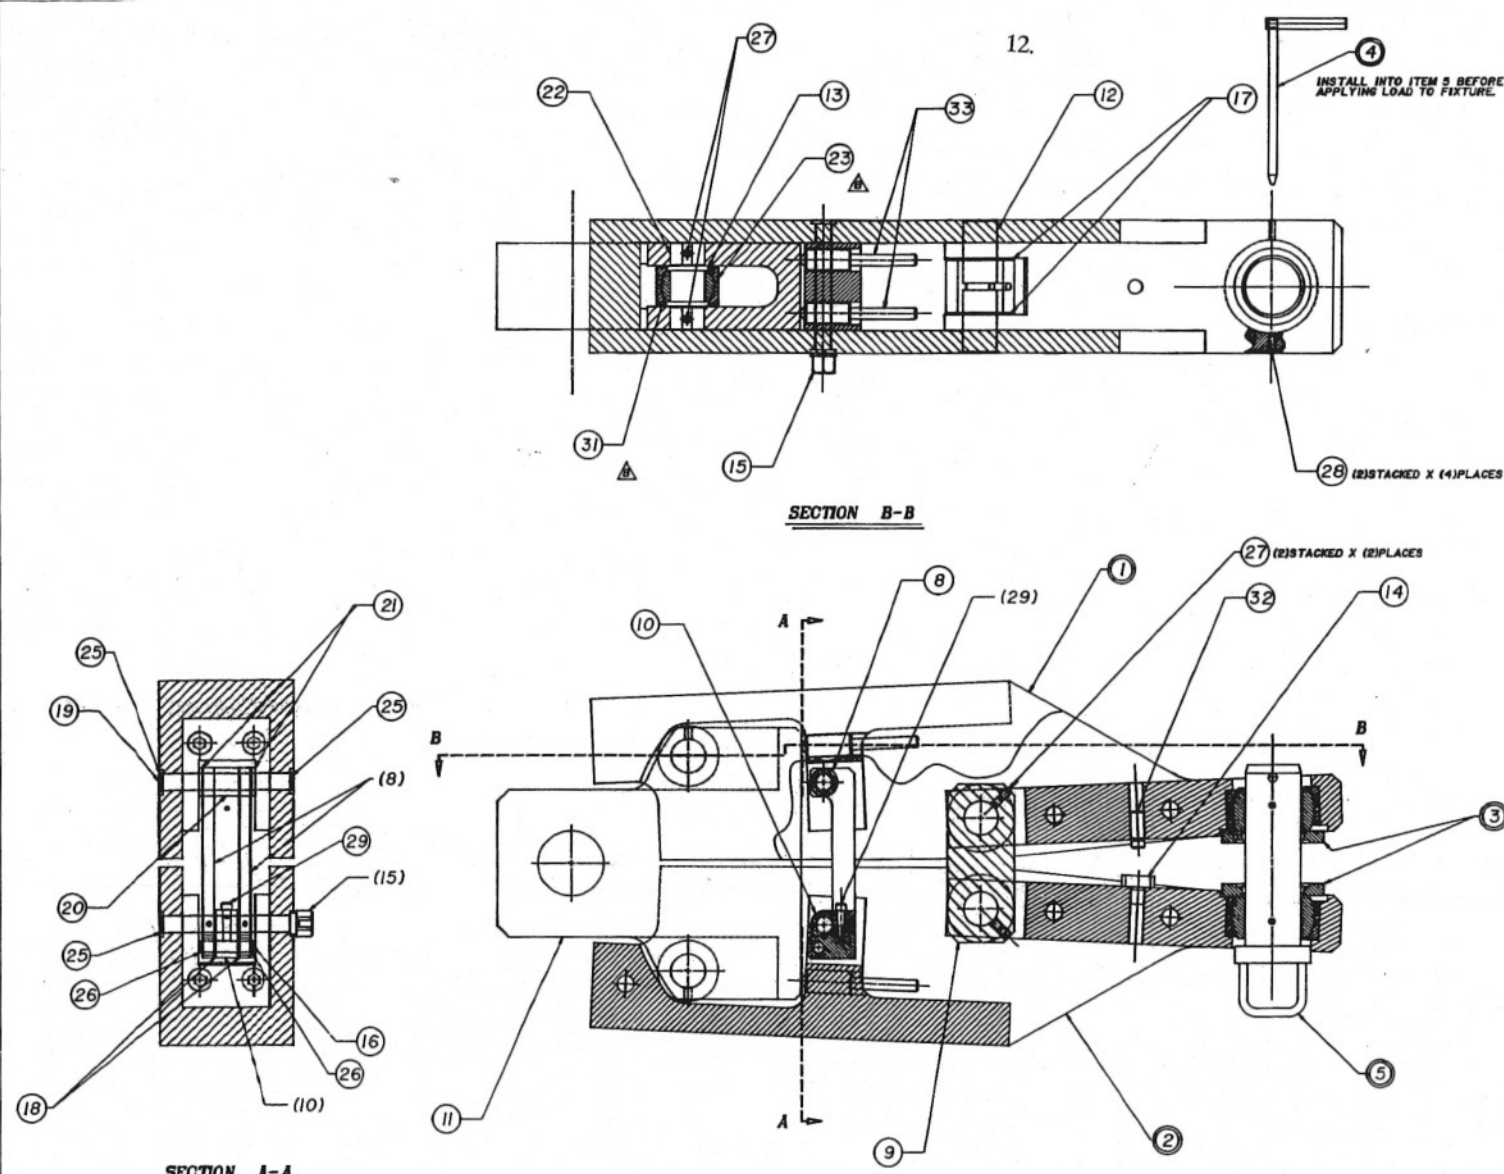
Fig. 6. New clamping lifting fixture.

The second item is being accomplished by making several hardware changes to reduce the stresses on the lugs. The large clearance problem evident in earlier lifting fixture, and a contribution to the first lug failure, has been eliminated by the use of spacers or shims as an interim measure. Since these shims must be installed each time a block is lifted (and thus could be forgotten), a passive type lifting fixture has been designed which will clamp the lugs in a manner which will transfer the bending stresses to an area of the lug which has sufficient strength to safely resist these bending stresses. Calculations show that this fixture reduces bending stresses by up to 50%. A prototype fixture has been built and tested and a full production design of a passive lifting fixture is currently being manufactured for each experimental area crane. A drawing of this new fixture can be seen in Fig. 6.

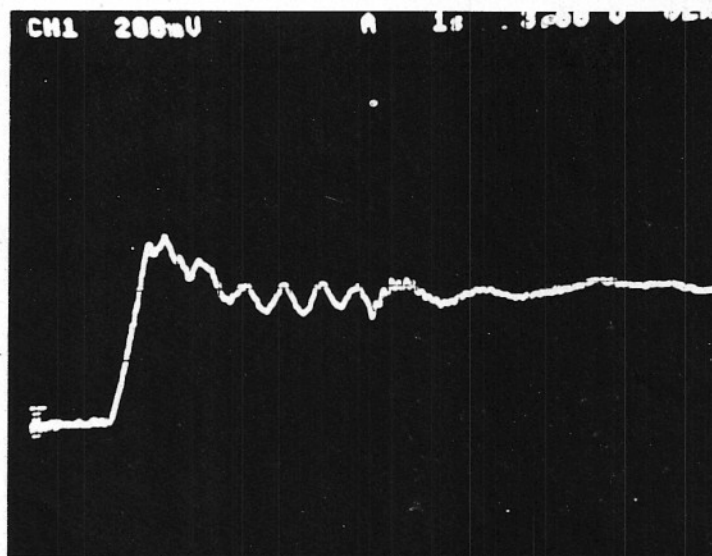
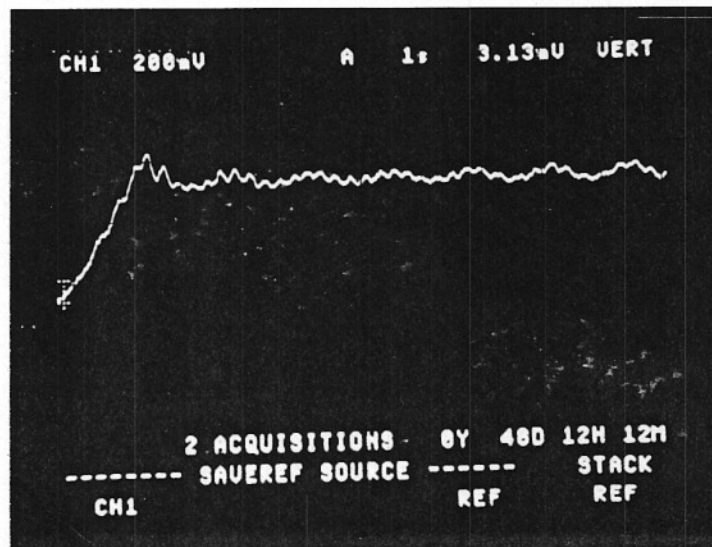
Fig. 7A. Lug strain during slow lift with stepped motor control.

Fig. 7B. Lug strain during slow lift with Variable Frequency Control.

standard stepped motor controls, it was found that stresses on an instrumented block were reduced by a minimum of 28%. Qualitative examples of this reduced stress can be seen in Figs. 7 and 8. Figure 7A shows the strain (stress) of a lug during a slow lift using an old style (stepped) crane control and Fig. 7B shows the strain using a Variable Frequency Control. Likewise, Fig. 8A shows the strain using the old style control during a fast lift and Fig. 8B shows the strain using the Variable Frequency Control. Speed controls, therefore, will be installed on all new crane motors and retrofitted on appropriate existing motors.

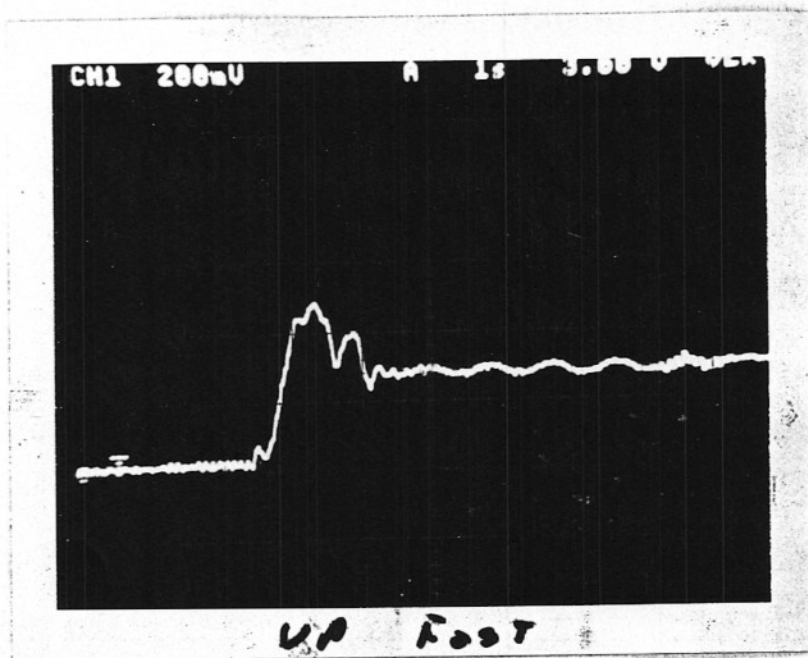
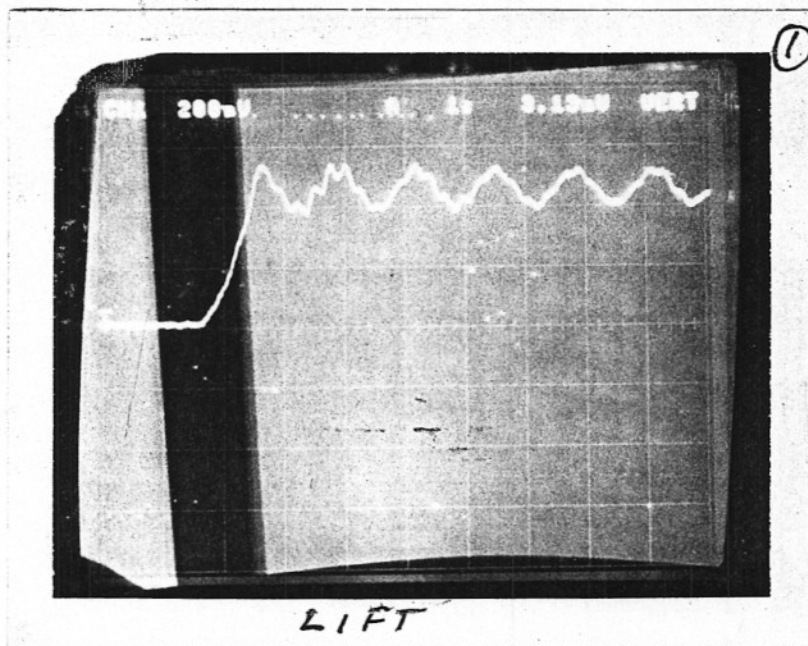
Fig. 8A. Lug strain during fast lift with stepped motor control.

Fig. 8B. Lug strain during fast lift with Variable Frequency Control.
