Proposed modifications to beam transport magnet power supplies to prevent damage resulting from power dips

EP&S DIVISION TECHNICAL NOTE

No. 56

PROPOSED MODIFICATIONS TO BEAM TRANSPORT MAGNET POWER SUPPLIES
TO PREVENT DAMAGE RESULTING FROM POWER DIPS

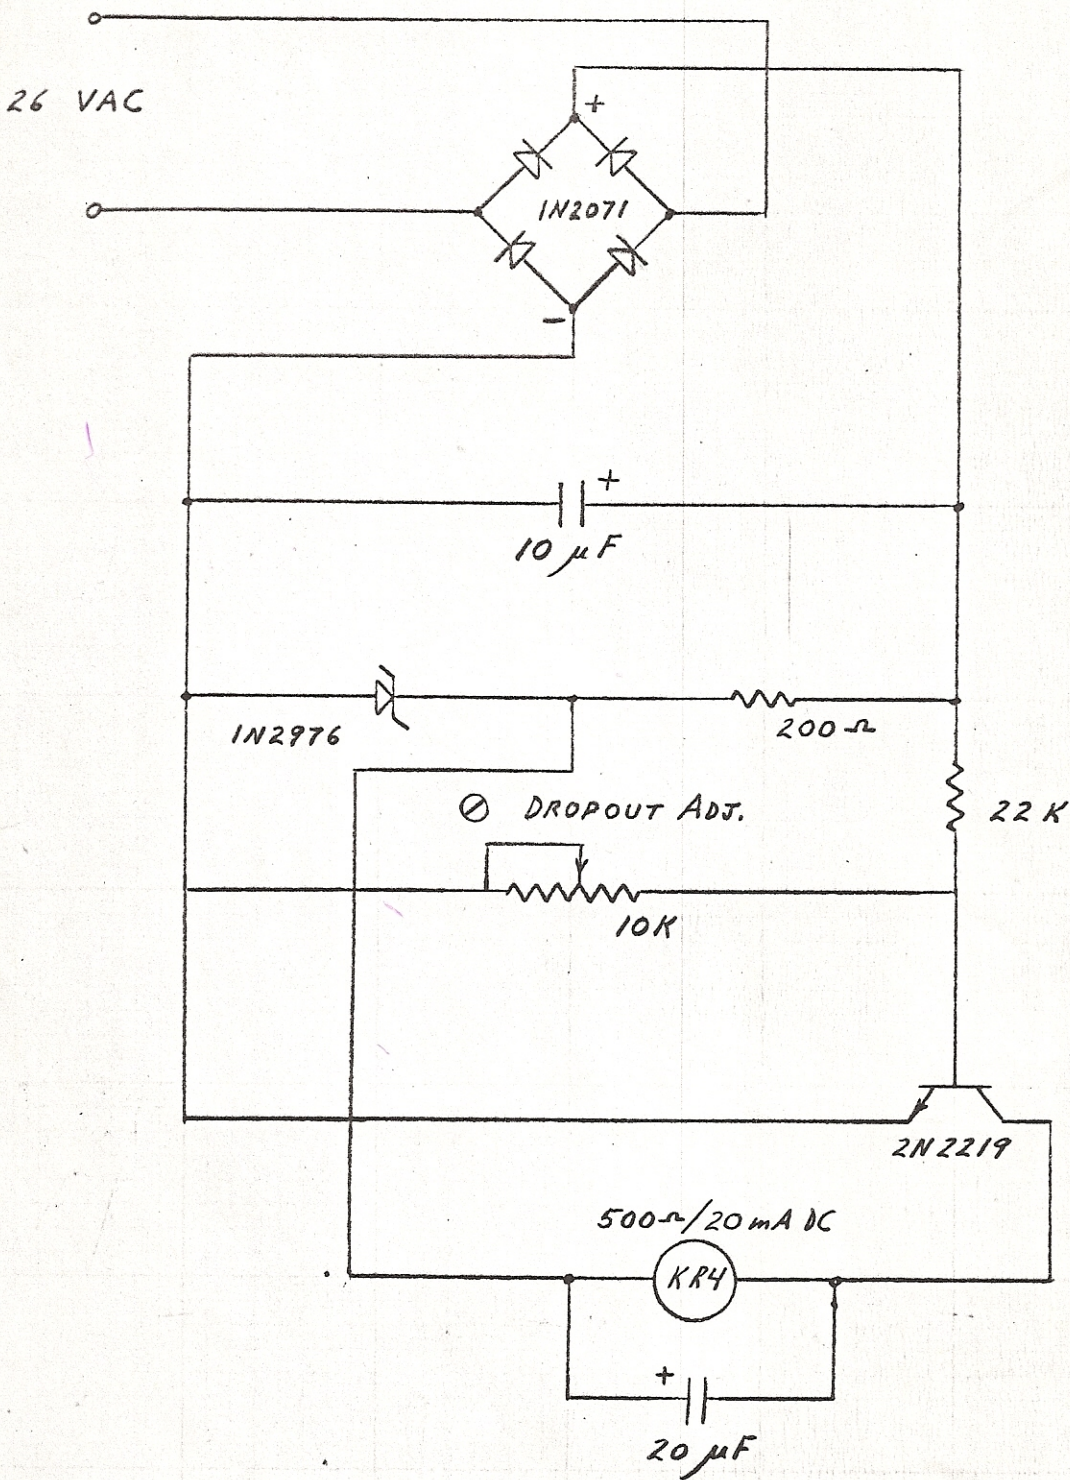
1. Sense an undervoltage situation (See Sketch 2) and drive the main circuit breaker (52) open by its motor-operator. Tests show the operator will function even at 50V ac. The UV sensor is adjustable but presently set to operate below 95V ac on the 115V ac line.
2. Prevent reclosure of the breaker until proper voltage is restored.

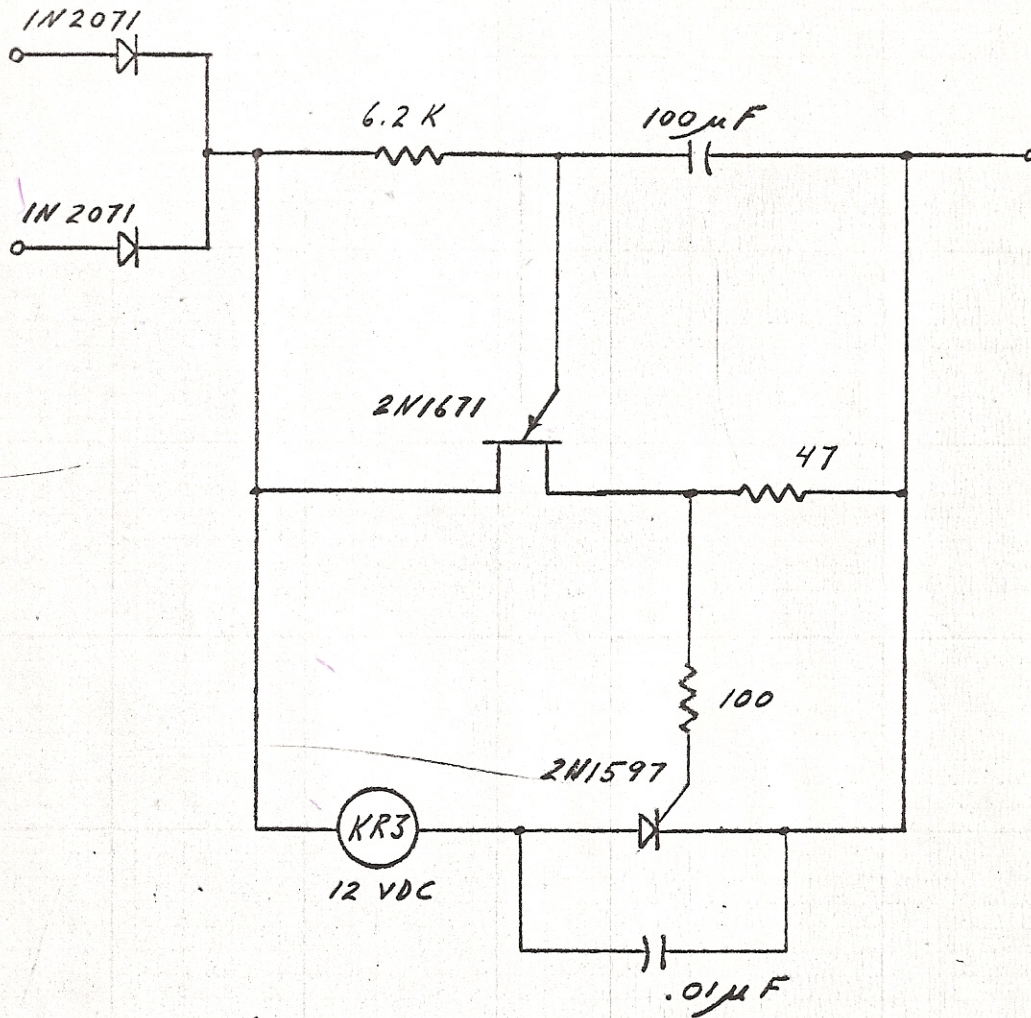
6. Provide a time delay (See Sketch 3) of approximately 400 msec. (24 cycles) to prevent the lock-out and annunciate circuits from being activated during normal "OFF" functions.

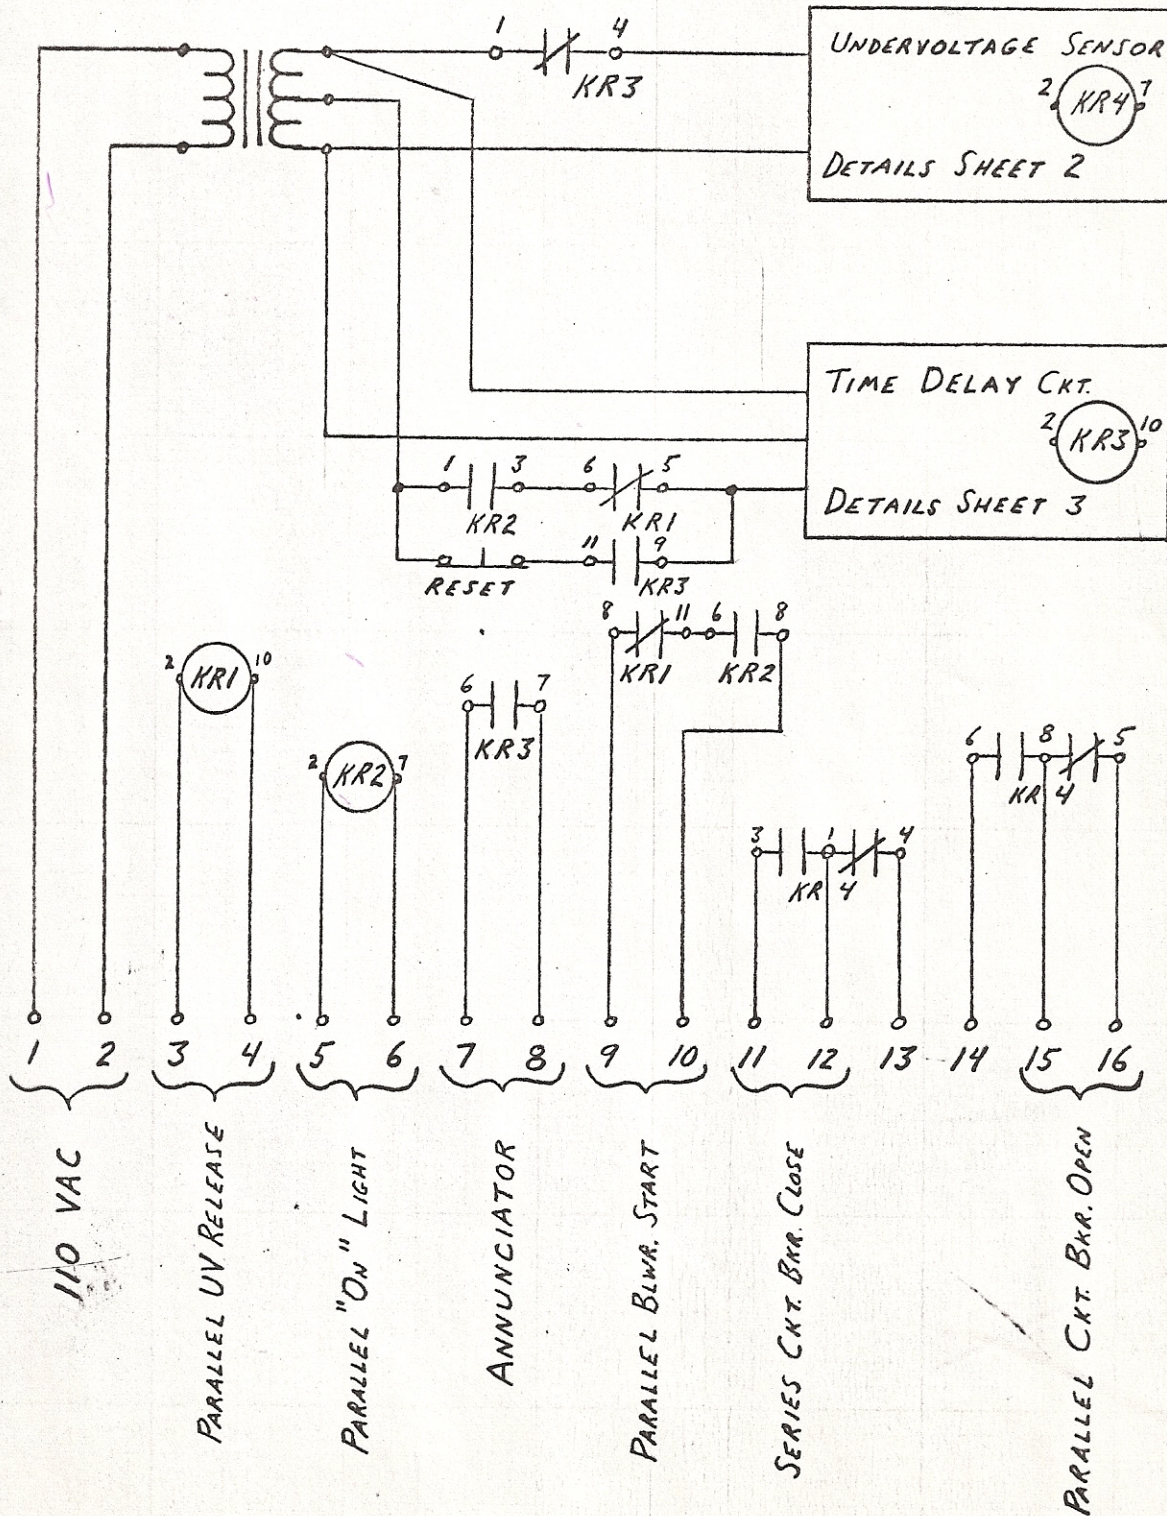
Modifications have been accomplished on one power supply (PS 431) for evaluation and possible incorporation into all units possessing the described potential for failure. This scheme was chosen because (1) it is relatively inexpensive compared to alternate schemes of adding line contactors, etc., and (2) most of the work can be prefabricated on a component board (Sketch 4) requiring only a few hours for actual installation into the power supply.
