Proposed modifications to beam transport magnet power supplies to prevent  
damage resulting from power dips

EP&S DIVISION TECHNICAL NOTE

No. 56

PROPOSED MODIFICATIONS TO BEAM TRANSPORT MAGNET POWER SUPPLIES  
TO PREVENT DAMAGE RESULTING FROM POWER DIPS

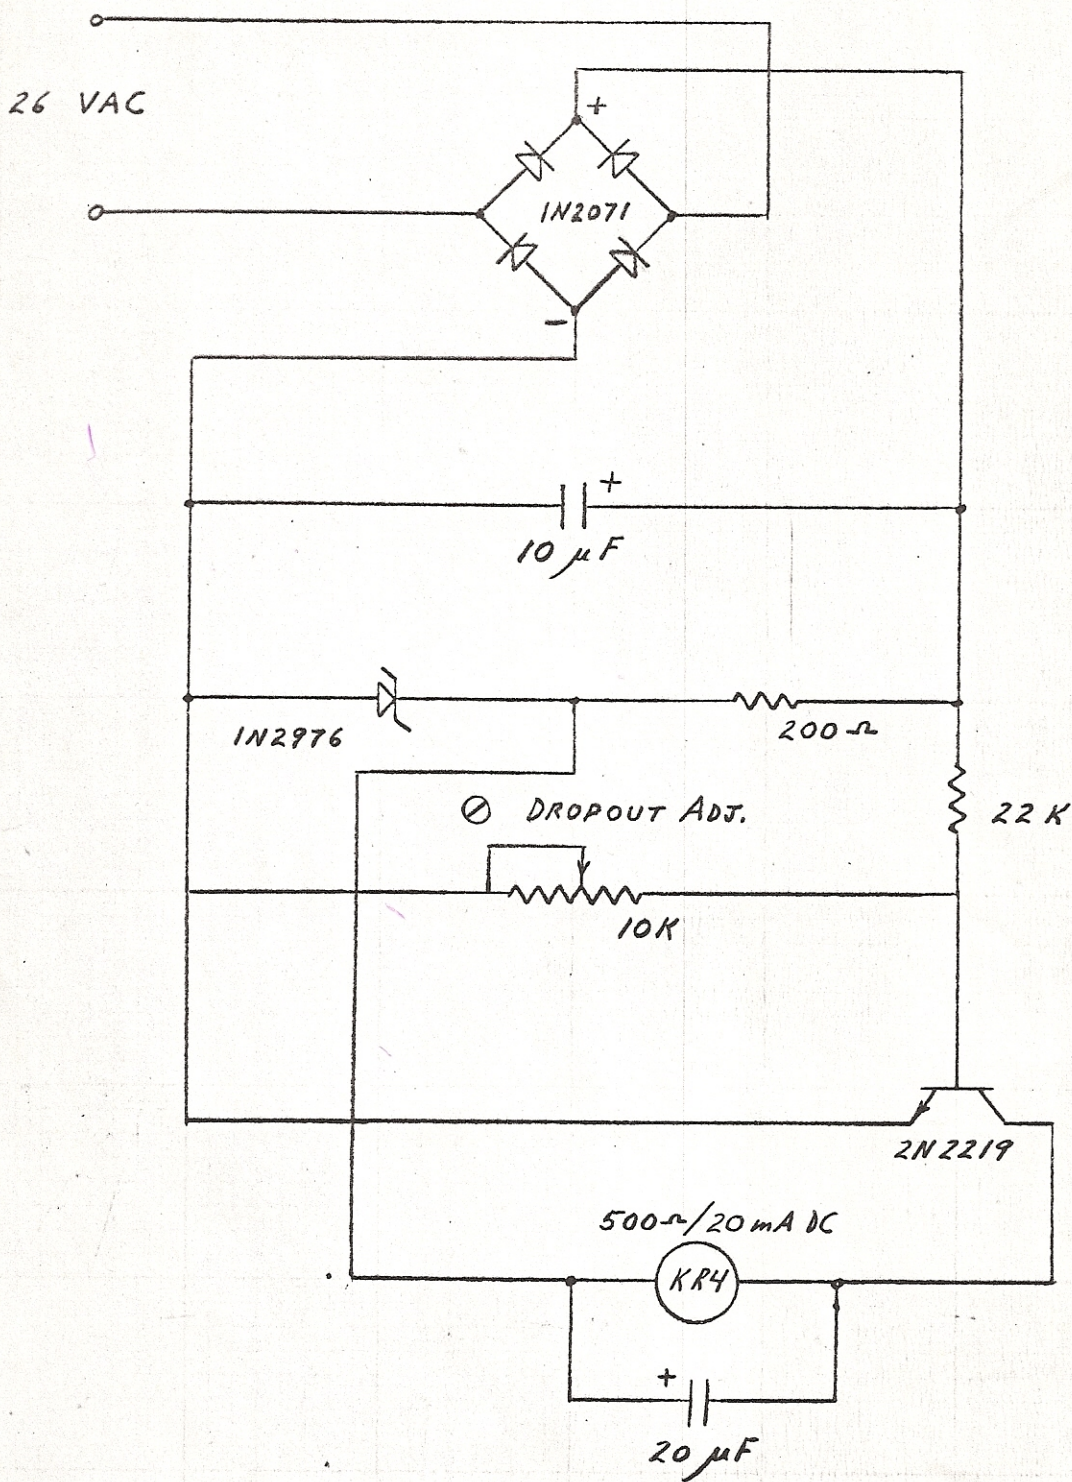
1. Sense an undervoltage situation (See Sketch 2) and drive the main circuit breaker (52) open by its motor-operator. Tests show the operator will function even at 50V ac. The UV sensor is adjustable but presently set to operate below 95V ac on the 115V ac line.
2. Prevent reclosure of the breaker until proper voltage is restored.

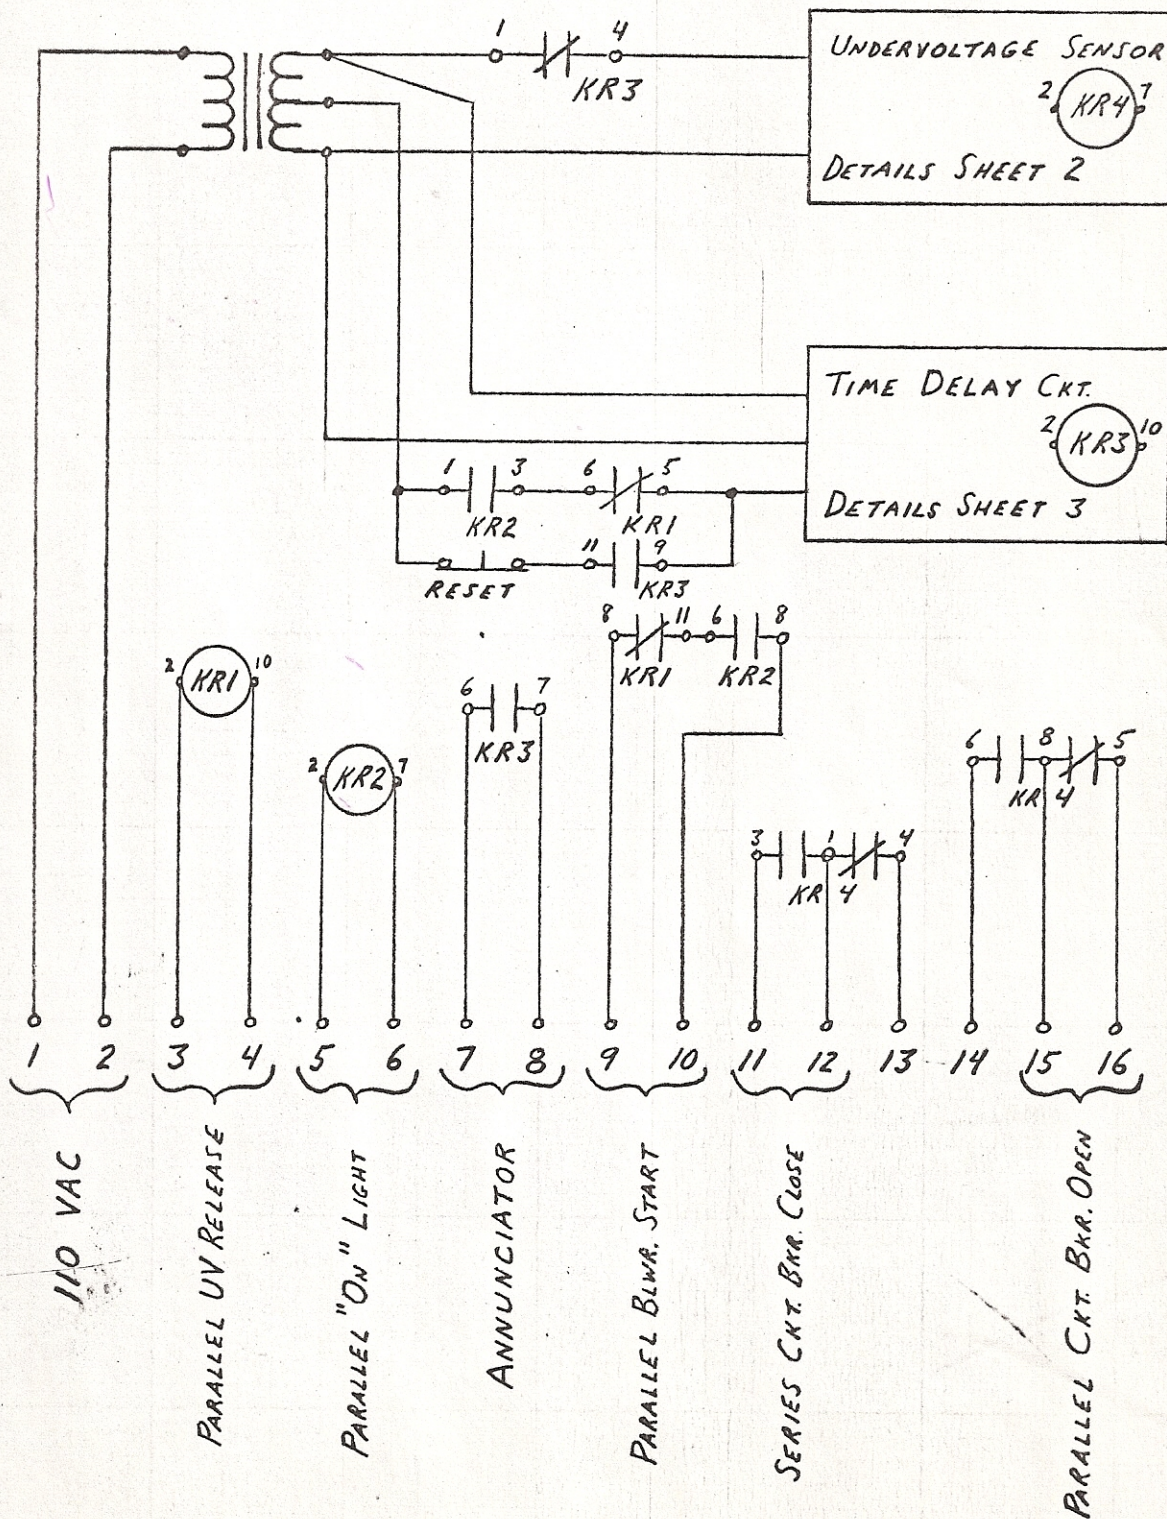
Modifications have been accomplished on one power supply (PS 431) for evaluation and possible incorporation into all units possessing the described potential for failure. This scheme was chosen because (1) it is relatively inexpensive compared to alternate schemes of adding line contactors, etc., and (2) most of the work can be prefabricated on a component board (Sketch 4) requiring only a few hours for actual installation into the power supply.
