Proposed modifications to beam transport magnet power supplies to prevent damage resulting from power dips

EP&S DIVISION TECHNICAL NOTE

No. 56

PROPOSED MODIFICATIONS TO BEAM TRANSPORT MAGNET POWER SUPPLIES
TO PREVENT DAMAGE RESULTING FROM POWER DIPS

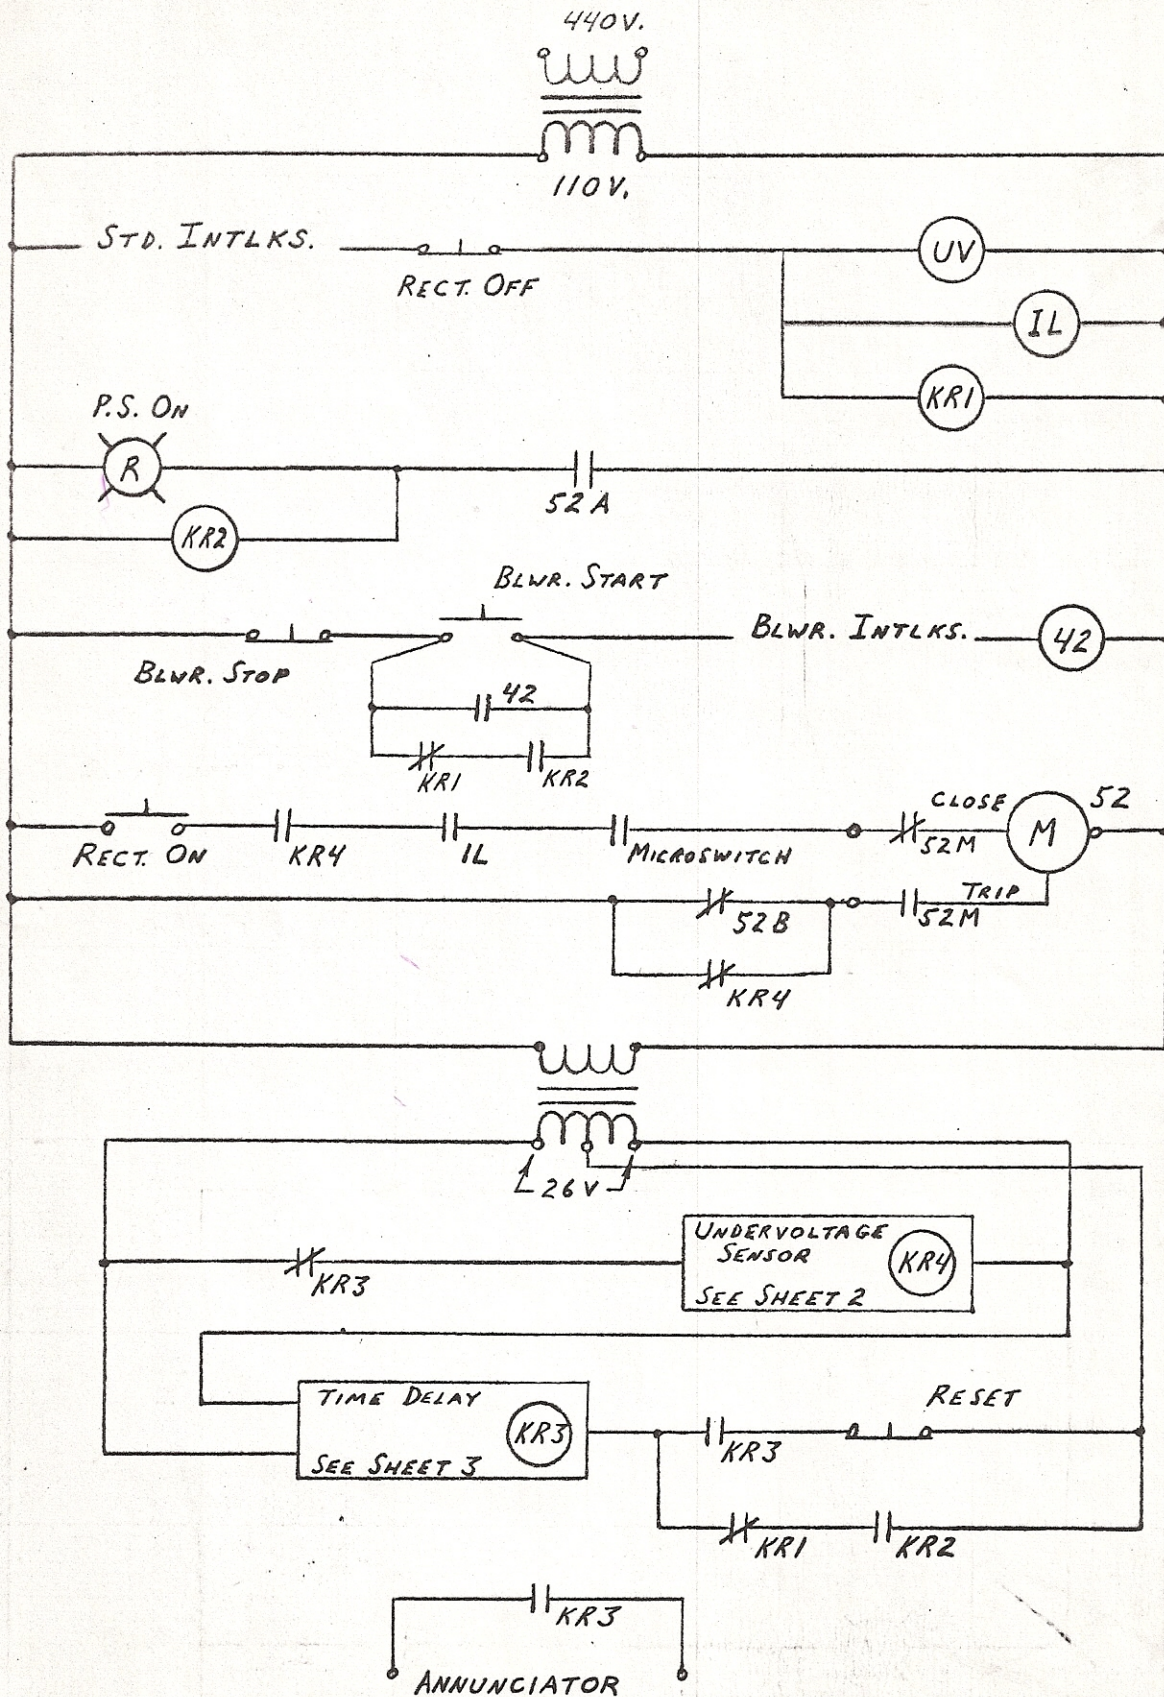
SHEET NO. 1 OF 4
 JOB NO.

The most frequent cause of these incidents has been the case of the saturable reactor-controlled power supply with a motor-operated molded case circuit breaker in use as the main line contactor. The undervoltage release of the breaker is used as the device by which the line circuit is opened by "OFF" buttons or protective device interlocks.

Hazards exist and damage is incurred when the power supply loses its cooling air and/or the magnet loses its cooling water but the main circuit breaker does not shut off the power supply. One or more of the following circumstances can occur in many of our older power supplies:

1. Most of the contactors and relays used for control and protection drop out in the 90-100V_{ac} range; but the undervoltage release of the main breaker is factory set to drop out in the 48-72V_{ac} range, and we have found some that do not operate until much lower. Obviously a line power dip resulting in a dip of the control voltage into the 80-volt range will take out some devices but not the main breaker.
2. The UV release can "hang up" when completely de-energized, such as would occur with an open series interlock circuit caused by the loss of magnet water, loss of power supply air flow, over-temperatures, etc.

3. The Sel-Rex power supply providing the control power for the magnetic amplifiers is connected to the load side of a contactor that may drop out on undervoltage. Since the mag-amps are biased "ON", loss of the control power drives the output voltage to the maximum for the particular transformer tap connected, and the resultant current will be the maximum determined by that voltage and the connected load. On most of this type power supply, the blower motors are connected to the same or a parallel contactor. Opening of this contactor(s), therefore, will cause the power supply to lose its cooling air at the same time it is running to the top output of the tap setting. The power dip may also have caused loss of the pumps providing cooling water to the magnets.

Modifications have been accomplished on one power supply (PS 431) for evaluation and possible incorporation into all units possessing the described potential for failure. This scheme was chosen because (1) it is relatively inexpensive compared to alternate schemes of adding line contactors, etc., and (2) most of the work can be prefabricated on a component board (Sketch 4) requiring only a few hours for actual installation into the power supply.

The relay components of the modification are arbitrarily prefixed KR- on the sketches to differentiate them from the control relay nomenclature (K-, 96-, CR-, etc.) of the various power supply manufacturers. The intent of the modification is to perform the following new functions:
