Dynamic Compensation of the Solid-State Driver for the 197 MHz Power Amplifier in RHIC

S. Zheng

June 2005

Collider Accelerator Department
Brookhaven National Laboratory

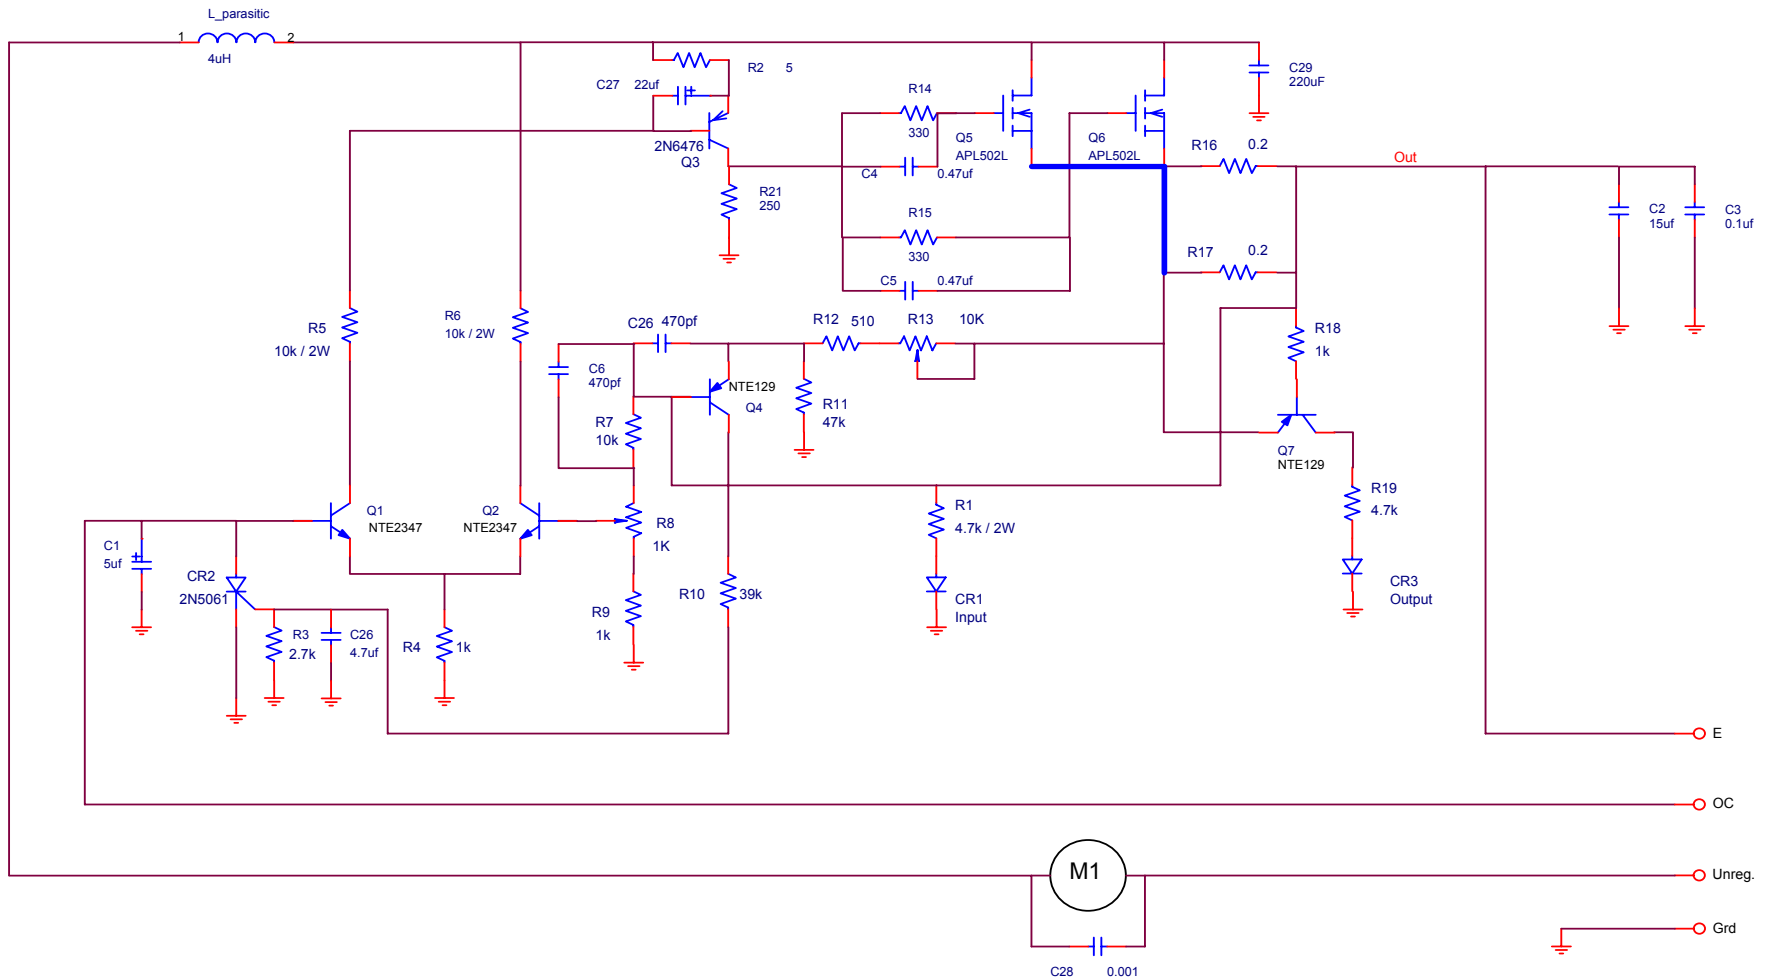
Fig. 1 The voltage regulator after modifications.

PSpice simulation was performed to analyze the dynamics of the circuit. The reason for the phase sag was identified to be the parasitic inductance of the wire transmitting the unregulated dc voltage from the cap bank of the rack (L-parasitic in Fig. 1), the front-end capacitor, and the RF decoupling capacitor at the power supply output side. The voltage regulation MOSFET (Q5 and Q6 in Fig. 1) connects the components in the unregulated and regulated side. They form a high-order circuit and interact with each other. While it is not practical to eliminate the phase dip completely, appropriate compensation can be employed to improve the phase margin.

Eventually the circuit was modified as following:

- 1) Remove two 5 ohms resistors from the RF decoupling capacitors (C2 in Fig 1).

- 2) Add 470 pf capacitor (C6 in Fig. 1) in parallel to a resistor (R7 in Fig. 1) in the feed back loop.

- 3) Add 0.47 uf capacitors C4-5 in Fig. 1) to the gate resistors (R14-15 in Fig. 1) of the MOSFET;

- 4) Change the front-end capacitor to 220 uf (C29 in Fig. 1), this provides a better ac ground for the voltage regulator circuit.

The voltage regulator after modifications is shown in Fig.1, and improved dynamic response is shown in Fig. 3.

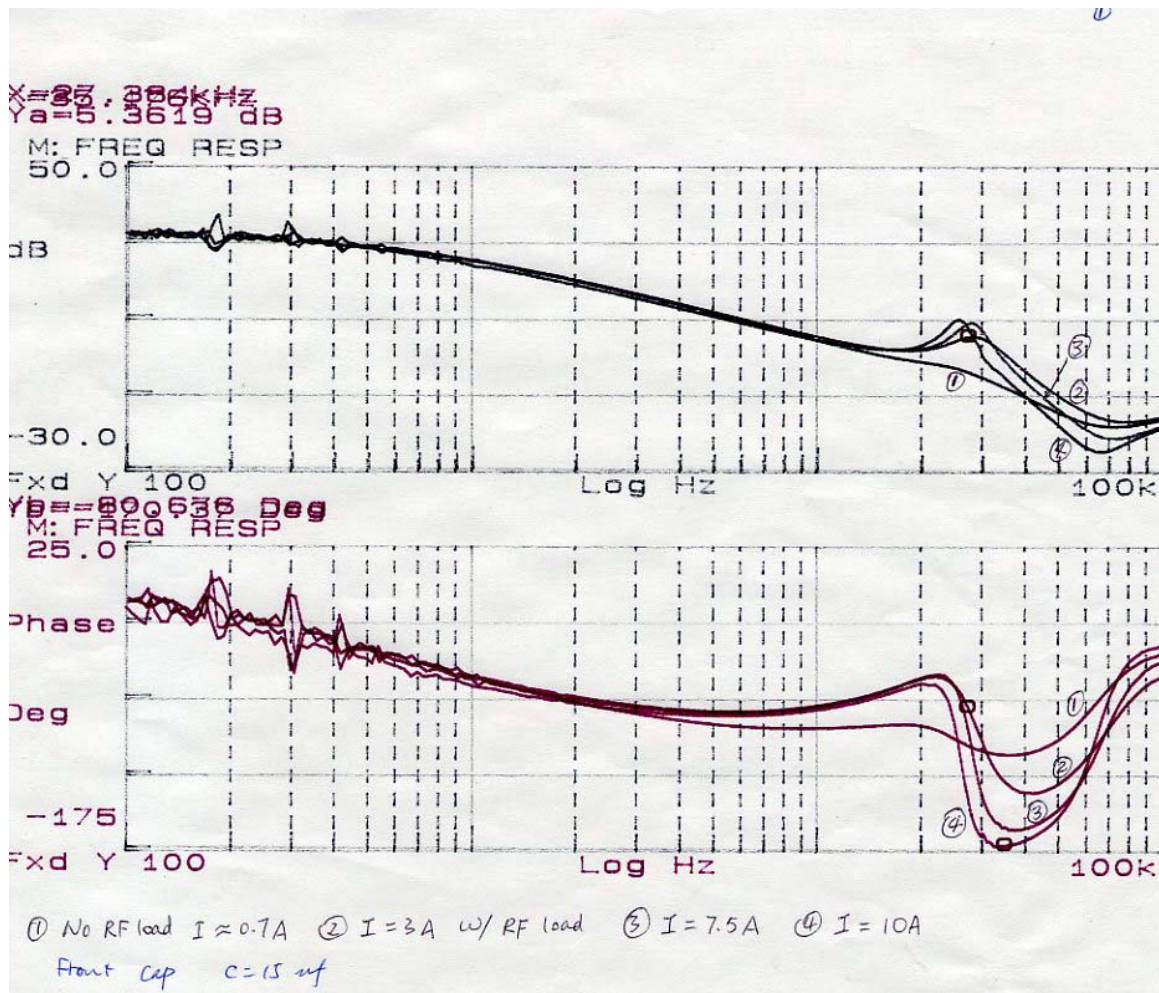
While trying to identify the root cause of the problem, we monitored the regulated voltage of each module while it was installed in the rack. We found there were unacceptable ripples on the regulated 50 volts bus of most modules. Thus we checked the dynamics of the regulation loop of the power supply for the module. And found there was a deep phase sag from around 30 kHz to 70 kHz. The worst point is very close to 180 degree, as shown in Fig. 2. Thus the regulation loop is potentially unstable.

Fig. 2 The dynamic response of the voltage regulator before modifications.

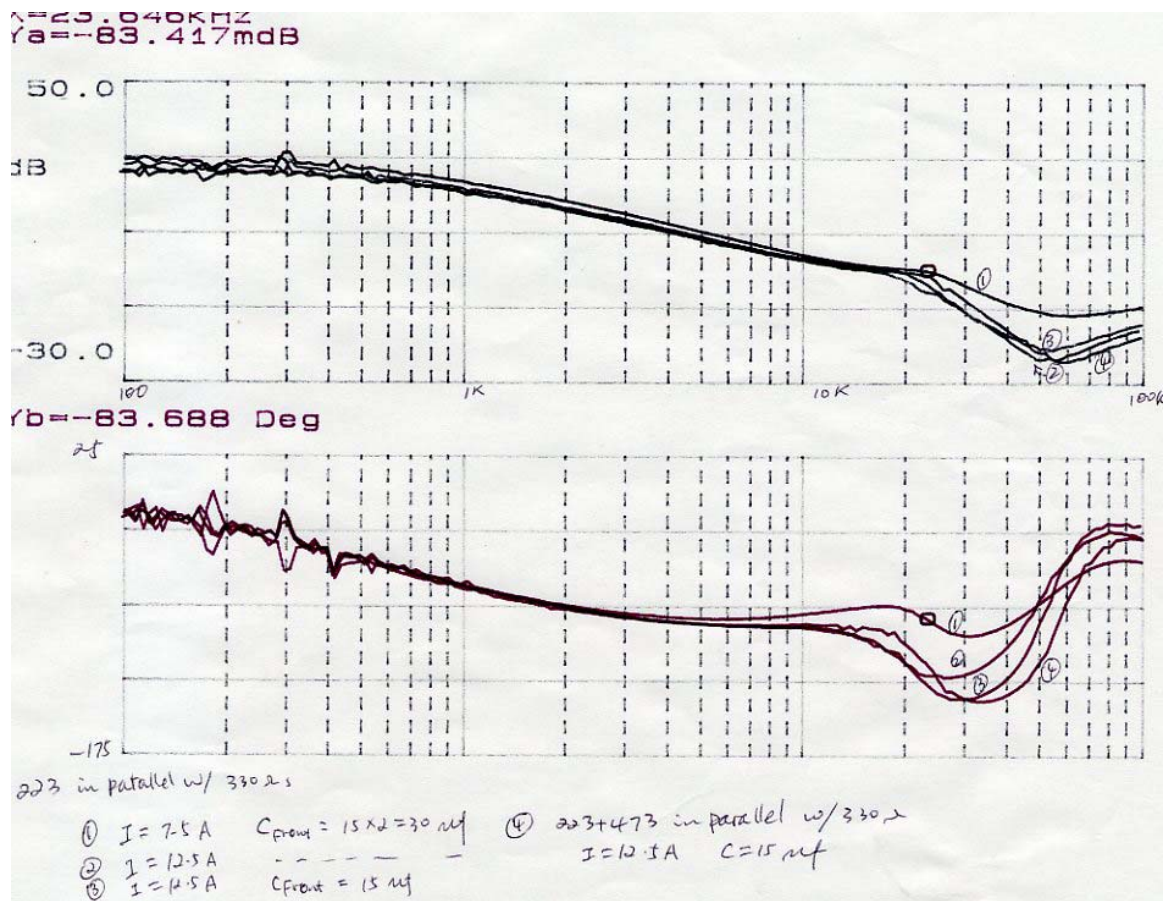
Lead-lag compensation was applied to the loop and the dynamic response was improved. In terms of the circuit modification, this compensation can be easily implemented by adding several capacitors to the circuit

Fig. 3 The dynamic response of the voltage regulator after modifications.
