A close look at beam aborts with rise times less than 40 ms from the years  
2014-2016. Case studies.

Collider Accelerator Department  
**Brookhaven National Laboratory**

C-A/AP/570  
September 2016

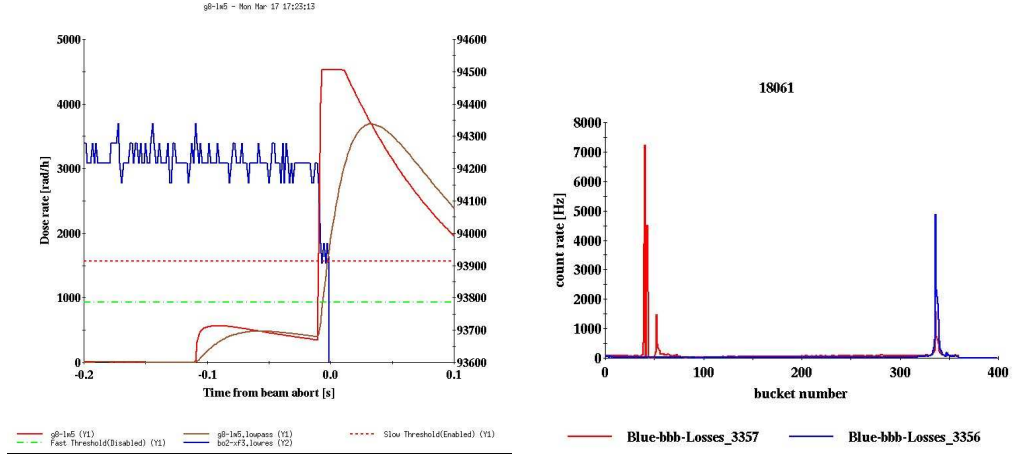
No quenches were associated with this abort. Fig. 2 (left) summarizes the event, including the loss data (red line), various thresholds and the beam current data. The data shows a 10 Hz structure (0.1 s steps), representing the fastest of the gap cleaning options of 10Hz, 1Hz or 0.25Hz. The g8-lm5 LM saturates with only 0.3% of the beam lost (and most of that would be lost on the collimators, not at g8-lm5). Due to the ongoing reboot of the FEC (cfe-2a-tune1) the status of the gapCleaner [5] cannot be reconstructed fully. However, as can be seen in Fig. 2 (right), the bunch-by-bunch losses clearly move from the gap to a location in middle of the bunch train. The blue trace is taken 1s before the abort, the red trace shows the data accumulated during the second in which the abort happened. The peak appears 'smeared' due to varying arrival times of particles in the collimator Pin Diodes.

**Conclusion:** The amount of beam loss is actually small (about 1/3 of one bunch), too small for damage beyond, perhaps, a quench. The gapCleaner, due to its kicker pulse length

Figure 2: 720 Hz loss monitor and current transformer data from PMViewer (left). Two traces corresponding to two consecutive seconds of bunch by bunch (bbb) loss data from the abort in 18061.

of only about 100 ns [5], affects only one bunch at a time but cannot impact the entire beam. The fastest time for it to switch from one bunch to another is 10 Hz, i.e. 100 ms, plenty of room for an additional 40 ms.

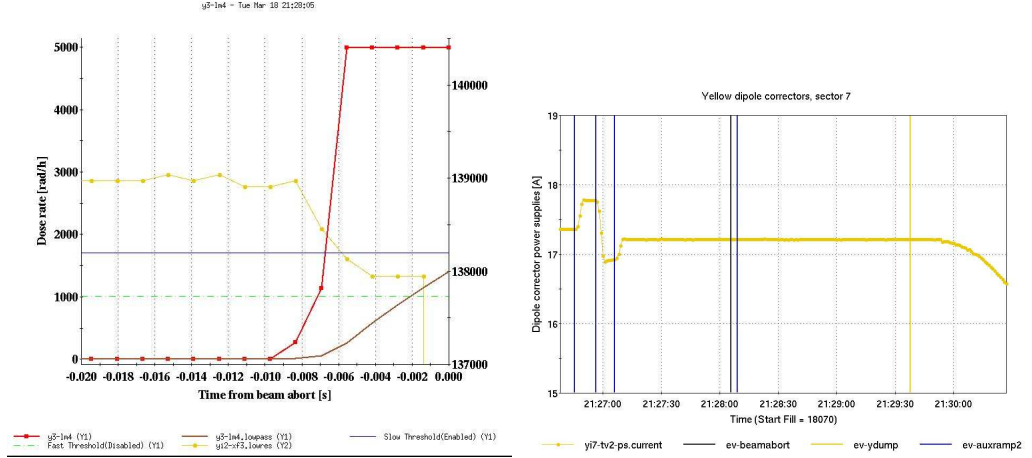
No quenches were associated with this abort. Current transformer and loss data are shown in Fig. 3, left. It is interesting that the losses appear to stall after a fast initial drop over the first 2.8 ms. The losses correspond to 0.7% of the total beam, a bit less than one full bunch. MCR attributed the abort event to a bad lisa [6] steering. Following are two excerpts from the appropriate 2014 lisa logfile:

This last automatic message and the accompanying retry appears to happen 3 seconds after the time of the beam abort making lisa steering unlikely to be the cause. This timing can be confirmed by checking the logged PS current data for the involved correctors and the timing of the abort- and auxramp2-events as can be seen in Fig. 3 on the right. Indeed, all correctors in question are at nominal values until the ramp-down starts (well after the abort).

In addition, y3-lm4 is an unusual loss monitor to be first responder in a failure caused by corrector magnets around IP6 and IP8. It is, on the other hand, close to a stochastic cooling tank which was indeed moving at the time and losses spike on yi3-ksch3-pd (the pin diodes associated with the yellow horizontal stochastic cooling kickers in sector 3) at the time. The extremely fast loss rise time, however, makes the move of a large mechanical system equally unlikely to be the root cause of this very fast event. Unfortunately, all abort kickers are accounted for and not one PS was alarming or reporting an issue at the time of question.

**Conclusion:** The abort was not due to a bad lisa activation. The SC kicker as a me-

Figure 3: 720 Hz loss monitor and current transformer data from PMViewer. Dipole corrector data during store 18070, before and after the abort.

chanical system is too slow to be the culprit. No other culprit candidate could be found and this case remains a mystery.

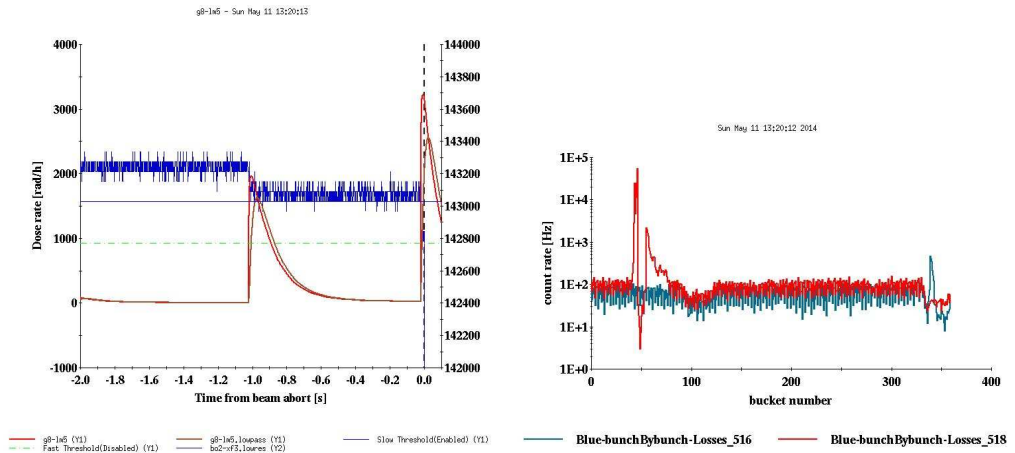
No quench associated with this abort. The gapCleaner was set to a 1 Hz frequency and the losses, as shown in Fig. 4, left, clearly show a 1 Hz structure. During the trigger at -1.0 s about 0.1% of the beam was lost and just before the abort another 0.2%. The bunch-by-bunch losses, shown in Fig. 4, right, were accumulated in a second before (trace 516) and during the abort (trace 518). They clearly show how the losses moved from the gap to an occupied bucket. A modest lowering of the trip threshold would have aborted the beam easily 1 s earlier. The FEC (cfe-2a-tune1) apparently rebooted itself spontaneously. A warning

Figure 4: Left: 720 Hz loss monitor and current transformer data from PMViewer. Right: Bunch by bunch losses accumulated two seconds before and the second including the abort.

message (not to reboot with beam in the machine) has been added since.

**Conclusion:** The gapCleaner, due to its kicker pulse length of only about 100 ns, affects only one bunch at a time and cannot impact the entire beam. Hence the associated beam loss is relatively modest and not close to a damaging amount.

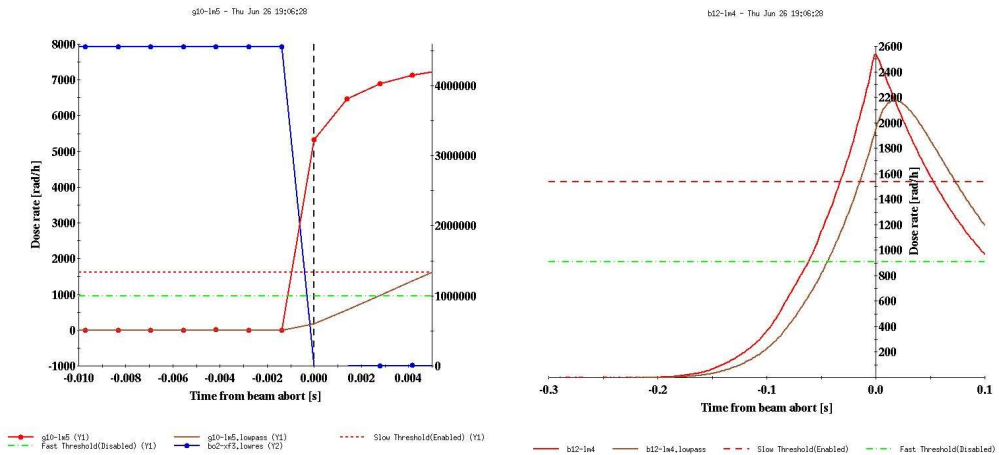
There were no quenches associated with this event. Fig. 5, left, shows g10-lm5 data. g10-lm5, showing losses caused by an ordinary beam dump, actually did not trigger the beam abort but b12-lm4 did (Fig. 5, right). The actual rise-time for b12-lm4 is well above 100 ms and

Figure 5: Left: 720 Hz loss monitor b12-lm4 data from PMViewer. Right: 720 Hz loss monitor g10-lm5 data from PMViewer

thus of no concern for the extra 40 ms delay. This event got into the list by accident. However, it indicates that a rise time of 2.78 ms can be falsely calculated from the 720 Hz data, here due to the continuous rise of the loss rate after the abort (thus shifting the maximum to after the abort). The actual rise time in this case is less than 1.39 ms (i.e. one 720 Hz bin). In addition, it is suggested to exclude APEX time from operating the aborts with the additional 40 ms. There are, of course, failure modes during APEX that could happen at

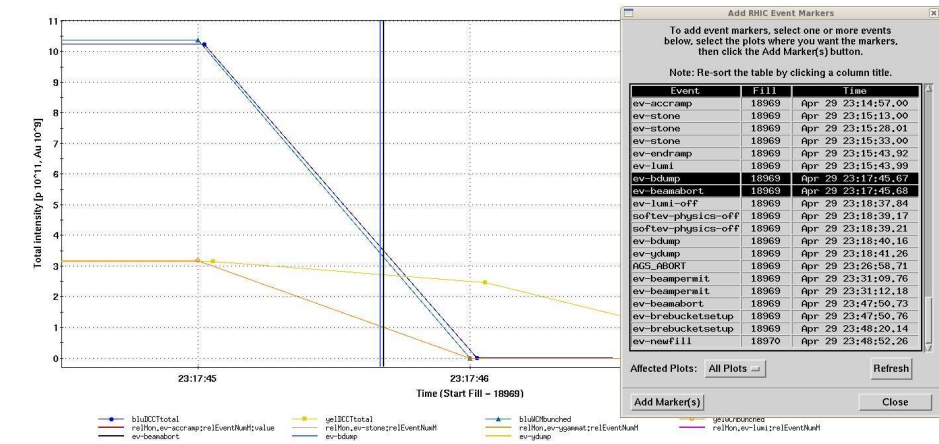
There were no quenches associated with this event. In principal, this event should not be listed here since it happened during ramp development. However, we need to check if this type of failure could not happen at other times as well. In any case, looking closely at the time of events as shown in Fig. 6, it shows that the permit pull by b10-lm4 comes following an ordinary beam dump. According to the list of RHIC event times, the two are 10 ms apart. b10-lm4, the first loss monitor down stream of the blue abort, is prone to and known for

Figure 6: LogView graph showing beam current data and list of events for end of store 18969.

permit pulls due to “spilled” losses from an ordinary beam dump, particularly during proton operation.

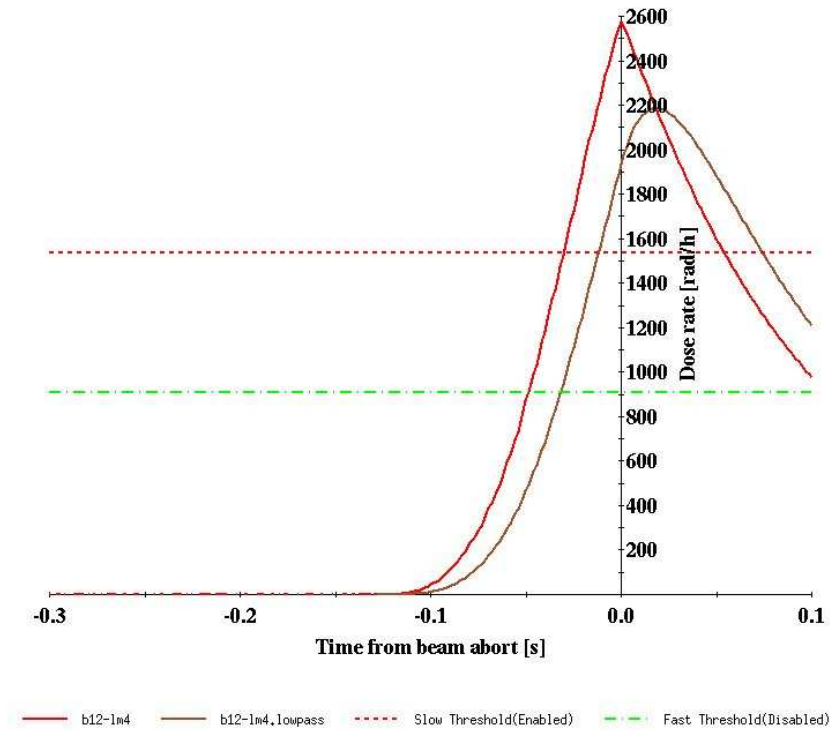
No quenches were associated with this abort. y9-lm4 (yellow!) actually goes above threshold after the abort and the triggering loss monitor is b12-lm4 (blue!). Fig. 7 shows the corresponding data. The rise time for this monitor is approximately 100 ms. Therefore this case is of no interest for this study. y9-lm4, the first loss monitor down stream of the yellow abort, is the yellow LM known for permit pulls due to “spilled” losses from an ordinary beam dump, particularly during proton operation.

Figure 7: PM 720 Hz b12-lm4 data

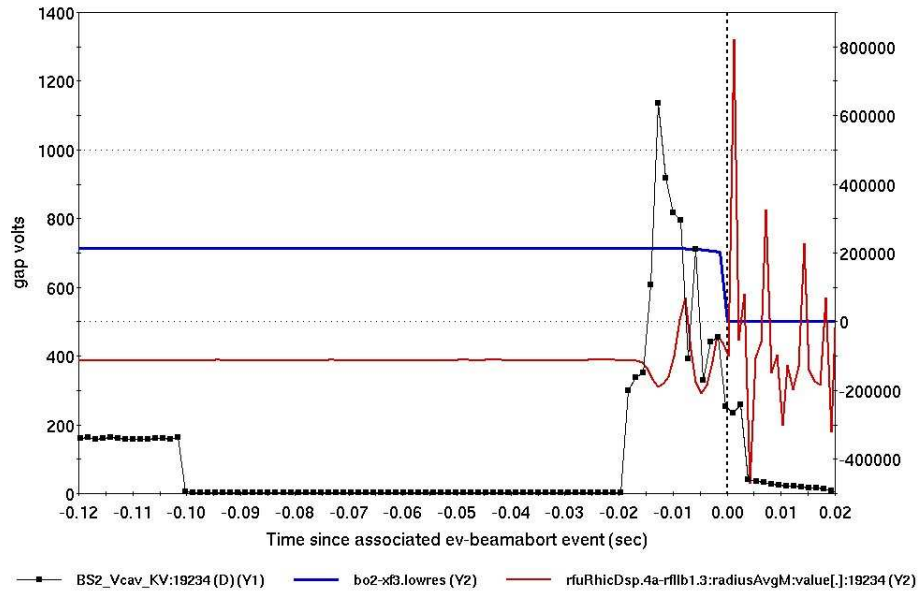
B6Q3 triplet quadrupole quenched in this case. This abort portrays the perfect storm of cavity trips where a faulty damper was not secured when the trip happened. Fig. 8 summarizes the course of events. Shown are the BS2 gap volts (black squares) in kV, the radius (red line) in micron and the beam current transformer data (blue line). The cavity trips 100 ms before the abort ( $t=0$ ). The unsecured tuner starts moving towards the beam, changing the cavities tune in the process. 20 ms before the abort very fast instabilities entail, visible as rapid oscillations of the cavity voltage as well as the radius. Actual beam loss is concentrated in the last  $5 \times 1.39 \text{ ms} = 7 \text{ ms}$  before the abort.

**Conclusion:** Only if the BS2 cavity would have been in the permit (it wasn't) this quench (with or without an additional 40 ms of delay) could have been prevented.

Figure 8: 720 Hz RF BS2 voltage data, radius data and beam current transformer data.

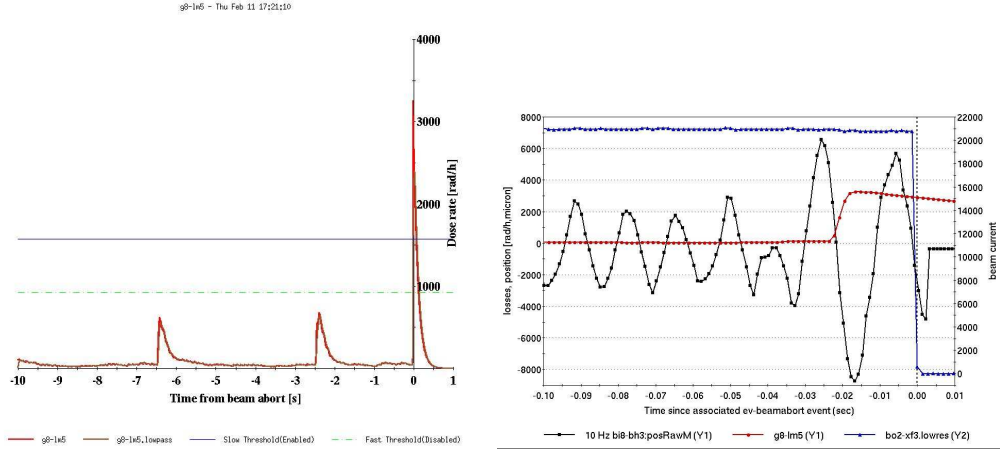
No quenches in this case. The abort happened during an APEX, a time during which no change to the abort system is planned. At the time of the abort were 12 bunches in the machine and a new ramp to squeeze IP8 to 50 cm was tested. As part of the ramp development TbT orbits were triggered every 4 s which include a trigger to the ARTUS tune meter kickers. The losses due to two of those triggers can be seen at -6.5 s and -2.5 s in Fig. 9 (left), precisely 4 s apart. There are two corresponding TbT data sets stored in the orbit archives. Only one bunch (# 31) is affected by the TbT triggers. However, beginning about 15 s before the abort (and 47 s into the ramp), all 12 bunches start to oscillate ( $\pm 3$  mm peak to peak, approximately 140 Hz frequency) and to show some beam losses according to the bbb beam loss monitor. The amplitude more than doubles about 25 ms before the abort as can be seen in Fig. 9 (right). Even though losses are visible on the loss monitors, there is no noticeable beam loss seen in the current transformers up to 1.39 ms before the abort.

**Conclusion:** No single cause of abort could be identified for this case although it is likely associated with the ongoing beta-squeeze. One could argue to ignore it since it happened during APEX and during a ramp, if only a squeeze. Alternatively one could establish a maximum allowable oscillation amplitude of, say,  $\pm 2$  mm (at store). In this case this ramp could have been aborted 15 s earlier than it actually did.

Figure 9: Left: g8-lm5 PM data from abort of store 18519. Right: The last 0.15 s before the abort depicting 1kHz data from GOFB\_10Hz BPM bi8-bh3, current transformer and g8-lm5.

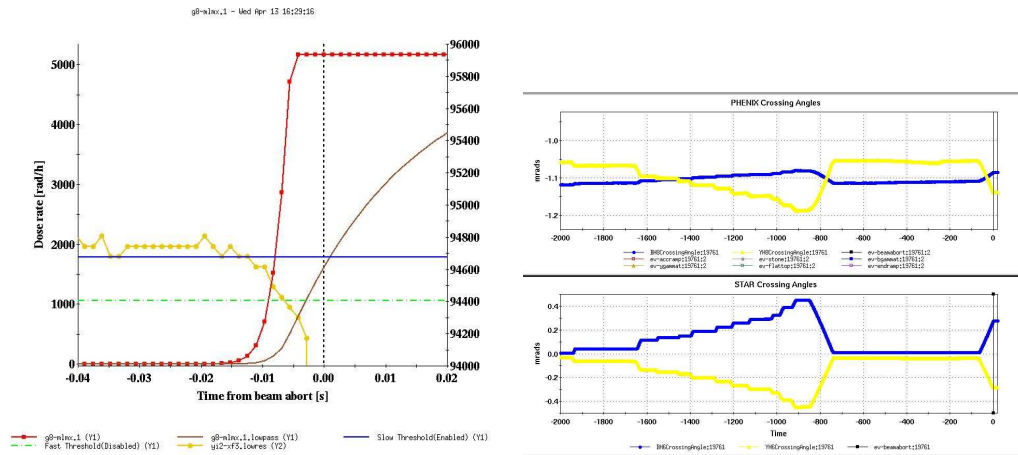
No quenches were associated with this event. This abort happened during an APEX study and would as such have happened without any changes to the abort system. However, this loss scenario is not associated with APEX activities such as the quoted angle steering in IR6 (which is not the root cause for this abort). The beam loss happened very fast (see Fig. 10, left). As can be seen in Fig. 10, right, most of the angle steering in IR6 was already completed when about 15 s prior to the abort angles start drifting again in both IPs and beam is lost at angles much smaller than the ones achieved before. At the time of abort all of the supplies in

Figure 10: left: g8-mlmx.1 PM data from abort 19761. Right: IP8 and IP6 crossing angles during APEX leading up to the abort.

alcove 9A, 9B and 9C tripped on a lead flow fault. Cryogenics replaced a power supply in the 1008B valve box for 8Q3. Yet, a lead flow fault alone does not quite explain the very short

rise time seen in this event. In another similar case (19837, in which the yellow injection kicker got damaged) the rise time was of the order of a few 100 ms.

**Conclusion:** It is unclear if the likely reason (lead flow fault) is enough to explain the very short rise time. No other reason could be found however. Therefore no recommendation in anticipation of an extra 40 ms delay can be made.

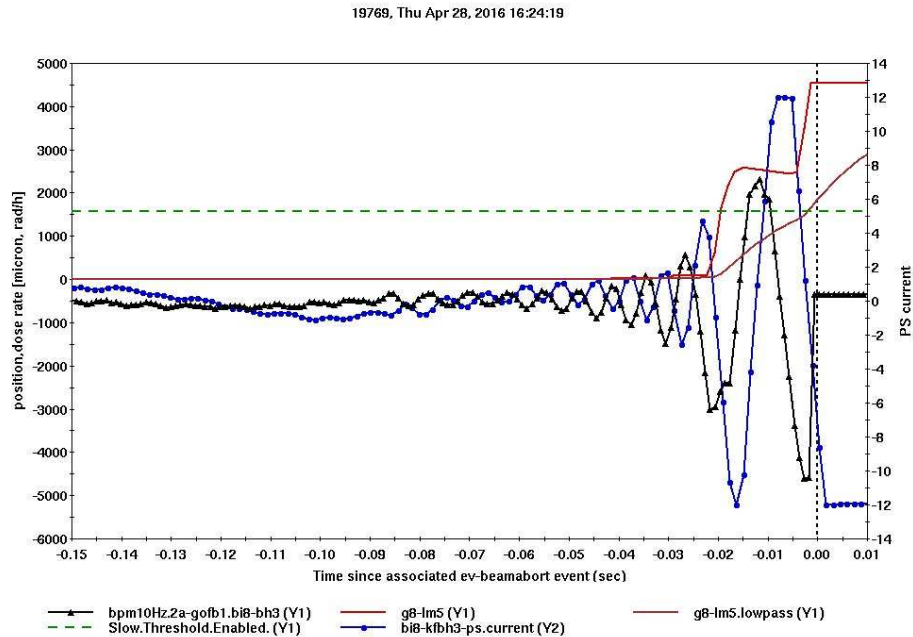
No quenches were associated with this case. This abort is caused by a failure of a GOFB\_FB 10Hz PS without any connection to the 56 MHz RF cavities. As can be seen in Fig. 11, the power supply and the orbit start oscillations about 70 ms before the abort (indicated by the dashed black vertical line), significant losses appear about 20 ms before.

Figure 11: Orbit oscillations, power supply current and loss monitor data during 0.15 s before the abort.

**Conclusion:** In order to trigger an abort 40 ms before the recorded time here, either a BPM based permit or a 10 Hz PS based permit would be needed with a response time of approx. 10 ms.

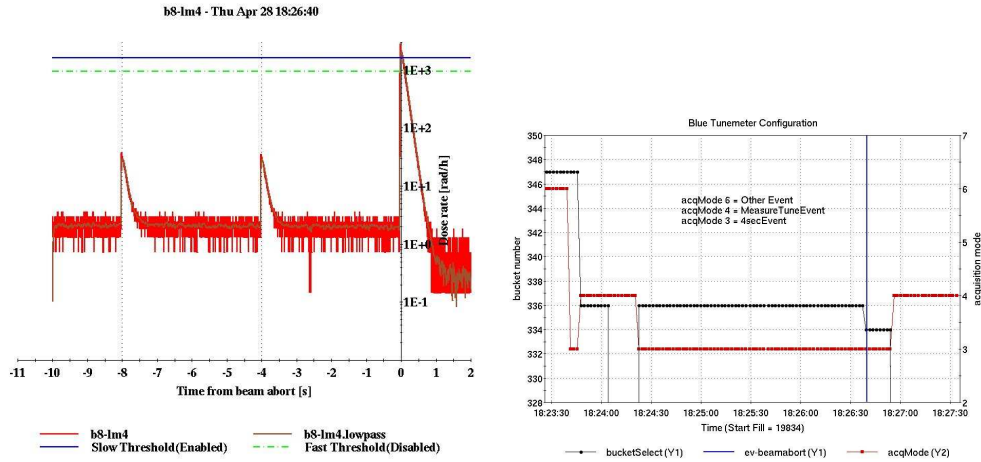
There were no quenches associated with this abort. The culprit in this case was not the 56 MHz cavity but operator error. b8-lm4 is the first loss monitor down stream of the blue

collimators with an enabled permit threshold. As can be seen in Fig. 12, left, gap cleaning was in progress at a modest level at 0.25 Hz, one of the three frequency options. This can be confirmed by the configuration setup for the blue gap cleaning kickers (Fig. 12, right). Acquisition mode is set to “3”, i.e. the 4secEvent, minutes before the abort. At the same time the default bucket for gap cleaning, was changed by operators from 347 to 336 and eventually to 334. Note that bucket numbers are offset by +1, starting from 0 and going up to 359. In addition, it can be expected that the kicker pulses are not perfectly centered on the occupied buckets. Timing shifts can occur during the ramp to store. The effect of the

Figure 12: Left: b-lm4 PM data, right: blue tune meter kicker setup before and during the abort.

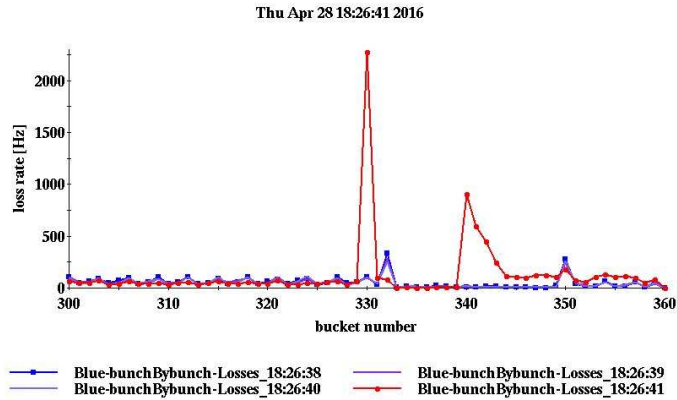
Figure 13: Bunch by bunch loss monitor for the seconds leading to (blue lines) and including the abort (red line).

bucket switch is apparent in Fig. 13. In the seconds leading up to the abort modest losses are evident at buckets 331 and 350. Both buckets are part of the gap. The last data set, including the abort (shown as a red line) shows a peak at bucket 330, the last one of the occupied buckets. The kickers were set to bucket 333, but due to the pulse length of about 110 ns, the last occupied bucket got hit, causing the abort.

**Conclusion:** There is very little risk for damage since the gap cleaner kickers will only affect one bunch at a time with a repetition rate of 0.1 s or slower. Adding a delay of 40 ms would still have aborted the beam well before the next trigger could have occurred, even if it was set to 10 Hz.

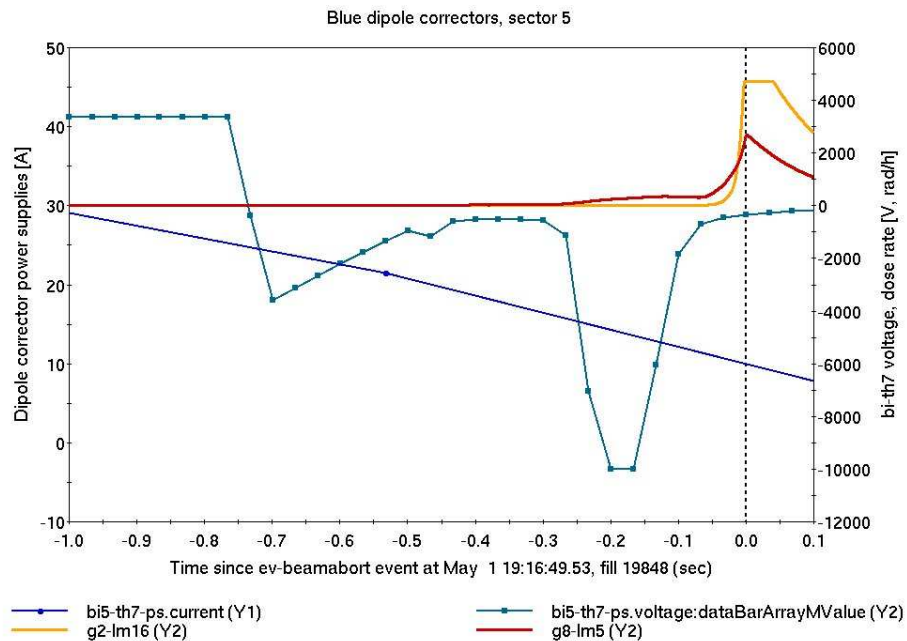
No quenches were associated with this abort. The blue longitudinal pick-up was certainly not involved in this event. Actually, about 700 ms prior to the abort a total of 11 dipole corrector supplies controlled by cfe-5c-ps1 started to fail. It is likely that cfe-5c-ps1 was compromised by the bad vacuum in sector 5, causing the concerted trips of many corrector supplies. One of the power supplies is shown in Fig. 14, together with the PM data for LM g2-lm16, at the maximum of the blue protection bump. Losses in g2-lm16 start showing over 500 ms after the dipole correctors first signs of errors. Only the LM down stream of the blue collimators experience some earlier losses, reaching only about 450 rad/h about 50 ms before the abort.

Figure 14: PM data from g2-lm16, g8-lm5, and bi-7th. LogView current data from bi-5th.

**Conclusion:** In order to violate the beam permit 40 ms earlier than the current abort time, a PS based permit system appears most promising. A much reduced permit threshold (about 25% of current level) for g8-lm5 could potentially do the same with the added risk of unnecessary and premature permit pulls. In addition, it relies on the collimators being in the proper position.

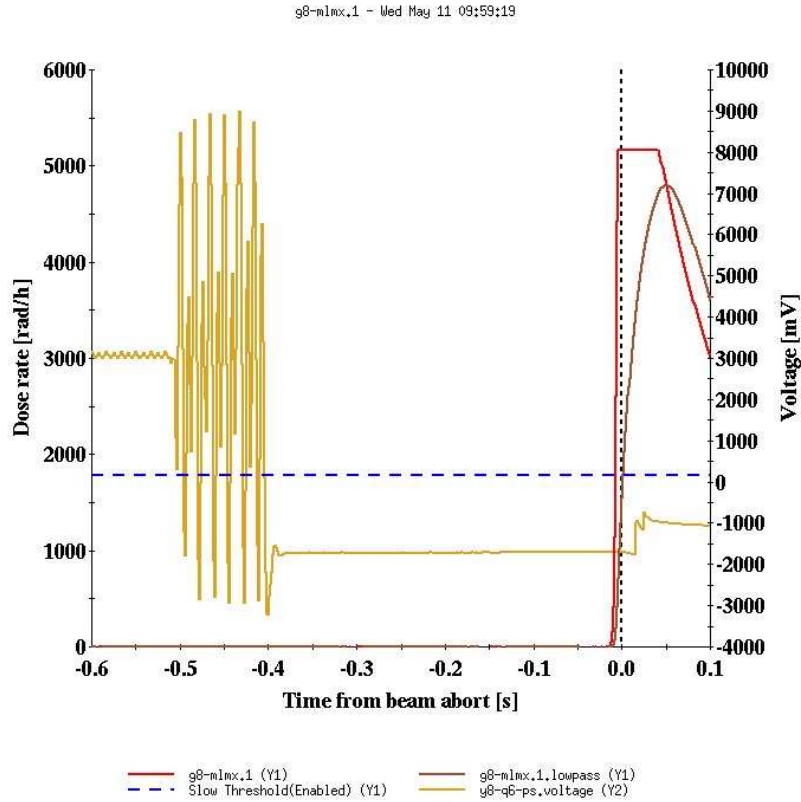
This event happened during dAu operation. A quench of Y7Q2 was associated with this abort. As can be seen in Fig. 15, the y8-q6 power supply started oscillating 0.5 s before the abort. It is in a steady error state at 0.4 s before the abort. Nevertheless, losses appear only at 0.01 s prior and the abort cannot prevent the quench of Y7Q2. No other loss monitor in the area sees earlier losses either.

Figure 15: g8-mlmx.1 and y8-q6-ps PM data during the 0.6 s prior to the abort.

**Conclusion:** Since there are no evident losses early enough only a permit system based on PS data could have prevented the quench. Given the time scale of 0.5 s, an additional 40 ms delay should not pose a problem.
