## Instabilities on the Booster Front Porch

Number 249AGS Studies Report

Date(s) February 15, 1989 Time(s) 1200 - 1600  
Experimenter(s) E. Gill, E. Raka, J.M. Brennan  
Reported by E. Raka, L. Ahrens  
Subject Instabilities on the Booster Front Porch

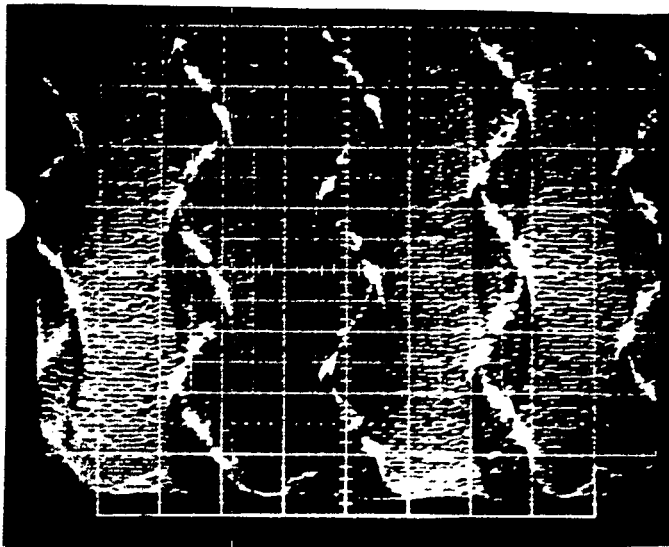
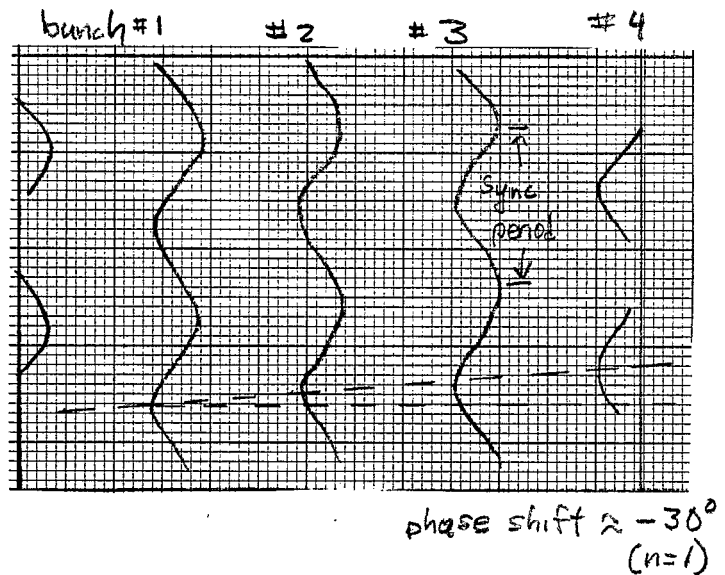
As part of the VHF cavity study of February 15, 1989, the high intensity characteristics of the beam without  $268 f_0$  excitation (VHF cavity off) were investigated. It was first noted that at intensity approaching  $10^{13}$  protons (total in 12 bunches) there was a strong transverse vertical instability present. This was suppressed by lowering the vertical tune on the 1.5 GeV flattop ( $GC \approx 4900$ ) while maintaining the "normal" damper settings. Next, we found that the beam became significantly debunched before the end of the 200 msec flattop was reached (at  $\approx 10^{13}$ ). As the intensity was increased to approximately  $1.2 \times 10^{13}$ , the blowup began 50-60 msec from the start of the flattop and some beam loss ensued. One could see unequal bunch population at the end of the flattop and significant bunch shape distortion and elongation.

At lower intensity, approximately  $6 \times 10^{12}$ , the instability was not present. Also, at intermediate intensity when there was blowup but no loss, the beam went through transition with no loss. Using a mountain-range display, it was possible to make a tentative identification of the coupled bunch mode present during the early part of the growth. It is either an  $n = 1$  or  $n = 11$  mode. This was also verified by using the spectrum analyzer (J.M. Brennan) to measure the amplitude of the 11th harmonic of the beam current relative to the 12th or rf component with and without the instability present. For the former, there was less than 10 db difference while at lower intensity the difference was  $> 30$  db. We note that the rf frequency was 4.171 MHz on the flattop.

The figure below shows the mountain range with the instability present (bunch intensity vs. time looking at the same bunches at 25  $\mu$ s intervals during the porch). One presumably trivial but as yet unexplained problem is that the synchrotron frequency derived from this picture (1.2 kHz) is too small (2 kHz calculated from reasonable rf parameters).

F-20 wall monitor "mountain range" photo and sketch; 25  $\mu$ s delay between sweeps, sweep speed adjusted to show 4+ bunches (100 ns/cm), 2 ms total time for display.

The first step in a study program to clarify the longitudinal blowup could involve observing the dependence of this phenomenon on frequency (vary the energy of the porch).
