A close look at beam aborts with rise times less than 40 ms from the years 2014-2016. Case studies.

A. Drees

September 2016

Collider Accelerator Department Brookhaven National Laboratory

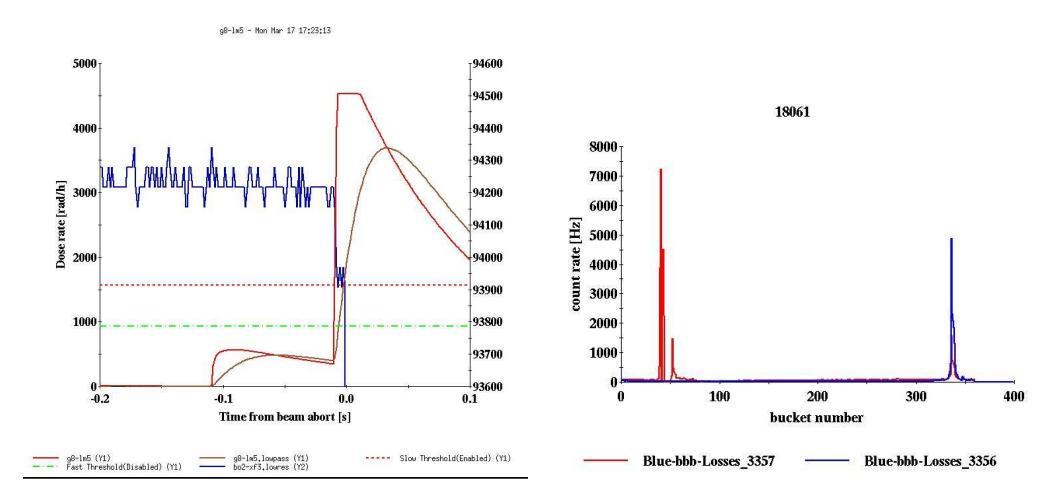
No quenches were associated with this abort. Fig. 2 (left) summarizes the event, including the loss data (red line), various thresholds and the beam current data. The data shows a 10 Hz structure (0.1 s steps), representing the fastest of the gap cleaning options of 10Hz, 1Hz or 0.25Hz. The g8-lm5 LM saturates with only 0.3% of the beam lost (and most of that would be lost on the collimators, not at g8-lm5). Due to the ongoing reboot of the FEC (cfe-2a-tune1) the status of the gapCleaner [5] cannot be reconstructed fully. However, as can be seen in Fig. 2 (right), the bunch-by-bunch losses clearly move from the gap to a location in middle of the bunch train. The blue trace is taken 1s before the abort, the red trace shows the data accumulated during the second in which the abort happened. The peak appears 'smeared' due to varying arrival times of particles in the collimator Pin Diodes.

**Conclusion**: The amount of beam loss is actually small (about 1/3 of one bunch), too small for damage beyond, perhaps, a quench. The gapCleaner, due to its kicker pulse length

Figure 2: 720 Hz loss monitor and current transformer data from PMViewer (left). Two traces corresponding to two consecutive seconds of bunch by bunch (bbb) loss data from the abort in 18061.

of only about 100 ns [5], affects only one bunch at a time but cannot impact the entire beam. The fastest time for it to switch from one bunch to another is 10 Hz, i.e. 100 ms, plenty of room for an additional 40 ms.

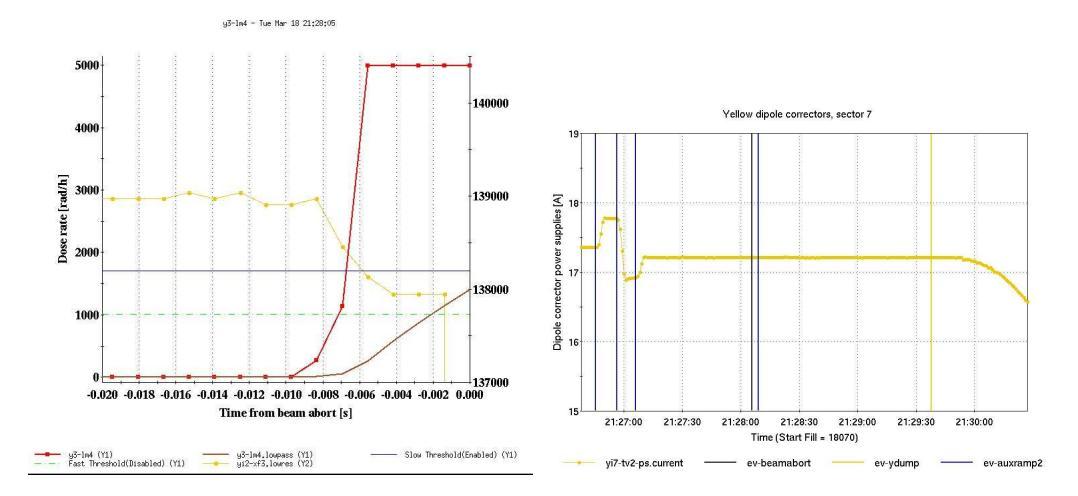
No quenches were associated with this abort. Current transformer and loss data are shown in Fig. 3, left. It is interesting that the losses appear to stall after a fast initial drop over the first 2.8 ms. The losses correspond to 0.7% of the total beam, a bit less than one full bunch. MCR attributed the abort event to a bad lisa [6] steering. Following are two excerpts from the appropriate 2014 lisa logfile:

This last automatic message and the accompanying retry appears to happen 3 seconds after the time of the beam abort making lisa steering unlikely to be the cause. This timing can be confirmed by checking the logged PS current data for the involved correctors and the timing of the abort- and auxramp2-events as can be seen in Fig. 3 on the right. Indeed, all correctors in question are at nominal values until the ramp-down starts (well after the abort).

In addition, y3-lm4 is an unusual loss monitor to be first responder in a failure caused by corrector magnets around IP6 and IP8. It is, on the other hand, close to a stochastic cooling tank which was indeed moving at the time and losses spike on yi3-ksch3-pd (the pin diodes associated with the yellow horizontal stochastic cooling kickers in sector 3) at the time. The extremely fast loss rise time, however, makes the move of a large mechanical system equally unlikely to be the root cause of this very fast event. Unfortunately, all abort kickers are accounted for and not one PS was alarming or reporting an issue at the time of question.

Conclusion: The abort was not due to a bad lisa activation. The SC kicker as a me-

Figure 3: 720 Hz loss monitor and current transformer data from PMViewer. Dipole corrector data during store 18070, before and after the abort.

chanical system is too slow to be the culprit. No other culprit candidate could be found and this case remains a mystery.

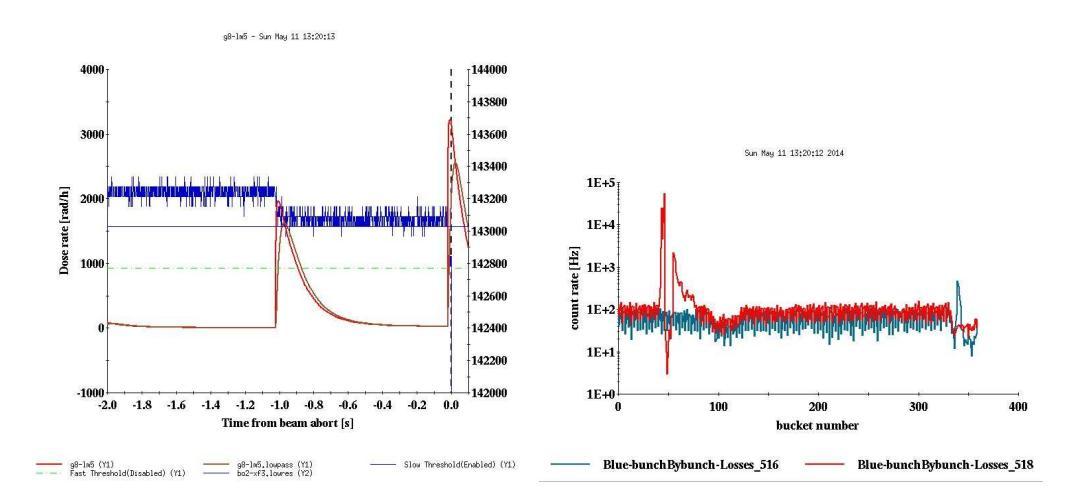
No quench associated with this abort. The gapCleaner was set to a 1 Hz frequency and the losses, as shown in Fig. 4, left, clearly show a 1 Hz structure. During the trigger at -1.0 s about 0.1% of the beam was lost and just before the abort another 0.2%. The bunch-by-bunch losses, shown in Fig. 4, right, were accumulated in a second before (trace 516) and during the abort (trace 518). They clearly show how the losses moved from the gap to an occupied bucket. A modest lowering of the trip threshold would have aborted the beam easily 1 s earlier. The FEC (cfe-2a-tune1) apparently rebooted itself spontaneously. A warning

Figure 4: Left: 720 Hz loss monitor and current transformer data from PMViewer. Right: Bunch by bunch losses accumulated two seconds before and the second including the abort.

**Conclusion**: The gapCleaner, due to its kicker pulse length of only about 100 ns, affects only one bunch at a time and cannot impact the entire beam. Hence the associated beam loss is relatively modest and not close to a damaging amount.

message (not to reboot with beam in the machine) has been added since.

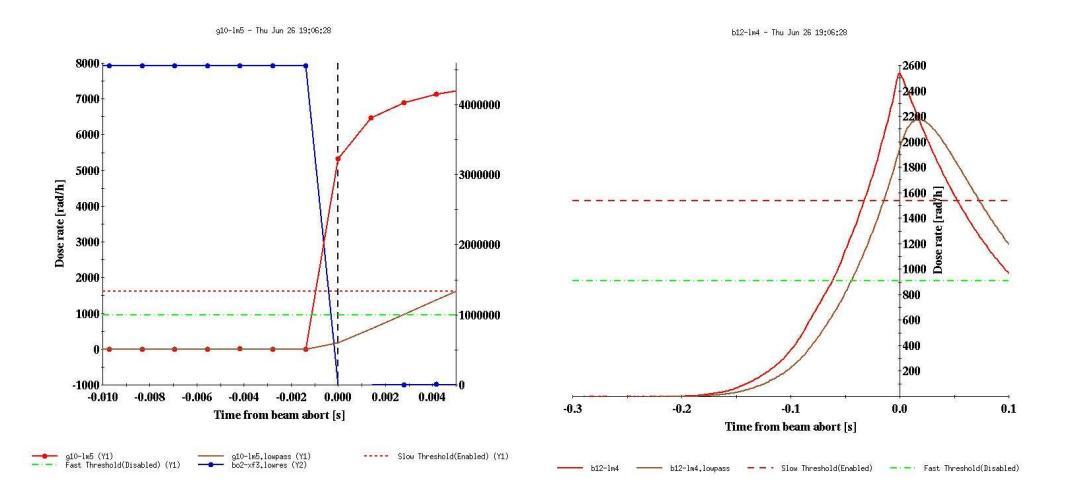
There were no quenches associated with this event. Fig. 5, left, shows g10-lm5 data. g10-lm5, showing losses caused by an ordinary beam dump, actually did not trigger the beam abort but b12-lm4 did (Fig. 5, right). The actual rise-time for b12-lm4 is well above 100 ms and

Figure 5: Left: 720 Hz loss monitor b12-lm4 data from PMViewer. Right: 720 Hz loss monitor g10-lm5 data from PMViewer

thus of no concern for the extra 40 ms delay. This event got into the list by accident. However, it indicates that a rise time of 2.78 ms can be falsely calculated from the 720 Hz data, here due to the continuous rise of the loss rate after the abort (thus shifting the maximum to after the abort). The actual rise time in this case is less than 1.39 ms (i.e. one 720 Hz bin). In addition, it is suggested to exclude APEX time from operating the aborts with the additional 40 ms. There are, of course, failure modes during APEX that could happen at any other time as well and therefore need to be checked.

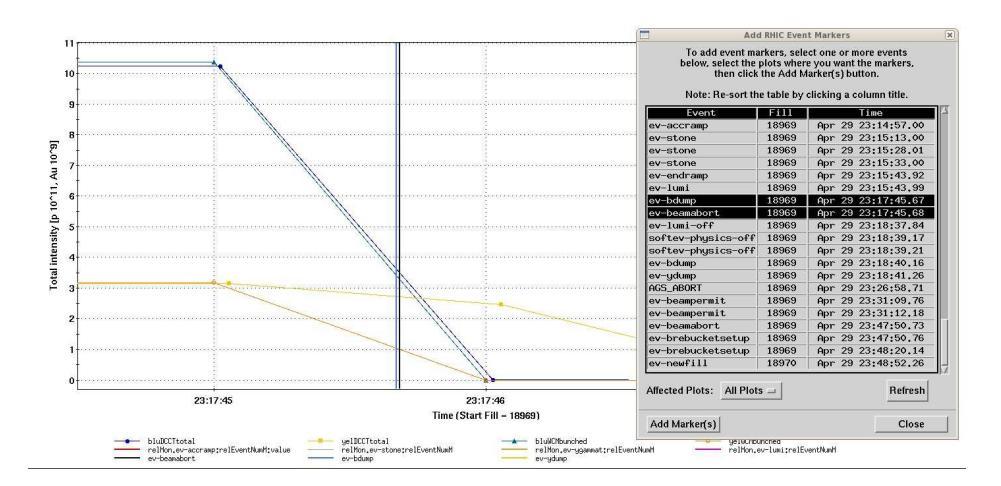
There were no quenches associated with this event. In principal, this event should not be listed here since it happened during ramp development. However, we need to check if this type of failure could not happen at other times as well. In any case, looking closely at the time of events as shown in Fig. 6, it shows that the permit pull by b10-lm4 comes following an ordinary beam dump. According to the list of RHIC event times, the two are 10 ms apart. b10-lm4, the first loss monitor down stream of the blue abort, is prone to and known for

Figure 6: LogView graph showing beam current data and list of events for end of store 18696.

permit pulls due to 'spilled" losses from an ordinary beam dump, particularly during proton operation.

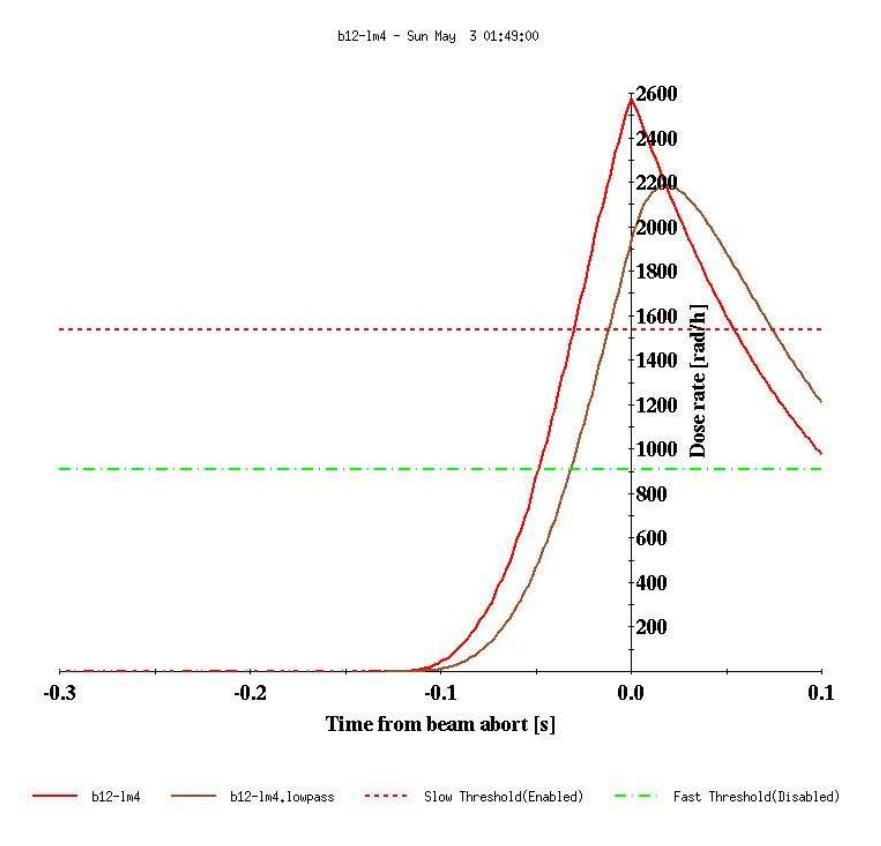
No quenches were associated with this abort. y9-lm4 (yellow!) actually goes above threshold after the abort and the triggering loss monitor is b12-lm4 (blue!). Fig. 7 shows the corresponding data. The rise time for this monitor is approximately 100 ms. Therefore this case is of no interest for this study. y9-lm4, the first loss monitor down stream of the yellow abort, is the yellow LM known for permit pulls due to "spilled" losses from an ordinary beam dump, particularly during proton operation.

Figure 7: PM 720 Hz b12-lm4 data

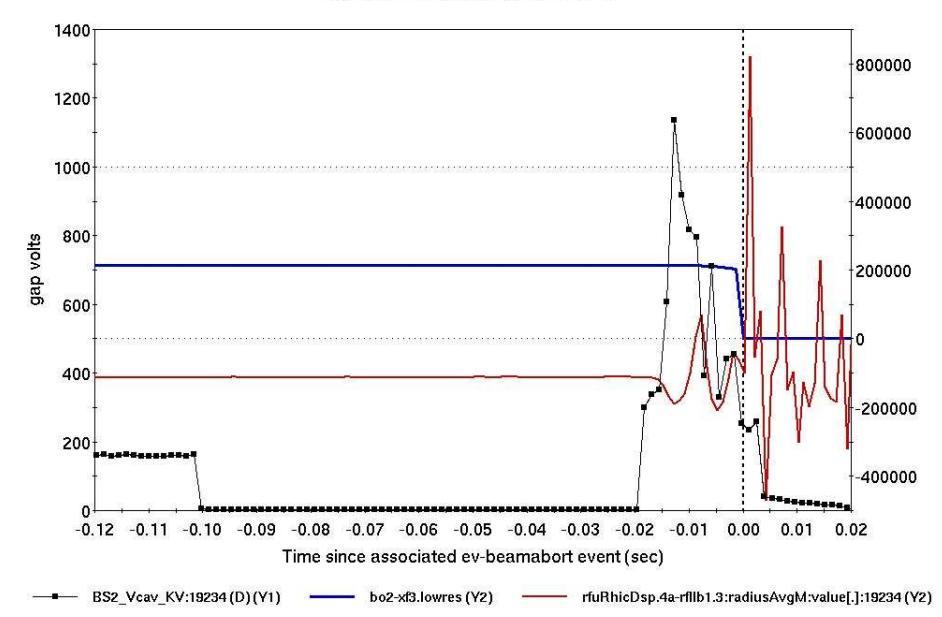
B6Q3 triplet quadrupole quenched in this case. This abort portrays the perfect storm of cavity trips where a faulty damper was not secured when the trip happened. Fig. 8 summarizes the course of events. Shown are the BS2 gap volts (black squares) in kV, the radius (red line) in micron and the beam current transformer data (blue line). The cavity trips 100 ms before the abort (t=0). The unsecured tuner starts moving towards the beam, changing the cavities tune in the process. 20 ms before the abort very fast instabilities entail, visible as rapid oscillations of the cavity voltage as well as the radius. Actual beam loss is concentrated in the last 5 x 1.39 ms = 7 ms before the abort.

**Conclusion**: Only if the BS2 cavity would have been in the permit (it wasn't) this quench (with or without an additional 40 ms of delay) could have been prevented.

Figure 8: 720 Hz RF BS2 voltage data, radius data and beam current transformer data.

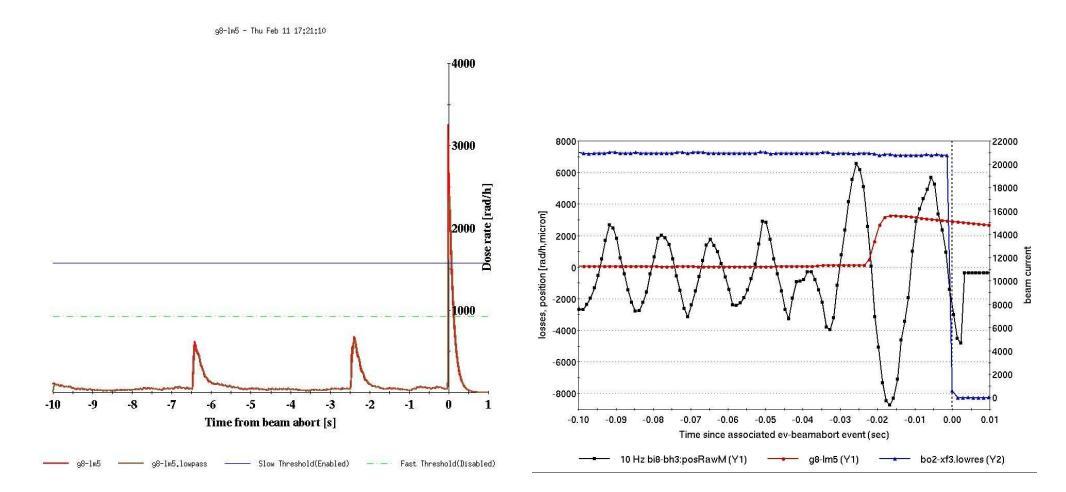
No quenches in this case. The abort happened during an APEX, a time during which no change to the abort system is planned. At the time of the abort were 12 bunches in the machine and a new ramp to squeeze IP8 to 50 cm was tested. As part of the ramp development TbT orbits were triggered every 4 s which include a trigger to the ARTUS tune meter kickers. The losses due to two of those triggers can be seen at -6.5 s and -2.5 s in Fig. 9 (left), precisely 4 s apart. There are two corresponding TbT data sets stored in the orbit archives. Only one bunch (# 31) is affected by the TbT triggers. However, beginning about 15 s before the abort (and 47 s into the ramp), all 12 bunches start to oscillate (+/- 3 mm peak to peak, approximately 140 Hz frequency) and to show some beam losses according to the bbb beam loss monitor. The amplitude more than doubles about 25 ms before the abort as can be seen in Fig. 9 (right). Even though losses are visible on the loss monitors, there is no noticeable beam loss seen in the current transformers up to 1.39 ms before the abort.

**Conclusion**: No single cause of abort could be identified for this case although it is likely associated with the ongoing beta-squeeze. One could argue to ignore it since it happened during APEX and during a ramp, if only a squeeze. Alternatively one could establish a maximum allowable oscillation amplitude of, say, +/-2 mm (at store). In this case this ramp could have been aborted 15 s earlier than it actually did.

Figure 9: Left: g8-lm5 PM data from abort of store 18519. Right: The last 0.15 s before the abort depicting 1kHz data from GOFB\_10Hz BPM bi8-bh3, current transformer and g8-lm5.

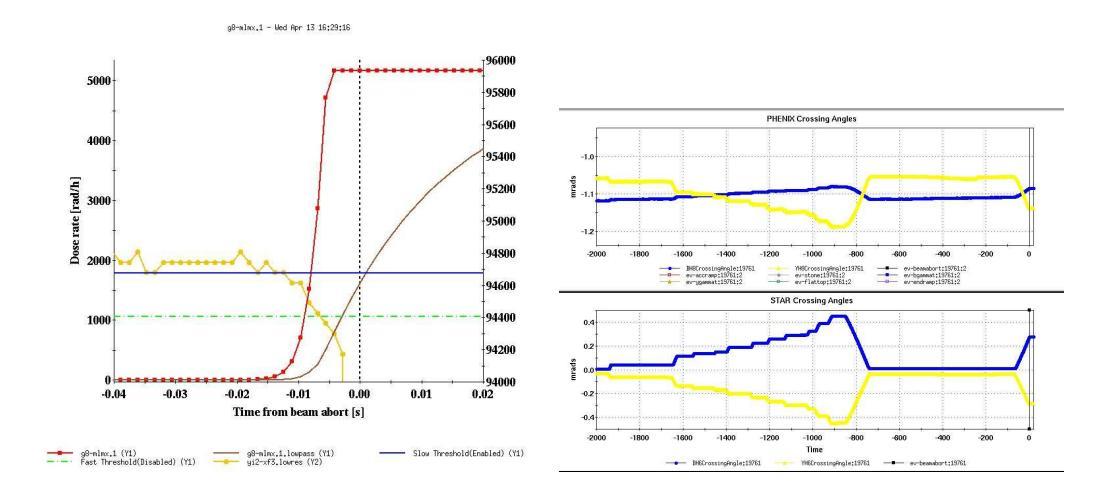
No quenches were associated with this event. This abort happened during an APEX study and would as such have happened without any changes to the abort system. However, this loss scenario is not associated with APEX activities such as the quoted angle steering in IR6 (which is not the root cause for this abort). The beam loss happened very fast (see Fig. 10, left). As can be seen in Fig. 10, right, most of the angle steering in IR6 was already completed when about 15 s prior to the abort angles start drifting again in both IPs and beam is lost at angles much smaller than the ones achieved before. At the time of abort all of the supplies in

Figure 10: left: g8-mlmx.1 PM data from abort 19761. Right: IP8 and IP6 crossing angles during APEX leading up to the abort.

alcove 9A, 9B and 9C tripped on a lead flow fault. Cryogenics replaced a power supply in the 1008B valve box for 8Q3. Yet, a lead flow fault alone does not quite explain the very short

rise time seen in this event. In another similar case (19837, in which the yellow injection kicker got damaged) the rise time was of the order of a few 100 ms.

**Conclusion**: It is unclear if the likely reason (lead flow fault) is enough to explain the very short rise time. No other reason could be found however. Therefore no recommendation in anticipation of an extra 40 ms delay can be made.

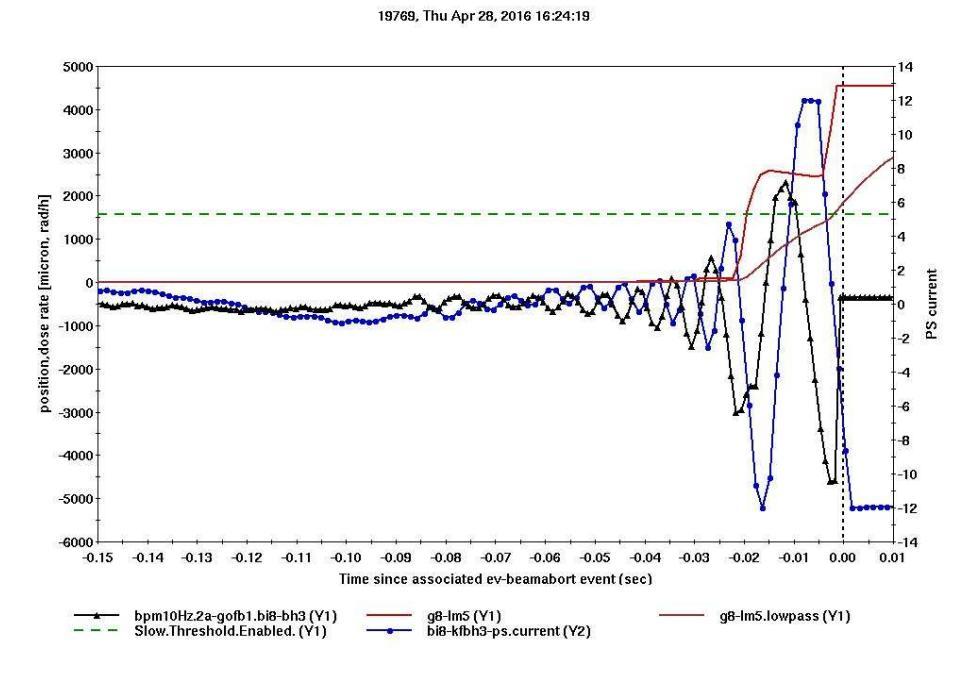
No quenches were associated with this case. This abort is caused by a failure of a GOFB\_FB 10Hz PS without any connection to the 56 MHz RF cavities. As can be seen in Fig. 11, the power supply and the orbit start oscillations about 70 ms before the abort (indicated by the dashed black vertical line), significant losses appear about 20 ms before.

Figure 11: Orbit oscillations, power supply current and loss monitor data during 0.15 s before the abort.

**Conclusion**: In order to trigger an abort 40 ms before the recorded time here, either a BPM based permit or a 10 Hz PS based permit would be needed with a response time of approx. 10 ms.

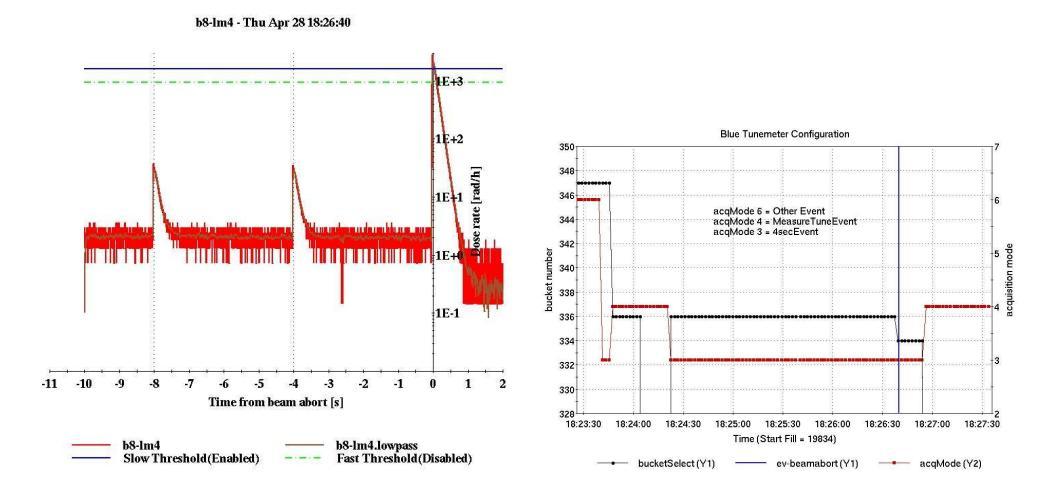
There were no quenches associated with this abort. The culprit in this case was not the 56 MHz cavity but operator error. b8-lm4 is the first loss monitor down stream of the blue

collimators with an enabled permit threshold. As can be seen in Fig. 12, left, gap cleaning was in progress at a modest level at 0.25 Hz, one of the three frequency options. This can be confirmed by the configuration setup for the blue gap cleaning kickers (Fig. 12, right). Acquisition mode is set to "3", i.e. the 4secEvent, minutes before the abort. At the same time the default bucket for gap cleaning, was changed by operators from 347 to 336 and eventually to 334. Note that bucket numbers are offset by +1, starting from 0 and going up to 359. In addition, it can be expected that the kicker pulses are not perfectly centered on the occupied buckets. Timing shifts can occur during the ramp to store. The effect of the

Figure 12: Left: b-lm4 PM data, right: blue tune meter kicker setup before and during the abort.

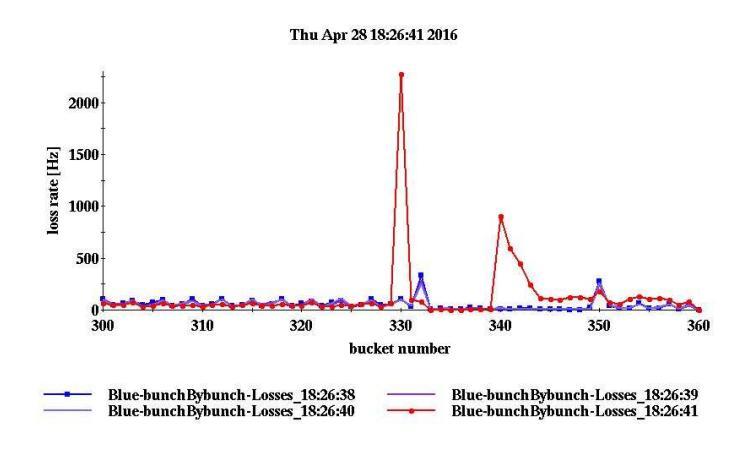
Figure 13: Bunch by bunch loss monitor for the seconds leading to (blue lines) and including the abort (red line).

bucket switch is apparent in Fig. 13. In the seconds leading up to the abort modest losses are evident at buckets 331 and 350. Both buckets are part of the gap. The last data set, including the abort (shown as a red line) shows a peak at bucket 330, the last one of the occupied buckets. The kickers were set to bucket 333, but due to the pulse length of about 110 ns, the last occupied bucket got hit, causing the abort.

**Conclusion**: There is very little risk for damage since the gap cleaner kickers will only affect one bunch at a time with a repetition rate of 0.1 s or slower. Adding a delay of 40 ms would still have aborted the beam well before the next trigger could have occurred, even if it was set to 10 Hz.

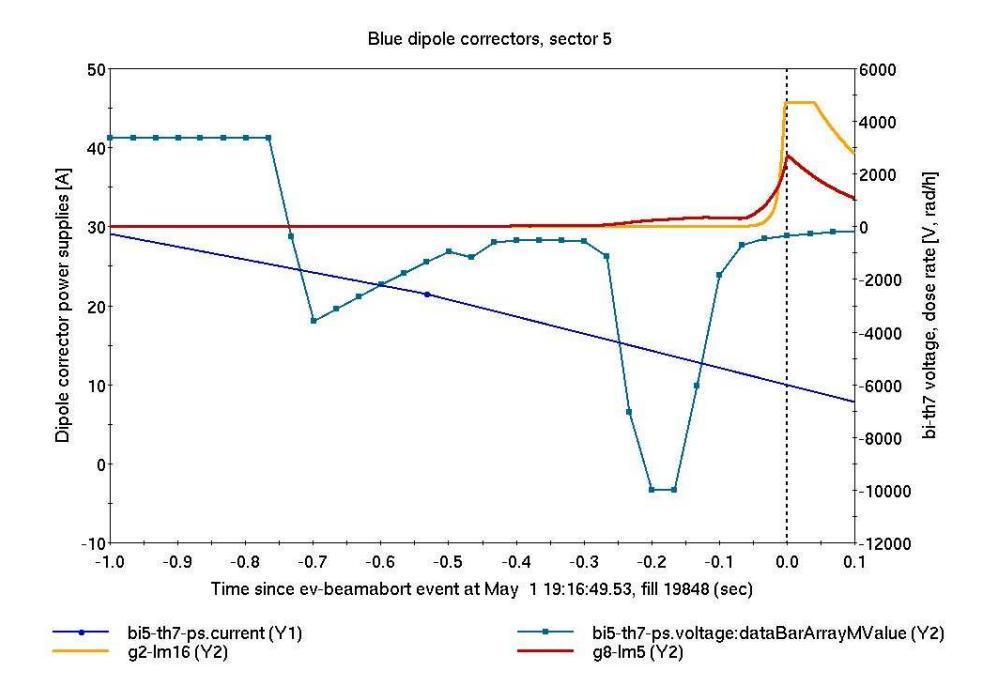
No quenches were associated with this abort. The blue longitudinal pick-up was certainly not involved in this event. Actually, about 700 ms prior to the abort a total of 11 dipole corrector supplies controlled by cfe-5c-ps1 started to fail. It is likely that cfe-5c-ps1 was compromised by the bad vacuum in sector 5, causing the concerted trips of many corrector supplies. One of the power supplies is shown in Fig. 14, together with the PM data for LM g2-lm16, at the maximum of the blue protection bump. Losses in g2-lm16 start showing over 500 ms after the dipole correctors first signs of errors. Only the LM down stream of the blue collimators experience some earlier losses, reaching only about 450 rad/h about 50 ms before the abort.

Figure 14: PM data from g2-lm16, g8-lm5, and bi-7th. LogView current data from bi-5th.

**Conclusion**: In order to violate the beam permit 40 ms earlier than the current abort time, a PS based permit system appears most promising. A much reduced permit threshold (about 25% of current level) for g8-lm5 could potentially do the same with the added risk of unnecessary and premature permit pulls. In addition, it relies on the collimators being in the proper position.

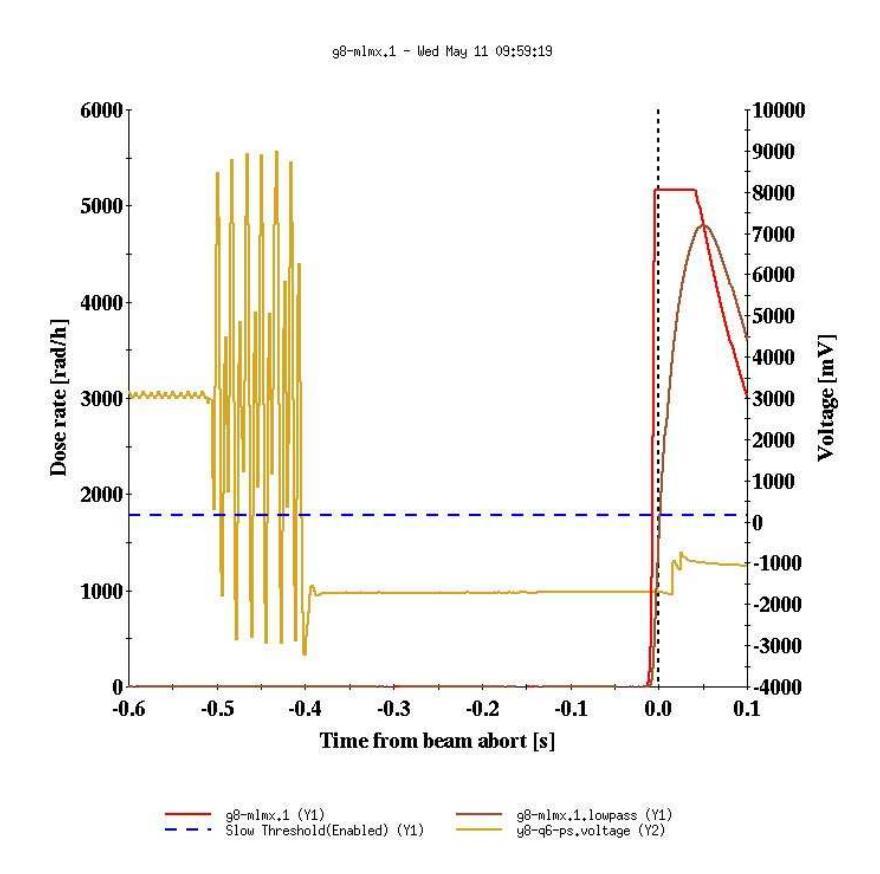
This event happened during dAu operation. A quench of Y7Q2 was associated with this abort. As can be seen in Fig. 15, the y8-q6 power supply started oscillating 0.5 s before the abort. It is in a steady error state at 0.4 s before the abort. Nevertheless, losses appear only at 0.01 s prior and the abort cannot prevent the quench of Y7Q2. No other loss monitor in the area sees earlier losses either.

Figure 15: g8-mlmx.1 and y8-q6-ps PM data during the 0.6 s prior to the abort.

**Conclusion**: Since there are no evident losses early enough only a permit system based on PS data could have prevented the quench. Given the time scale of 0.5 s, an additional 40 ms delay should not pose a problem.
