**Technical Note No. 418**

**Observations of Secondary Emission Chamber Efficiency  
Degradation For Very High Intensity Slow Extracted Beams**

**K. A. Brown**

**August 24, 1995**

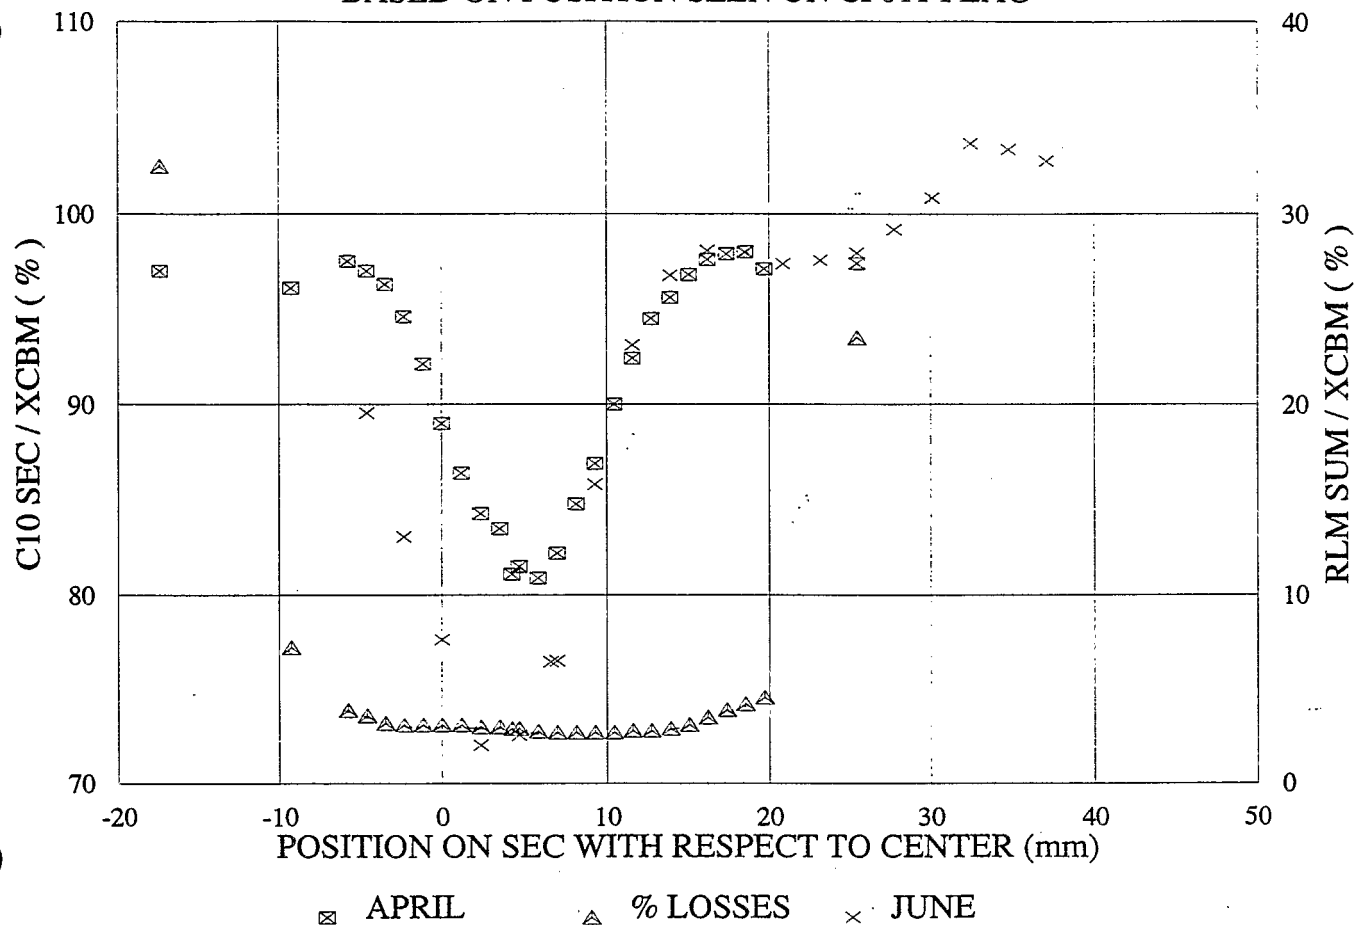
FIGURE 1: C10 SEC RESPONSE vs POSITION ON SEC  
 BASED ON POSITION SEEN ON CF011 FLAG

Figure 1: Horizontal Response Scan of the C10 SEC; Efficiency versus position of the beam on the SEC. The scan clearly shows the degradation of the surfaces of the SEC. The data plotted shows the results of two scans, one performed in April and the other performed at the end of the SEB run (in June). Also plotted is the sum of the four long loss monitors subtending the AGS ring. The scan was made by changing the current in the F10 ejector magnet. Thus at the edges of the scan the losses shoot up quickly, corresponding to greatly mis-steered beam and beam being lost in the AGS ring. The scans do not overlap because the F10 was worked on between the time of the scans, giving a different range of currents by which we could adjust the power supply. The setpoint of the F10 was varied a great deal between the time of the two scans, to provide different sharing ratios, and also due to problems, or perceived problems, with the F10 P.S. Drifts in the beam sharing ratios were often corrected by adjusting the F10 P.S., which was also the suspected cause of the drifts, but they were also adjusted by changing the SEB splitter positions. Therefore the position of the center of the two scans could easily have changed. The scan done in June also shows the effect of beam losses upstream and near the SEC by a step in the efficiency at 30 mm.

What this simple simulation suggests is that for a scan in which the most degraded spot may show to be about 70 % of the normal response, the actual depth of this degradation is 40 %. Even a spot which has degraded to a depth of 0 % will only show a minimum response of 50 %. The June scan of the C10 SEC dropped to 70 % at the minimum, suggesting the actual response at this point is more on the order of 40 %.

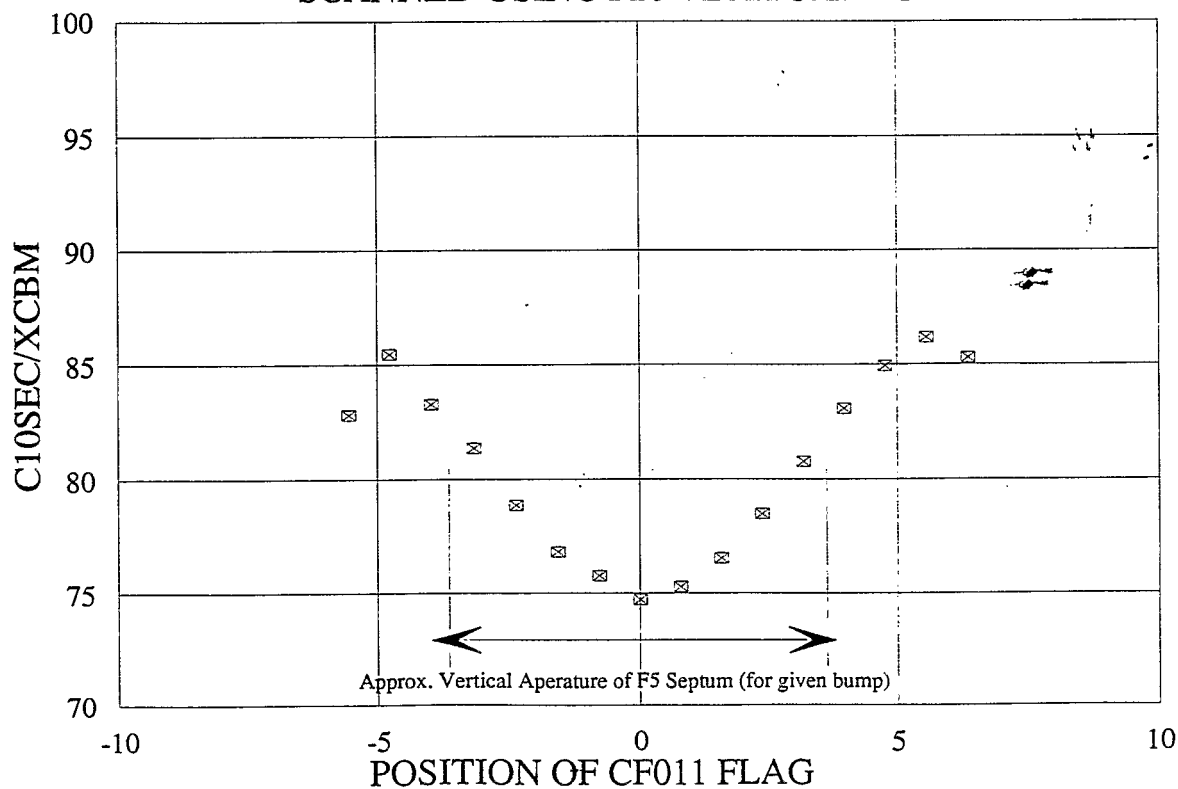
FIGURE 2: VERTICAL SCAN OF C10 SEC  
 SCANNED USING F20 VERTICAL BUMP

Figure 2: Vertical Response Scan of the C10 SEC. In this case the beam position was moved using the F20 Vertical bump in the AGS, causing a vertical orbit distortion displacing the beam at the F5 through to the C10. The motion at the F5 septum was about 3

time greater than at the C10, causing the beam to scrap vertically on the septum. The lines drawn on the figure correspond approximately to the points at which the beam begins to hit the vertical apertures of F5.

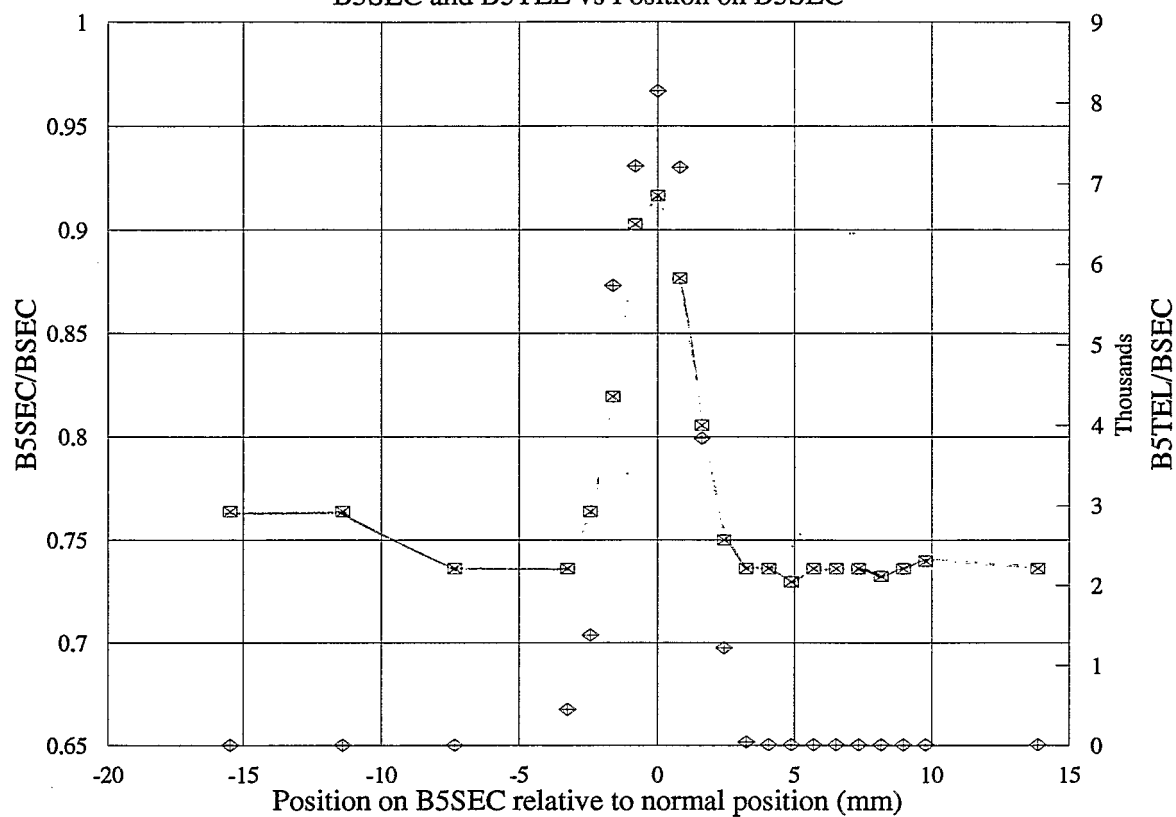
# Figure 3: HORIZONTAL SCAN OF B5SEC

B5SEC and B5TEL vs Position on B5SEC

Figure 3: Horizontal B5 SEC Response Scan. This data was presented in reference 2 but is presented here because of the unusual nature of the response. All other target SEC scans show the same basic character as the C10 SEC, a reduced SEC efficiency at the point most frequently hit by the beam. B5 SEC, on the other hand, shows an increased efficiency.

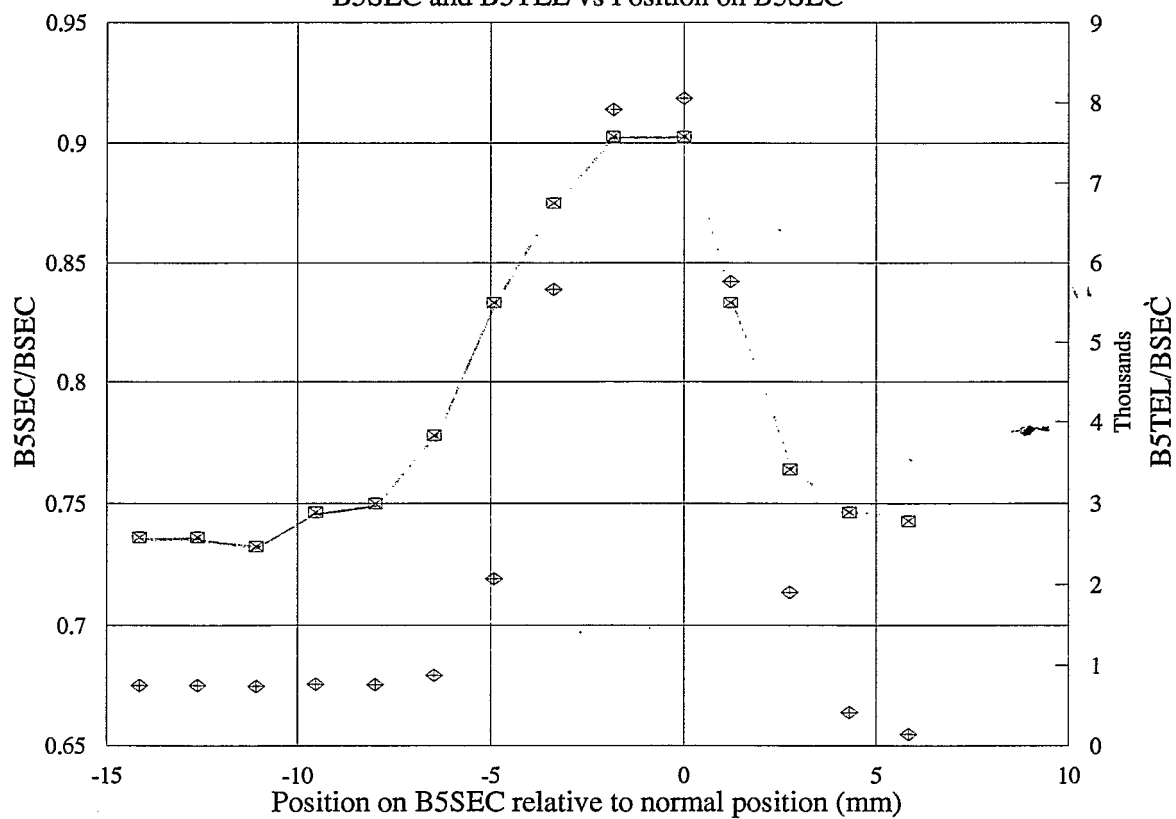
# Figure 4: VERTICAL SCAN OF B5SEC

B5SEC and B5TEL vs Position on B5SEC

Figure 4: Vertical B5 SEC Response Scan.

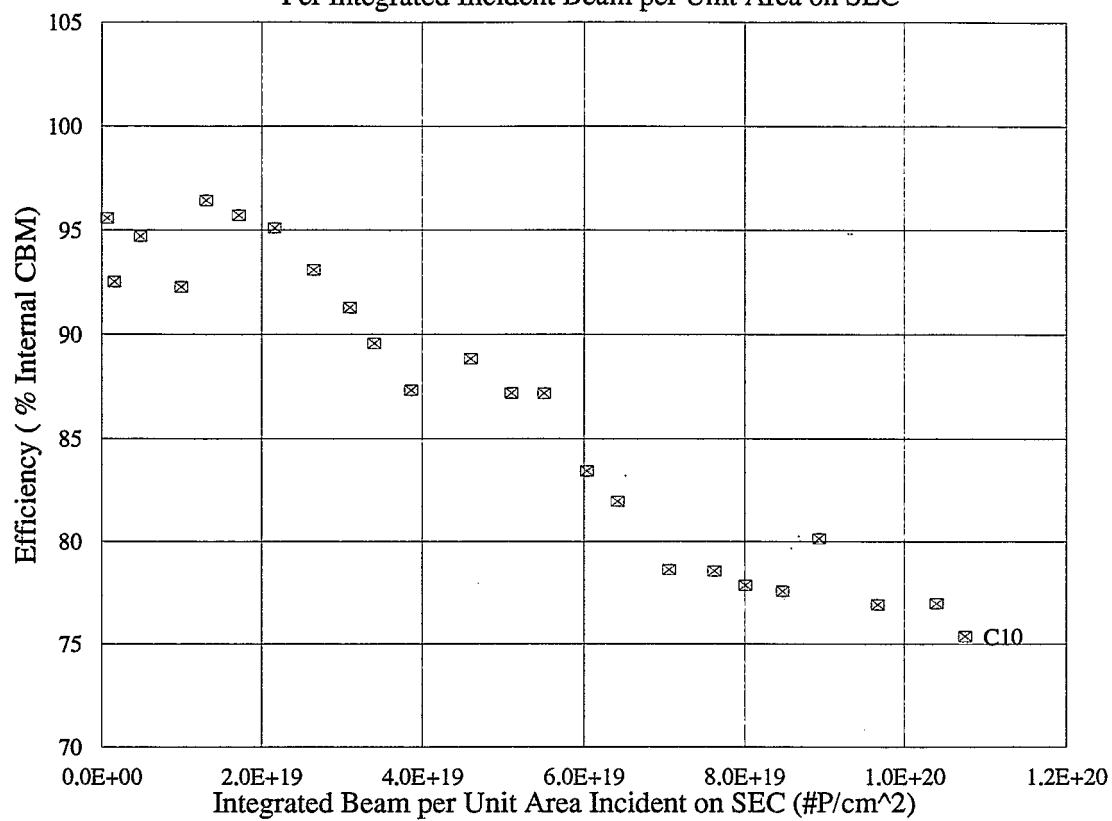
FIGURE 5: Degradation of C10 SEC  
Per Integrated Incident Beam per Unit Area on SEC

Figure 5: C10 SEC Response versus integrated proton fluence per  $\text{cm}^2$ . The SEC efficiency can be seen to be dropping linearly with integrated incident beam at a rate of 0.2 % per  $10^{18} \text{ p/cm}^2$ . The data is taken from MCR Coordinator logs and is the ratio of C10 SEC to the internal current transformer just before extraction, plotted versus the integrated beam intensity divided by the area the beam is interacting with on the SEC. Variations in the curve would be due to beam targeting the SEC differently and due to variations in the extraction inefficiency.

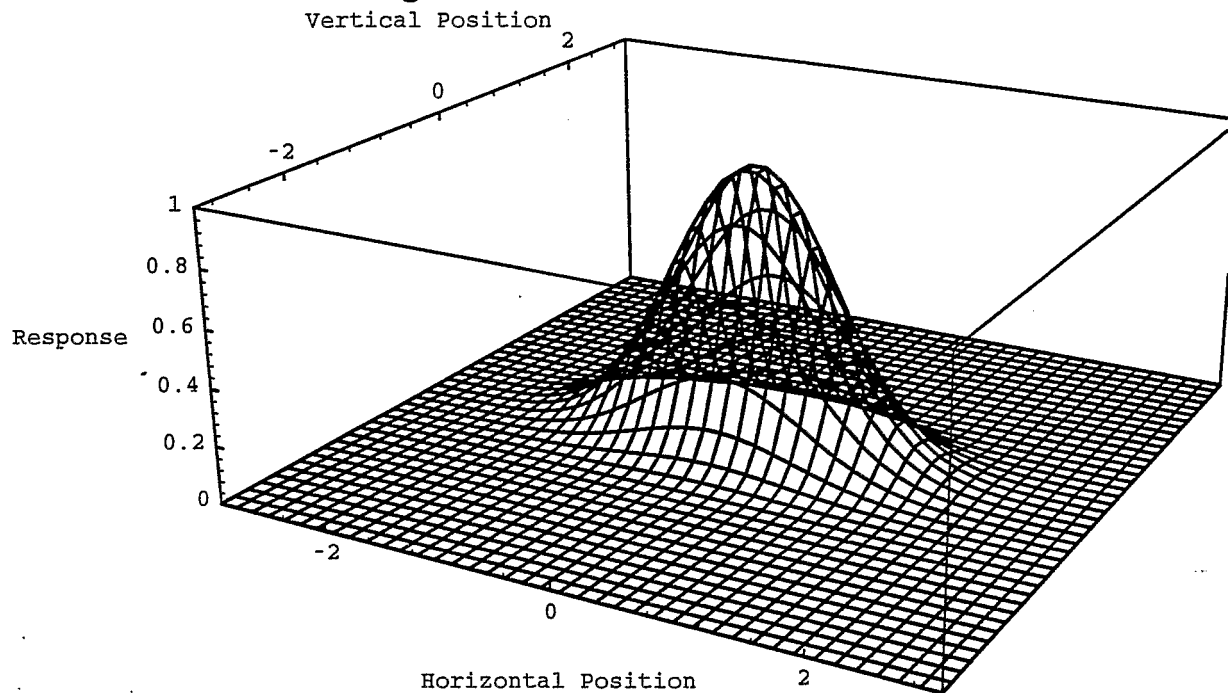
**Figure 6: Simulated Beam on C10 SEC**

The simulation consisted of moving a 2-dimensional Gaussian 'beam' over a 2-dimensional Gaussian target, taking the product and integrating to obtain a single number representing the SEC output current (all normalized to give numbers in percent). Figures 6 - 8 summarize a typical run. In figure 8 the line represents the SEC surface efficiency and the points represent the integrated product of the two Gaussians for the beam centered at each point (thus simulating a scan).

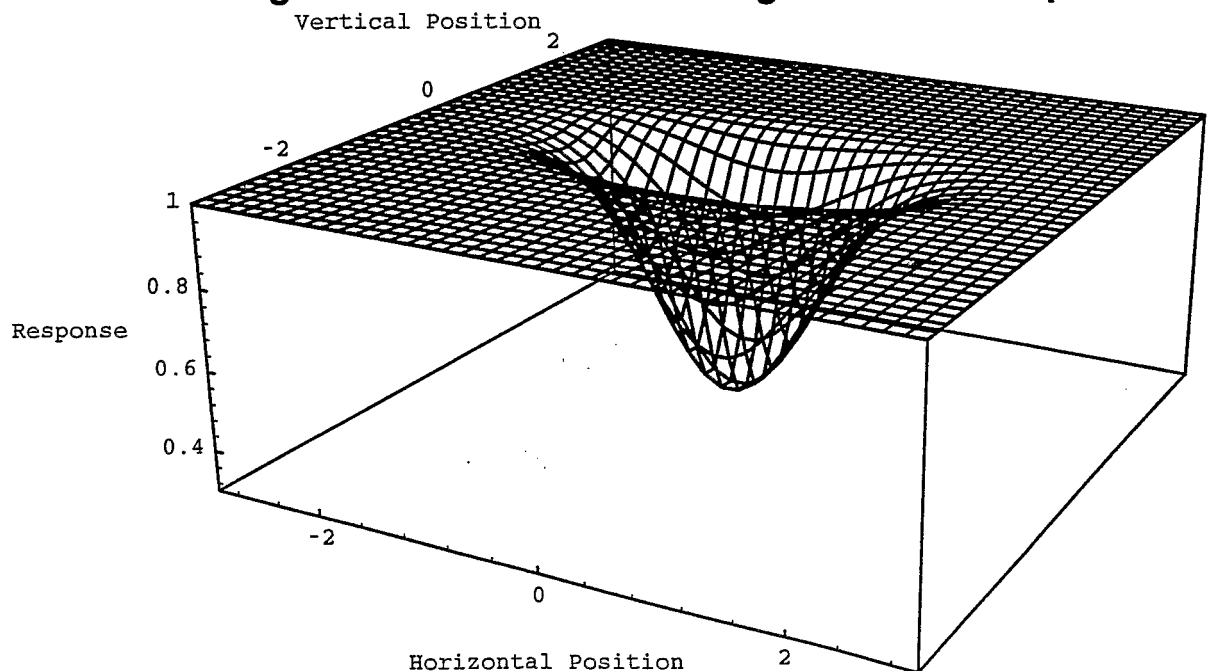
**Figure 7: Simulated SEC Target Surface Response**

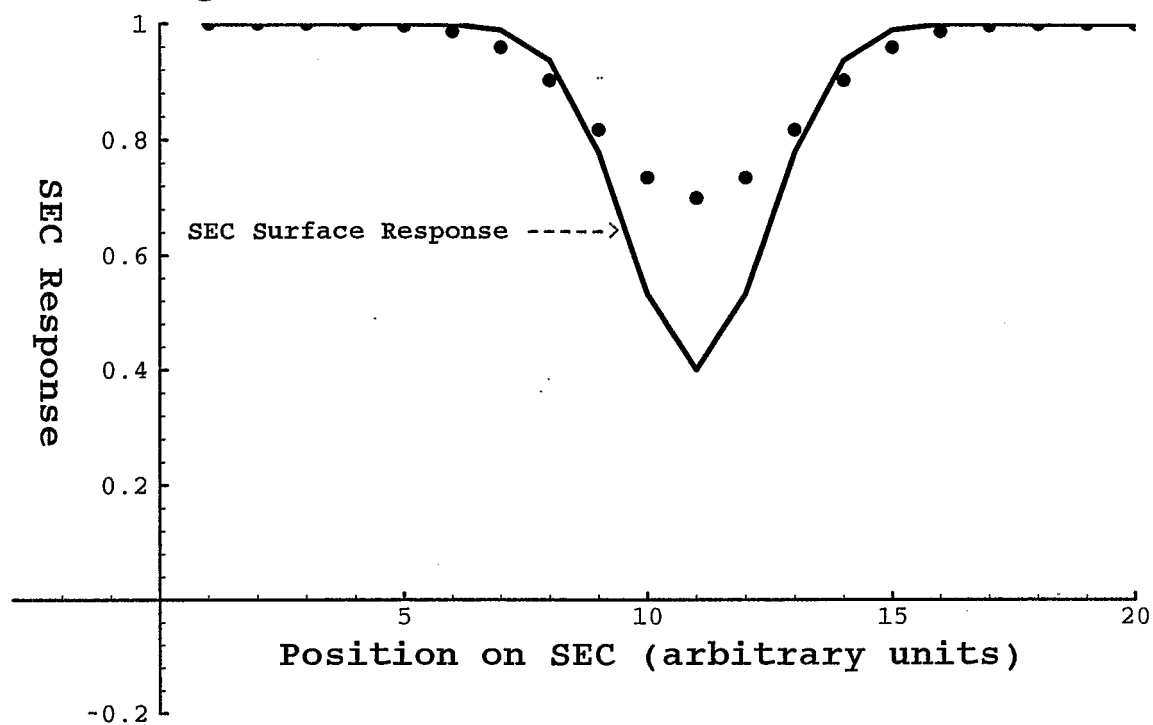
**Figure 8: Simulated Scan of C10 SEC**
