# AGS Circumference Change when Pulsing $3/2$ Lambda G10 Bump

J. W. Glenn

July 2002

Collider Accelerator Department  
**Brookhaven National Laboratory**

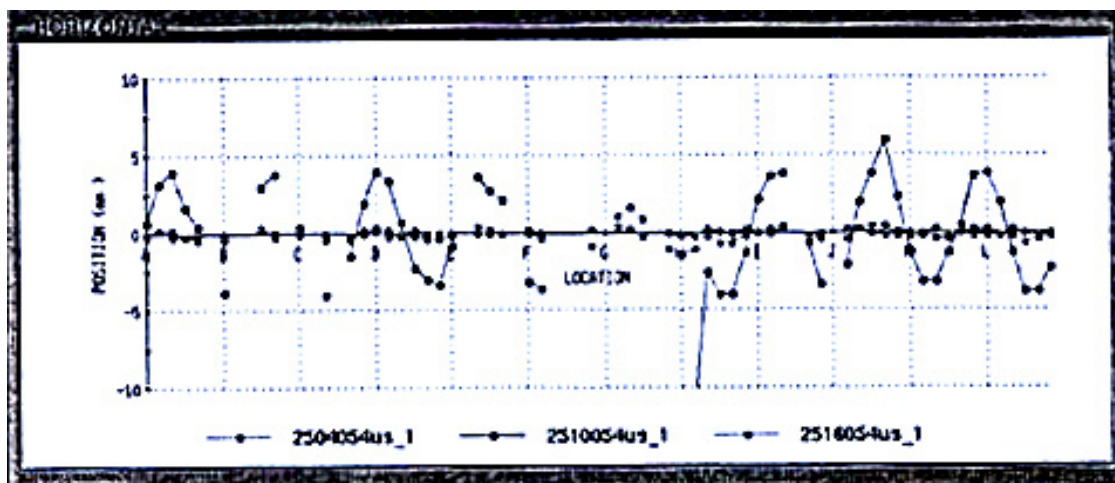
Figure 3. Closeup of orbit residuals at horizontal tune of 8.65.

The G10 bump reaches its' maximum amplitude in  $\sim 3.5$  ms, figure 1. The bump displaces the horizontal beam orbit by  $\sim 20$  mm from the ideal orbit to the inside of the AGS ring at F18,  $\sim 45$  mm to the outside at G08 and  $\sim 20$  mm to the inside again at H02. We also see a displacement vertically of  $\sim 2$  mm near G08 indicating there may be some coupling. A reference orbit was measured just before turning on the bump. The power supplies were 'balanced' to minimize residuals. Figure 2 shows the difference orbits at a horizontal tune of 8.65. The tunes were changed from 8.65-8.75 to try to further reduce residuals. The minimal residuals are found over the 8.65-8.7 tune range, figure 3. At 8.75 they are approximately twice as large. Tests also showed that there is a  $\sim 6$  mm motion away from H10 due to these residuals, figure 4. If this proves to be a problem (the amplitude of the pulse required of the G10 kicker has to be increased to compensate) raising the H11A supply and lowering the G09A should reduce this motion at the expense of more residuals around the AGS

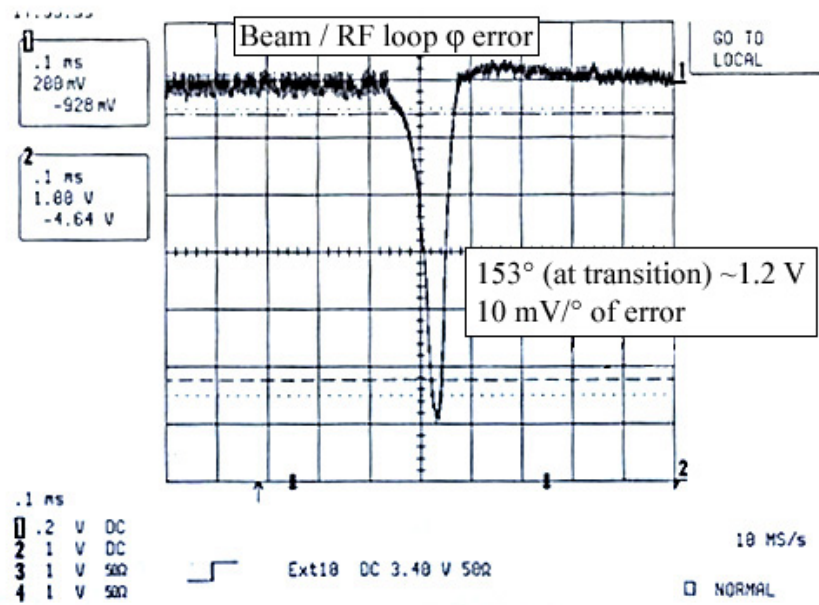
Figure 6. (a) RF phase error trace for calibration  
(b) RF phase error trace with beam showing a maximum of 2.5° shift.

The rf phase error trace shows a maximum of  $\sim 2.5^\circ$  twitch when the bumps were on and  $\sim 1^\circ$  of noise when off, figure 6. Thus the beam and rf are tracking and the beam frequency is to within a couple of Hertz and circumference to a mm or so. This phase bump is less than 5 mSec long and  $2.5^\circ$  implies a 1.5 KV/turn acceleration giving a max energy change of 250 KV or less than a part in  $10^4$ . Time did not allow for observations at higher rf voltages.
