Tensile Tests for Quality Control of Injection Molded Composite Posts

Collider Accelerator Department
Brookhaven National Laboratory

AD/RHIC-78

R H I C P R O J E C T

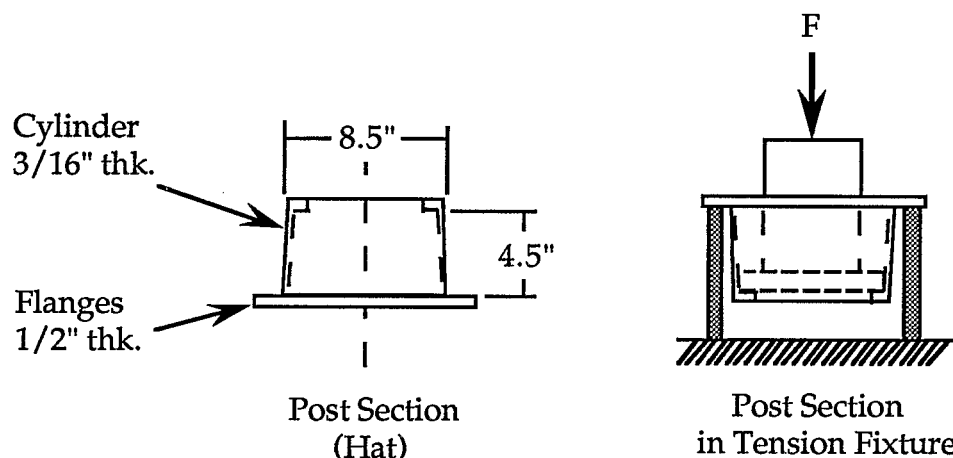
shown in Figure 1. The post is inverted and placed in the fixture on the platen of the testing machine. The compression force, F , supplied by the testing machine causes a direct central tension force of the same level on the cylindrical shell. While the cylindrical shell of an IMC post supporting the cold mass of a magnet will rarely experience a direct central tensile force in the operation or construction of RHIC, this test is intended for all post sections which will be used in the production magnets. Good post sections will not fail under the specified test load. Those with serious flaws will be destroyed.

Figure 1
The quality control testing fixture.

The tensile test of an IMC post section can be conducted in a fixture such as

Not shown in Figure 1, are the fixture flanges and the back-up rings. Both flanges of the IMC post section under test must be sandwiched between metal flanges. They must be carefully bolted, otherwise the flanges will rotate elastically and cause the relatively brittle post flange to crack due to the discontinuity stresses at the flange and cylinder junction.¹ The bolts on the inner flange were torqued to 30 foot-pounds, and those on the outer flange to 40. For production testing, some quick-acting flange clamping mechanism will need to be designed.

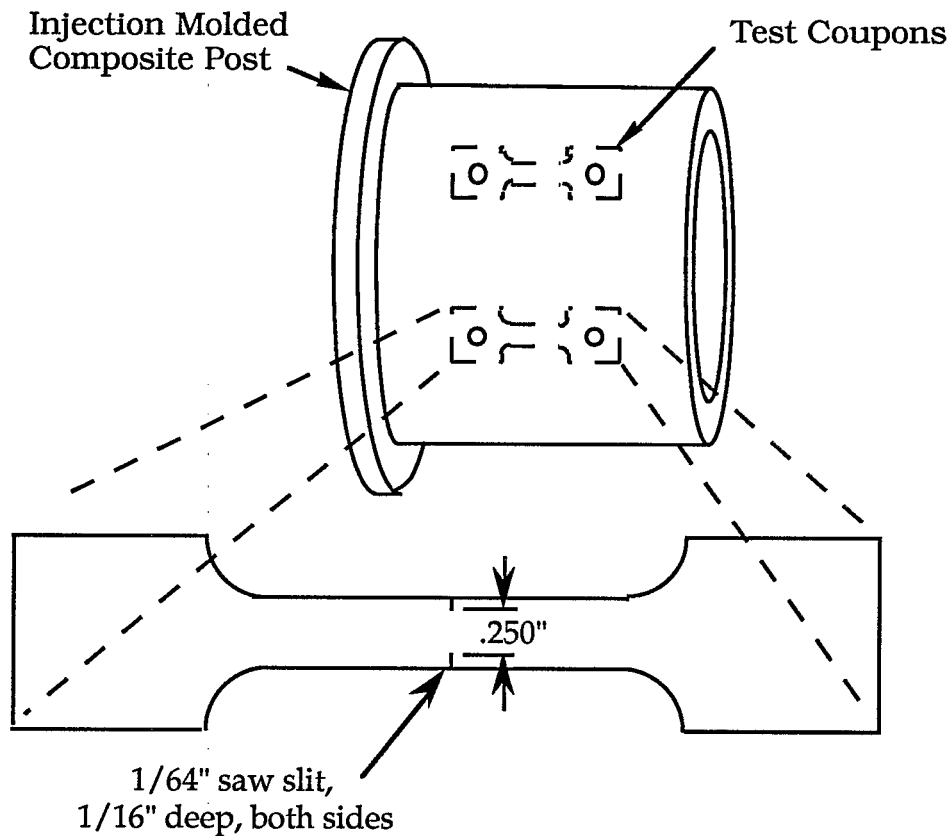
To arrive at a quality control procedure, eight coupons were cut from the .188 inch thick cylindrical wall of a Noryl and an Ultem post section. They were milled flat, giving them a thickness of about .170 inches. Four specimens notched with a square edged slit saw, as shown in Figure 2, were prepared in order to simulate a flaw. Four unnotched specimens, having the same stress width of .250 inches, were prepared as samples of the good material. Two each of the notched and the unnotched specimens were tested at room temperature and at liquid helium temperature. These resulting eight tensile tests constitute an inexpensive, albeit crude, application of fracture mechanics principles.

Figure 2
Test coupons cut from IMC post sections.

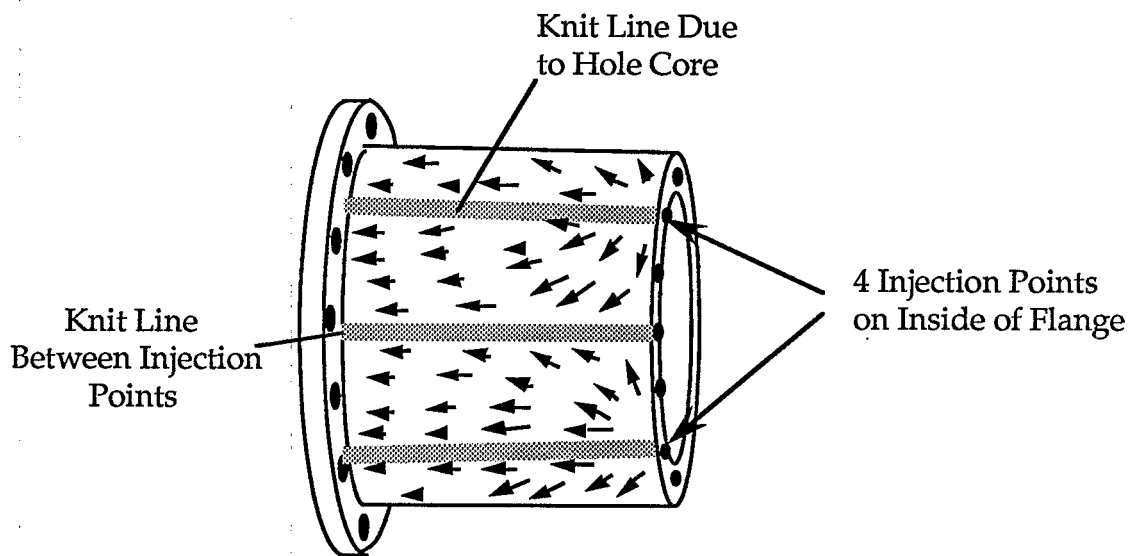
Most of the flaws, including flange porosity and cracks, occurred at the *knit lines* of the casting. Knit lines form where masses of the injected material come back together after the flow has been separated as sketched in Figure 3. The flow is separated by hole cores or by having several different gates in the mold. The mold produced eight knit lines running down the cylindrical shell of each casting. Four were due to hole cores, and four were caused by flow coming together from different injection points. Due to the orientation of the glass fibers, the knit lines are clearly visible on the surface of the castings.

Figure 3
Knit lines produced by the mold flow.

After almost every tensile test, inspection revealed that the crack initiated at or near a knit line, at a point between the cylindrical shell and a flange. Since the typical internal flaw in the flange is also at a knit line, it was concluded that the knit lines are a significant weakening mechanism. The decision was made to change the mold to remove the hole cores and to replace the four injection gates with a single diaphragm gate feeding along the inner edge of the flange. In the new castings the holes will have to be drilled, but the post sections will be free of knit lines. Castings from the revised mold have not yet been received for testing.

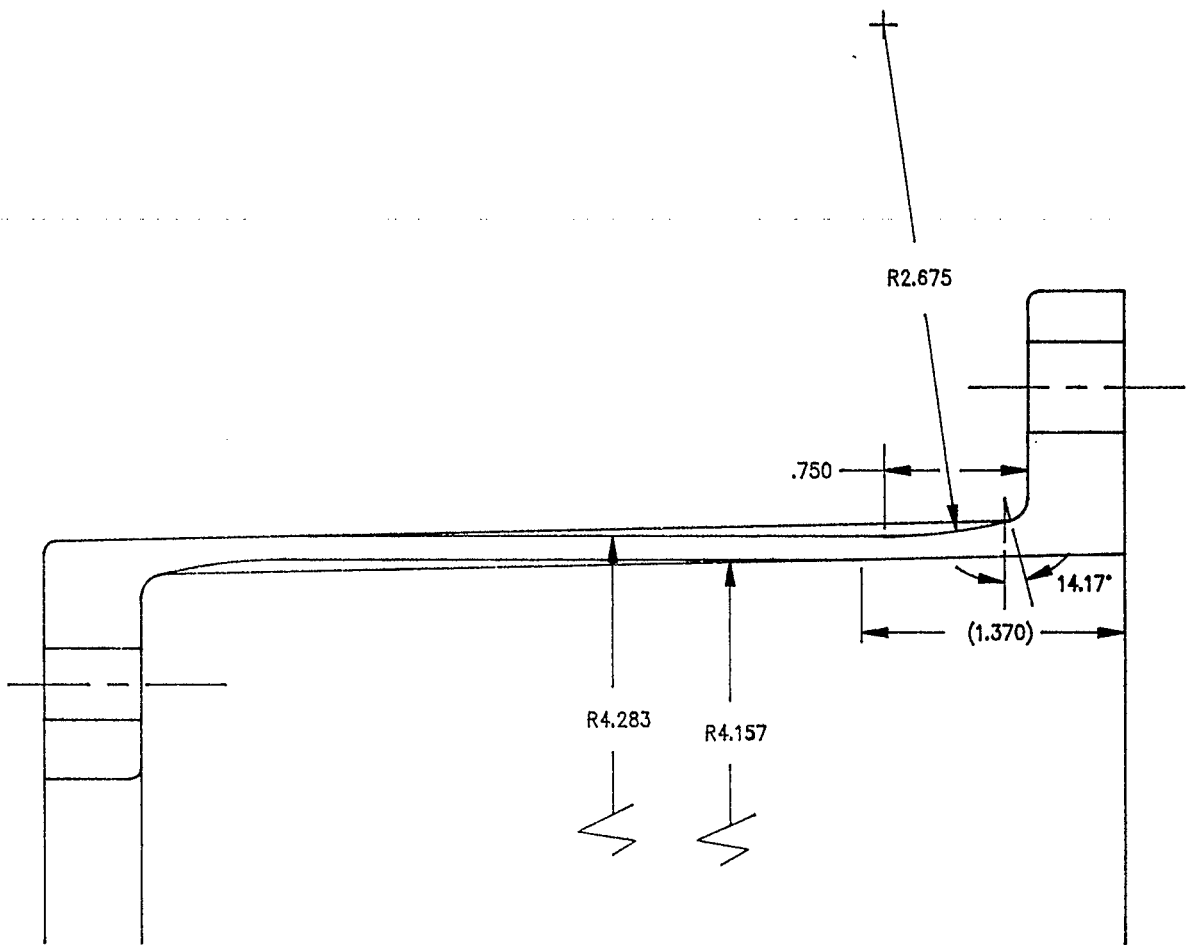
Two posts each of Ultem and of Noryl were machined as shown in Figure 5. The new profile has a large radius transitional hub which blends into the as-cast 1/8th-inch corner radius. In the new profile one-third of the material in the cylinder wall was machined away, reducing it from 3/16-inch in thickness to 1/8th of an inch. The hub extends back 3/4 inch from the flange.

Figure 4
Dimensions of machined stress relief profile on
castings N16, N17, U9 and U10.

* With machined stress relief profile as shown in Figure 4.

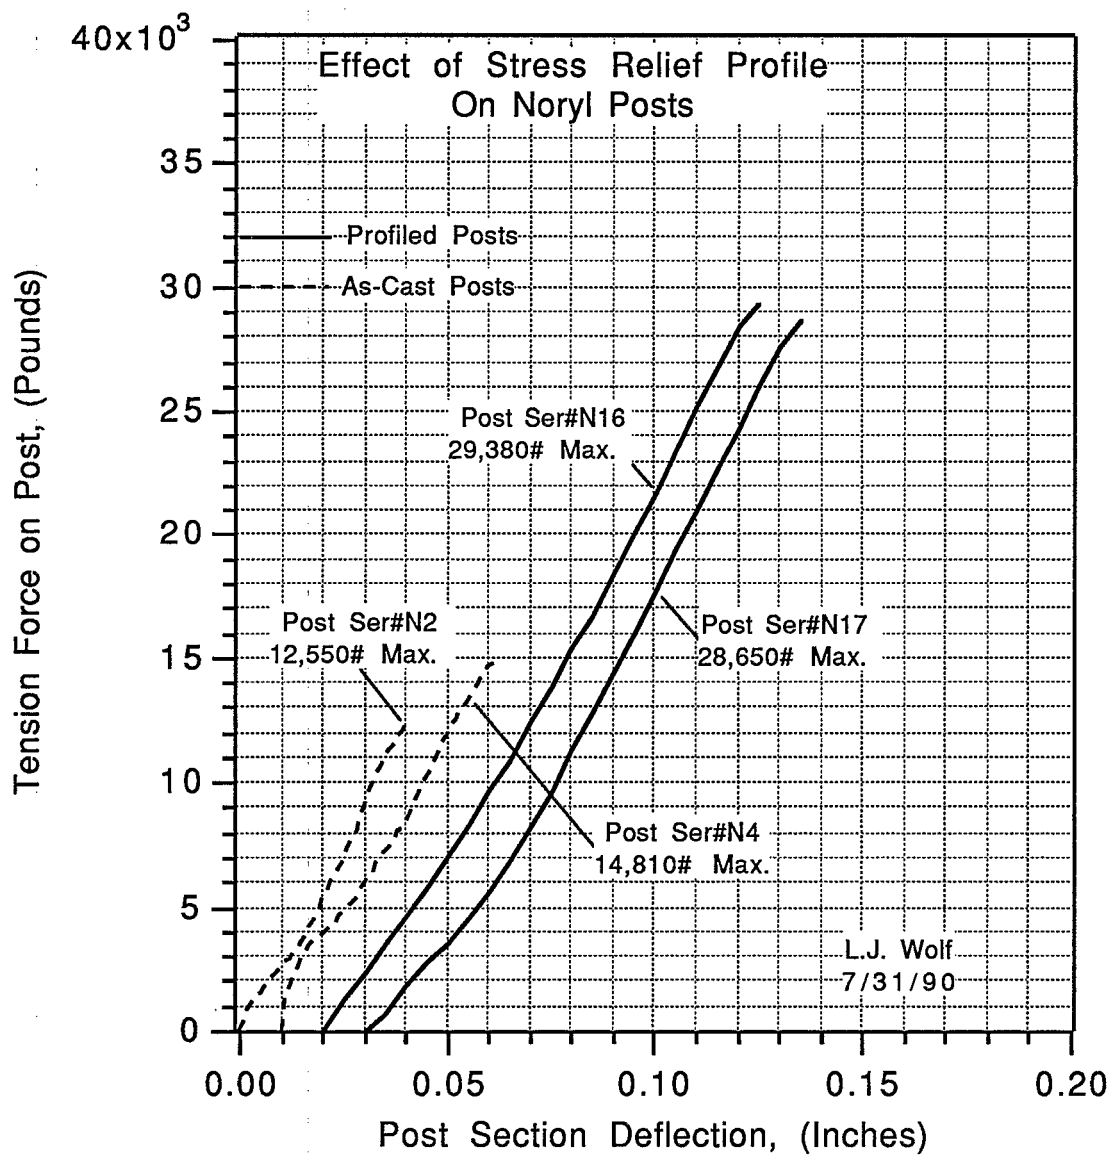
The results of the stress relief profile were dramatic as shown in the graphs of Figures 5 and 6. In these figures, force is plotted against deflection for two of the newly profiled posts and for two of the original posts. Figure 5 depicts the results for Noryl and Figure 6 is for Ultem.

The removal of the material to form the stress relief profile actually strengthened the posts. The effect was most prominent in the case of Noryl where the profiled posts had approximately twice the load capacity as the original posts and three times the stress carrying capacity. In the case of Ultem, the effect was not as pronounced. One of the machined castings of Ultem, U10, was weakened by a flaw in the cylindrical shell and should be discounted. The other had only a slightly higher load capacity than its unmachined counterparts. But, because its wall thickness is two-thirds that of the unmachined pieces, there was a 50% gain in stress carrying capacity.

Clearly, the first batch of Ultem posts, U1 through U8, could not pass the quality control test. Individuals from the second batch, U9 through U24, which were cast using pellets having the proper preheating, could pass the quality control test. None of the Noryl posts tested thus far would have been able to pass the quality control test except N16 and N17 which, counterintuitively, were machined thinner on a lathe as described in the last section of this paper. The tests of N16 and N17 are plotted in Figure 5.
