Tensile Tests for Quality Control of Injection Molded Composite Posts

L. J. Wolf

August 1990

Collider Accelerator Department
Brookhaven National Laboratory

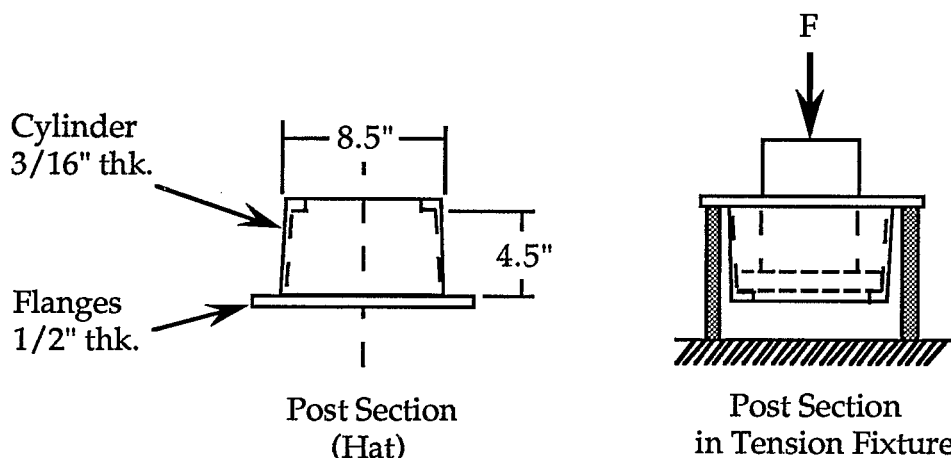
shown in Figure 1. The post is inverted and placed in the fixture on the platen of the testing machine. The compression force, F , supplied by the testing machine causes a direct central tension force of the same level on the cylindrical shell. While the cylindrical shell of an IMC post supporting the cold mass of a magnet will rarely experience a direct central tensile force in the operation or construction of RHIC, this test is intended for all post sections which will be used in the production magnets. Good post sections will not fail under the specified test load. Those with serious flaws will be destroyed.

Figure 1
The quality control testing fixture.

Not shown in Figure 1, are the fixture flanges and the back-up rings. Both flanges of the IMC post section under test must be sandwiched between metal flanges. They must be carefully bolted, otherwise the flanges will rotate elastically and cause the relatively brittle post flange to crack due to the discontinuity stresses at the flange and cylinder junction.¹ The bolts on the inner flange were torqued to 30 foot-pounds, and those on the outer flange to 40. For production testing, some quick-acting flange clamping mechanism will need to be designed.

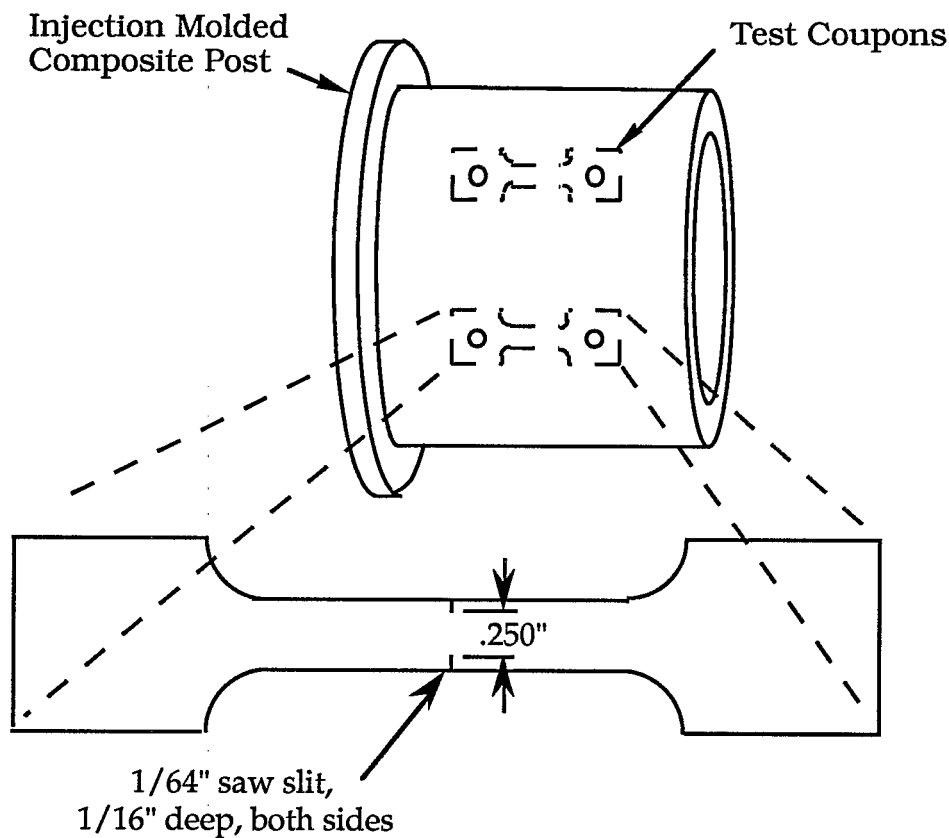
To arrive at a quality control procedure, eight coupons were cut from the .188 inch thick cylindrical wall of a Noryl and an Ultem post section. They were milled flat, giving them a thickness of about .170 inches. Four specimens notched with a square edged slit saw, as shown in Figure 2, were prepared in order to simulate a flaw. Four unnotched specimens, having the same stress width of .250 inches, were prepared as samples of the good material. Two each of the notched and the unnotched specimens were tested at room temperature and at liquid helium temperature. These resulting eight tensile tests constitute an inexpensive, albeit crude, application of fracture mechanics principles.

Figure 2
Test coupons cut from IMC post sections.
