Collider Accelerator Department
Brookhaven National Laboratory

C-A/AP/567
August 2016

Run 16
eIPM Summary

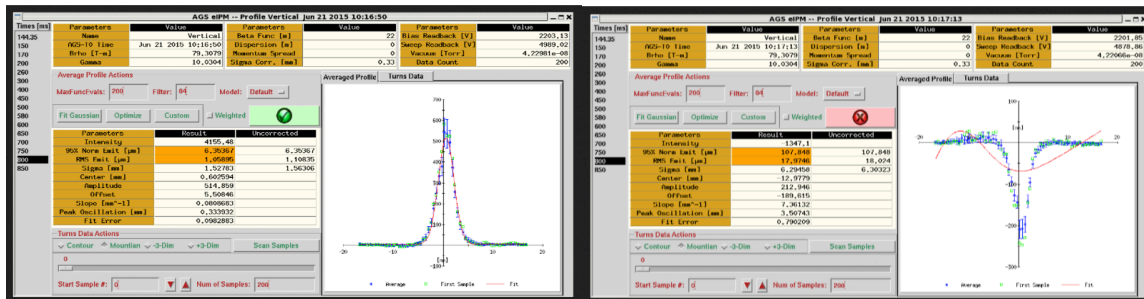
We installed new amplifiers for Run 15. These were charge-sensitive amps designed to integrate over the 200ns-long injected bunches and decay to baseline in one full revolution period, $\sim 2.7\mu\text{s}$. The input stage was built on a small circuit board which replaced the fast pulse amplifiers used originally in RHIC. We used the existing output drivers on the carrier board which were transformer-coupled to the twisted-pair signal lines leaving the tunnel. With AC coupling, there could be no DC component in the output signal. When the digitizers were triggered on the beam pulse we got good profiles, left. When we moved the trigger point we got 'inverted profiles' from the undershoot, right. In these two examples the trigger signal timing is different by 70° at harmonic number 1.

The "negative profiles" were not a problem during proton fills when only one bunch was injected in each AGS cycle. However when several bunches were injected the individual bunch profiles interfered with each other and dramatically reduced the average profile. During the shutdown we removed the output transformers to dc couple the amplifiers to the digitizers. This eliminated the "negative" profiles and provided good profile measurements with heavy-ion operation.

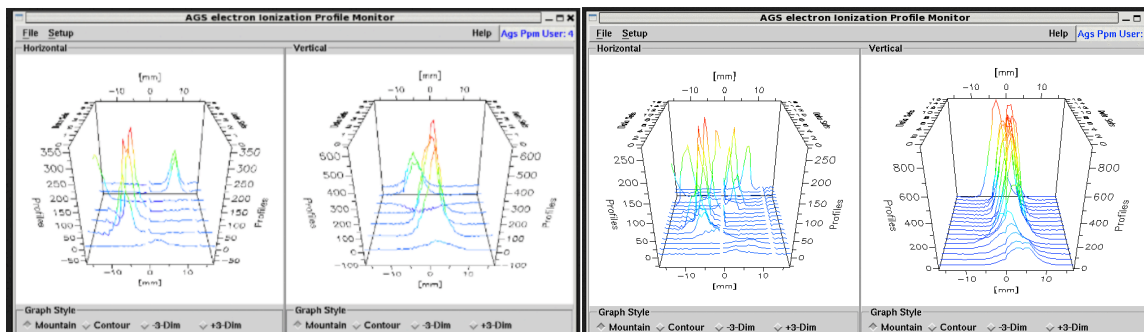
The measurement aperture issue with the vertical eIPM was discovered during beam studies. When beam is extracted from AGS a steering bump is introduced which moves the beam to the outside of the ring. Normally the beam leaves the AGS so the disappearance of vertical profiles was expected. During the beam studies the steering bump was being introduced but the beam was not extracted. The left plot below shows the horizontal and vertical profiles records from the beginning of the machine cycle (front) to the end (back) taken at seven different times. At the fifth measurement the beam moves out of the horizontal eIPM aperture to the left and the vertical profile disappears, which is the behavior we had been observing. However the bump is removed for the last two measurements and both horizontal and vertical profiles are back. The vertical eIPM was installed with the MCP on the outside of the ring. The extraction bump was moving the beam into the dead zone of the detector.

To correct this measurement artifact, we rotated the detector head by 180° moving the dead zone to the inside of the ring. The right figure shows that in this configuration we get good vertical profiles during the full machine cycle with large horizontal movements of the beam.

Once we were aware of the measurement artifacts arising when the beam was near the dead zone boundary we were able to understand that this was the cause of strange behavior of the horizontal eIPM. Dedicated measurements showed that the AGS orbit in the horizontal IPM was consistently below beam line center, in the direction of the MCP. During the Run 15-16 shutdown we flipped over the horizontal eIPM detector to place the 'dead zone' at the top of the chamber.

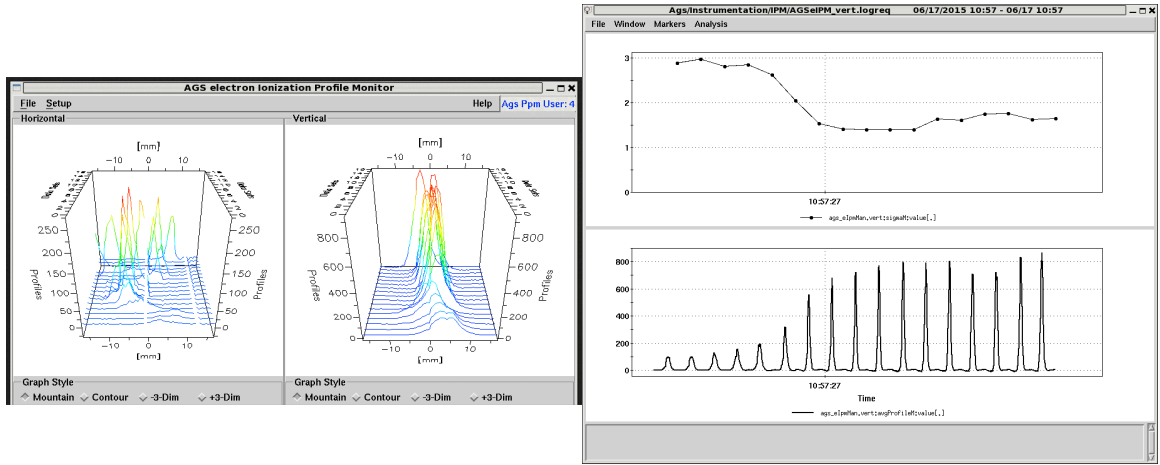
In the AGS we want to make several profile measurements during a single machine cycle. As the beam is accelerated, the profile width decreases and the amplitude increases. This is shown in the two figures below. We would like the amplitudes of the measured profiles to remain about the same during the machine cycle. To do this we added the

Top of right plot shows the beam sigmas and the bottom shows profile amplitudes during the full AGS acceleration cycle.

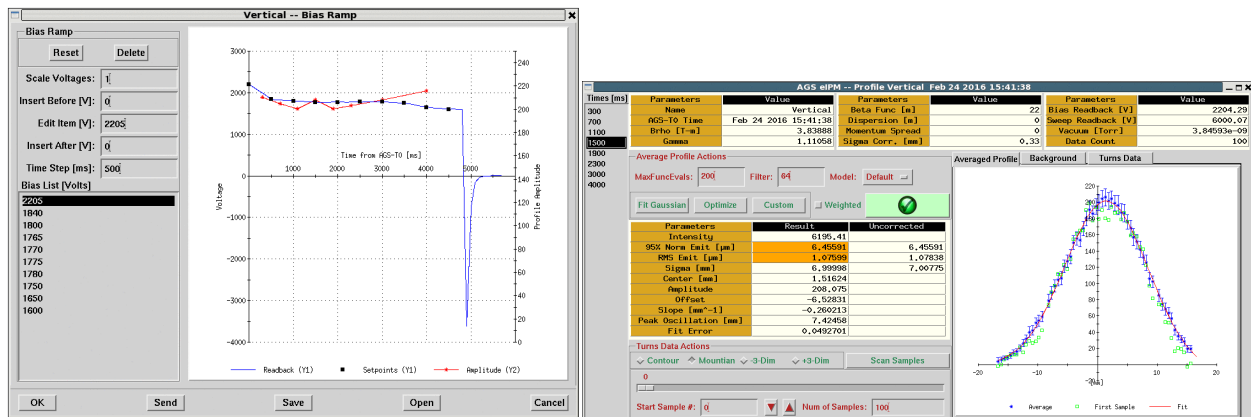
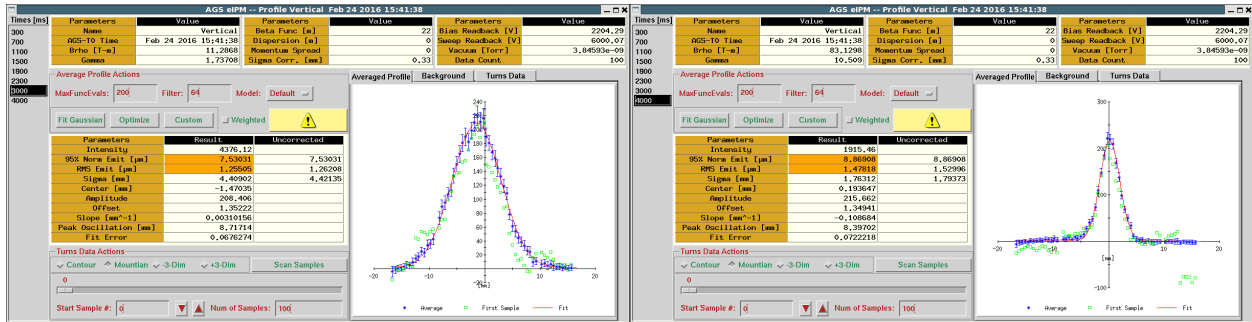
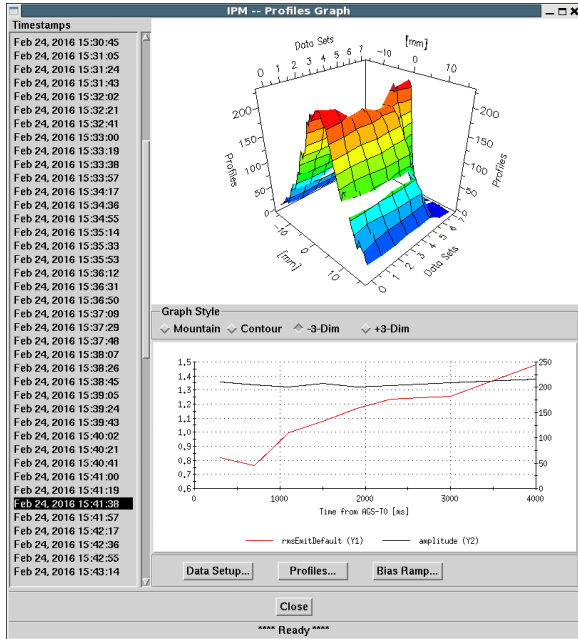
The plots below show the gain control results. The first plot shows the Bias Ramp editing page. The blue data shows the set voltage points and the read back of the MCP bias voltage. Here we have ten points at 0.5s intervals. The red points show the measured profile amplitudes. The next three plots show the measured beam profiles before, during and after the acceleration ramp. The last plot is a mountain range plot of the ten-profile record with a plot of the profile amplitudes and the measured emittances.

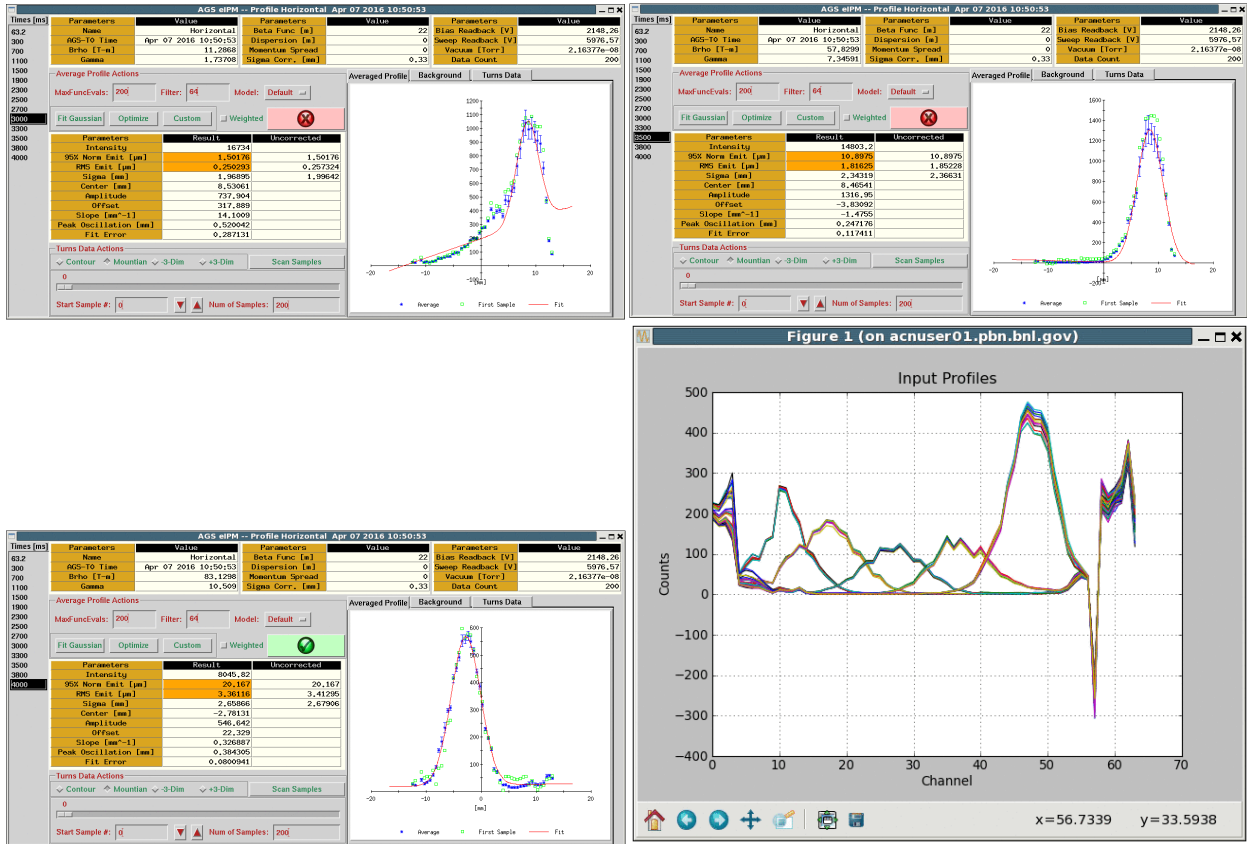
The top three figures show this effect. These are measurements taken at 3.0s, before acceleration, and at 3.5s and 4.0s after acceleration. The profile before acceleration has a long tail and the Gaussian fit shows the beam to be smaller before acceleration than after. Figure 4 is a crude calibration scan showing five profiles taken at different horizontal

positions. This shows that MCP is severely damaged over the center and left parts of the aperture, but maintains good gain on the far right. The first profile actually is a broad beam peaked at about 4mm with the right tail amplified by a factor of three higher than the center and left of the profile.

At the start of Run 16 the vertical eIPM gave good profiles, but the horizontal gave mixed results. The beam moves horizontally continuously during the AGS beam cycle. This movement is large enough that the beam is frequently out of the measurement aperture of the eIPM. If there is a position-dependent error in the eIPM, the beam movement can result in a measured beam emittance that appears to get larger and smaller as the beam cycle progresses. As we studied these measurements we found that when the beam was left of center or far to the right in the detector the profiles were very clean but they became distorted when the beam moved to the right of center.

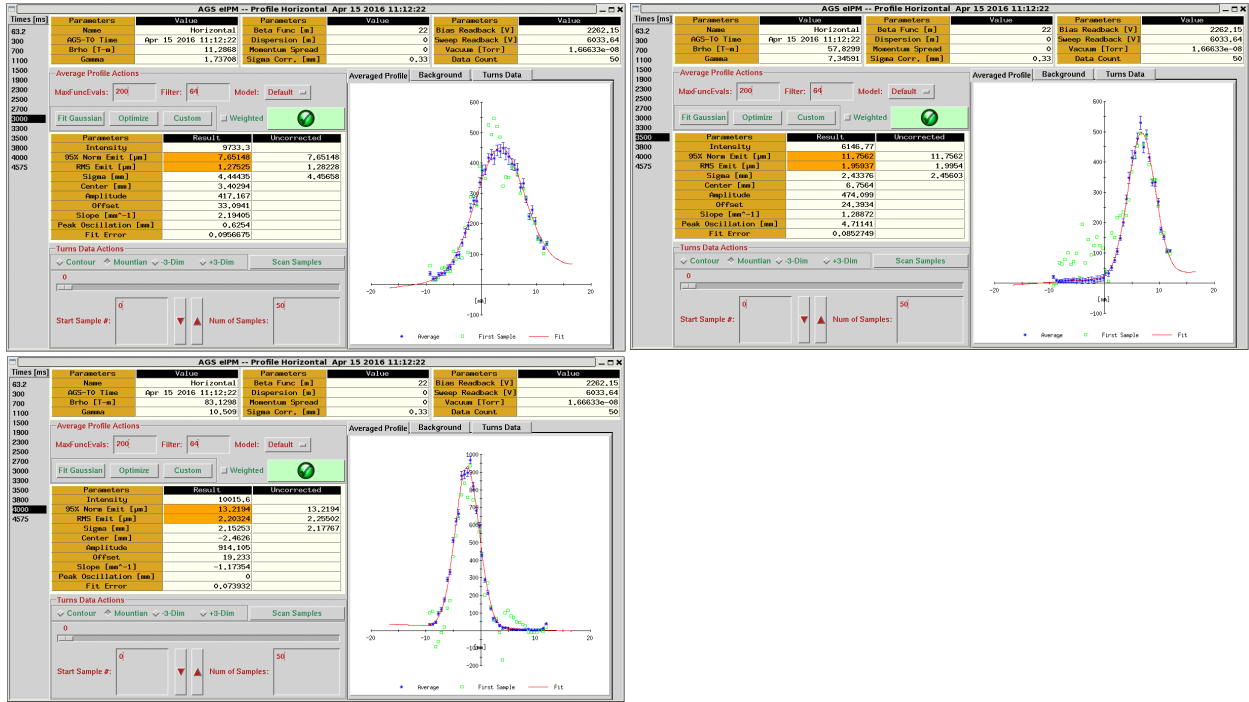
We constructed approximate gain correction values for channels 10-48 from the scan. Below is a calibration scan after these first corrections were applied. Also are profiles after corrections at the same times as those above. The profile at 3.0s is Gaussian and the beam sigmas decrease as the beam is accelerated.

These results show that the distorted profiles are caused by a severely damaged MCP from beam exposure. The damage is most severe in the MCP center. It is least damaged on the right side which is the inside of the AGS ring. The left side which is damaged is the outside of the ring where the beam is kicked for extraction.

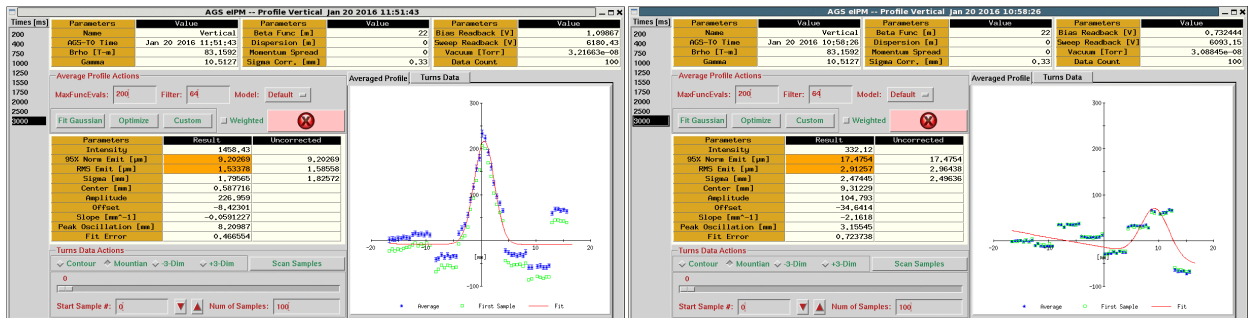
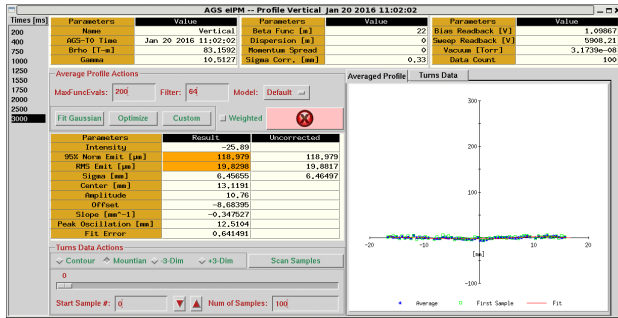
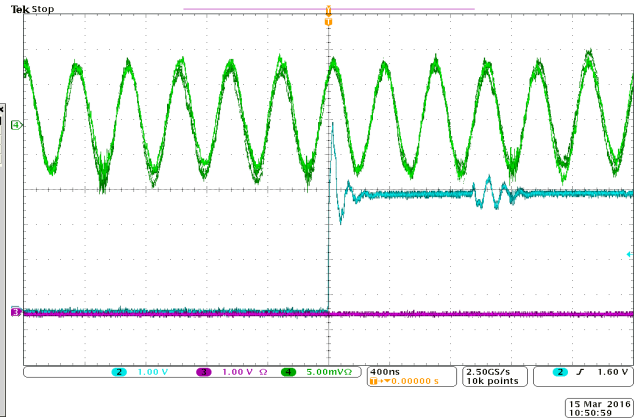
Before Run 16 started the dc offsets on the eIPM amplifiers were measured and corrections were entered into the Manager. When beam operations started we saw large dc offsets. These offsets appeared in groups of 8, corresponding to the 8-channel amplifier boards. For each board the dc offsets were about the same, but the value of the dc offsets were different for the eight amplifier boards. The left figure below shows a beam profile and the right figure shows the baseline with no beam. This 8-channel grouping of dc offsets is due to rf noise being picked up in the tunnel. The left figure in the second row shows the dc offsets with the acceleration rf turned off and the right figure shows the rf signal on one of the signal cables from the amplifiers in the tunnel to the digitizers in E10.

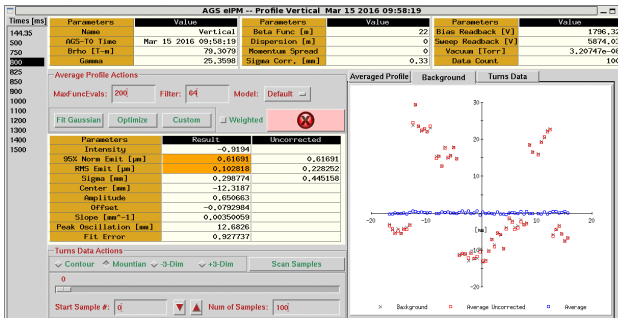
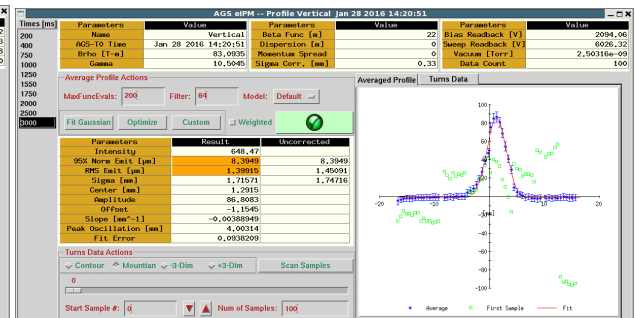
To correct the rf pickup we added active background subtraction in the manager. Each measurement now uses two machine cycles. One is done normally and one is done with the electron gate turned off. The "off" data are subtracted from the "on" data to produce a complete profile data set. An example of this is shown in the two figures below. The left figure shows the baseline with no beam and rf subtraction and the right figure shows a beam profile with background subtraction.

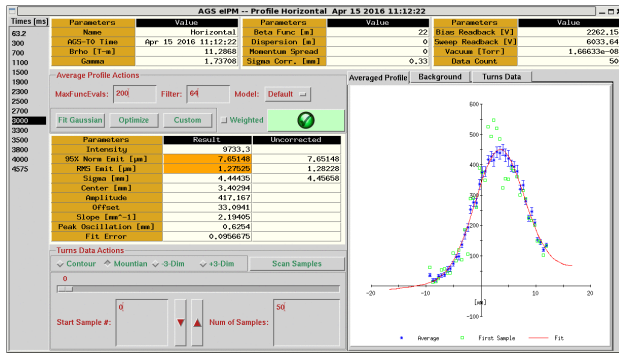
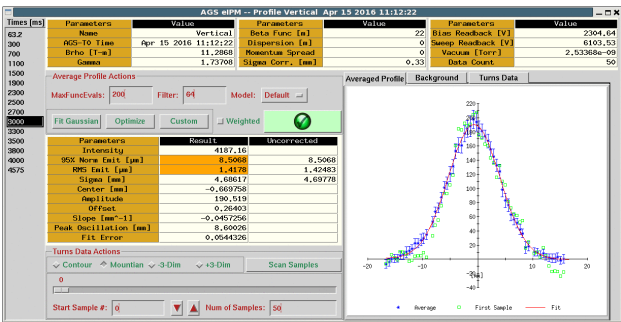
Profiles of Au beam at injection energy, April 15

The rf background subtraction was implemented early in the run. After that the vertical eIPM gave good results, but there were still problems with horizontal. The biggest issue was the depleted MCP. The gain corrections implemented on April 12 brought the vertical and horizontal eIPMs into agreement, as shown in the figures below. The top pair are horizontal and vertical profiles of Au beam made just before acceleration on April 15 and the bottom pair are profiles from the deuteron beam at full energy on May 10.

One issue with the horizontal detector can be seen in the two left profiles. On April 15 we had all channels to the left of -10mm and to the right of +10mm removed from the data analysis. On both extremes of the detector we were getting anomalous signals which are not understood. This is seen in the left of the profile from May 10 with all of the channels enabled.

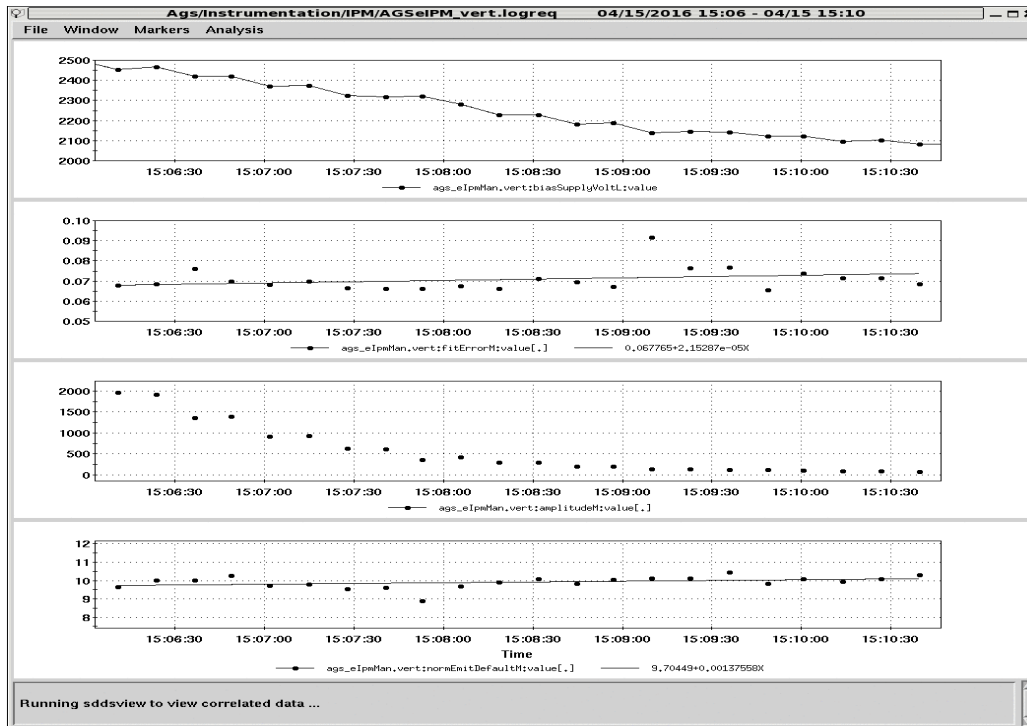
Finally we show a study where the MCP bias voltage was continuously lowered (top plot). This lowers the gain of the MCP resulting in lowering the profile amplitude from 2000 to 83 (third plot). Dropping the gain through the full range of the VME digitizers increases the measured emittance by only 4% (bottom plot) and increases the fit error from 0.068 to 0.074 (second plot).

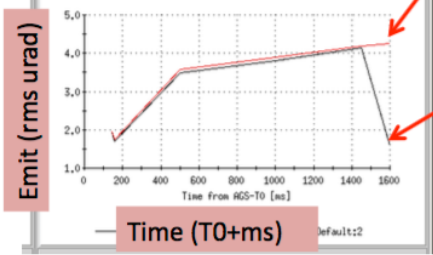
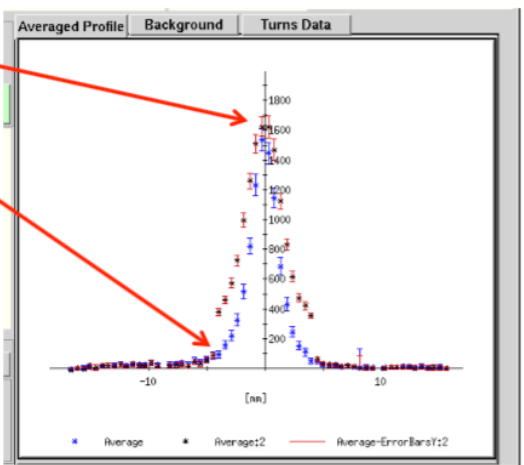
Vert eIPM

The surprise from this run was that the rf noise pickup had a different effect on the profile measurements than it had for the entire Run 16. For these three days, the rf had very little effect on the baseline but had a strong effect on the beam profile. This is seen in the first figure below. We noticed the measured emittance at full energy was about twice as large with the rf on than with it off (left). When the profiles were compared with beam centered on the vertical eIPM, the rf-on case shows the portion of the profile covered by the center two 8-channel amplifier groupings was raised and broadened compared to the rf-off case but the rest of the 8-channel groupings show no difference with rf on and off (right).

eIPM strongly affected by turning the RF on and off on the flattop

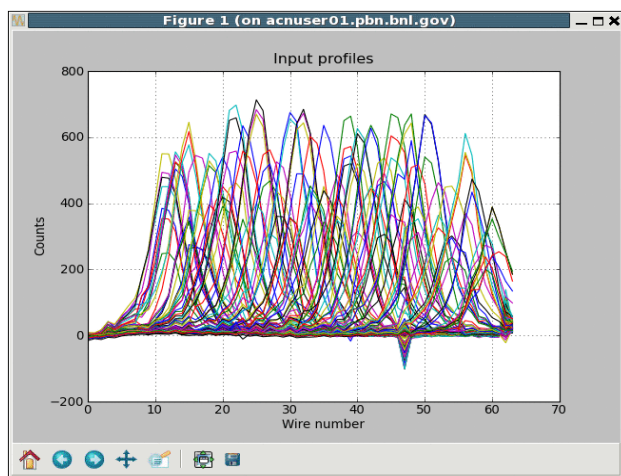
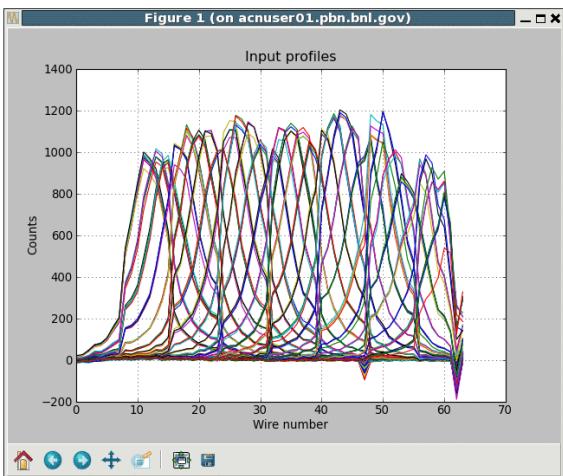
This pattern of profiles discontinuities at the breaks between the 8-channel amplifier groupings with the rf on appeared across the entire eIPM as shown here. The left figure shows a composite of all the profiles taken with rf off and the right figure shows the profiles with the rf on.

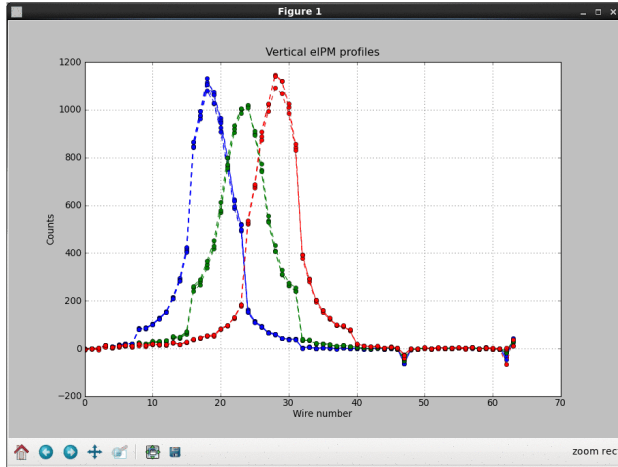
The figure above shows profiles of the beam with the beam in three positions in the vertical eIPM. There is a gain step between 8-channel amplifier boards and the size of the step increases as the profile amplitude gets larger. This behavior results in a position-dependent emittance as shown below. Here we plot the measured σ^2 vs. position of the center of the beam. This 8-channel gaps in the profile measurements was not seen in the rest Run 16 and it is not understood.

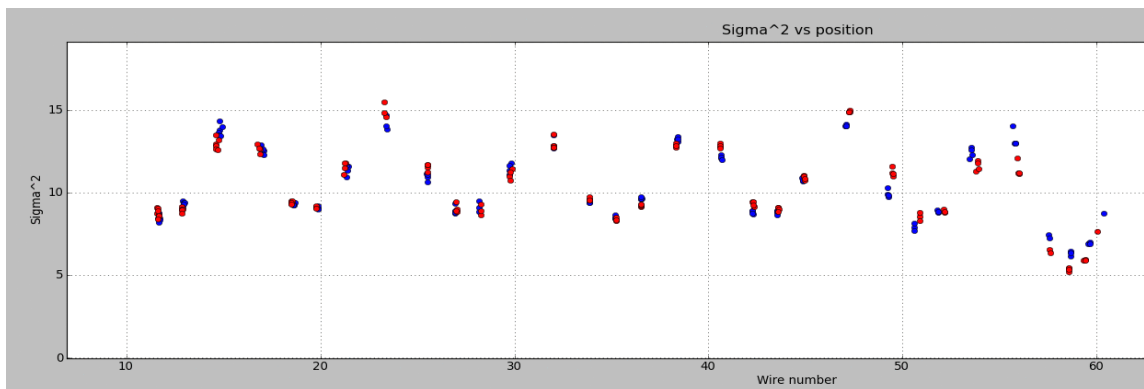
Measured σ^2 vs. position of the center of the beam

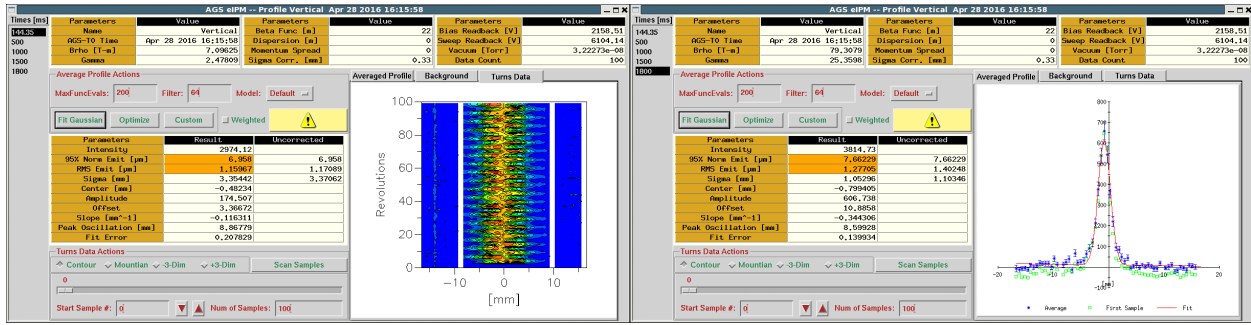
These two figures are proton-beam measurements made with the vertical eIPM on April 28, 2016. The left plot is a contour plot of the first 100 turns at injection (144ms past t_0) showing dipole oscillations. The right plot is the beam profile at top energy showing the measured beam sigma and the calculated beam emittance.

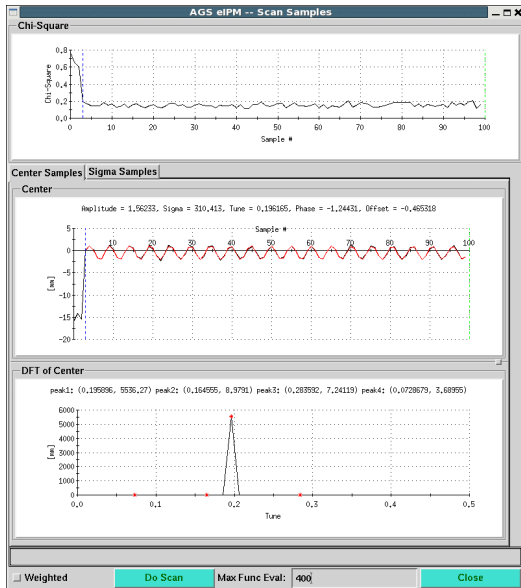
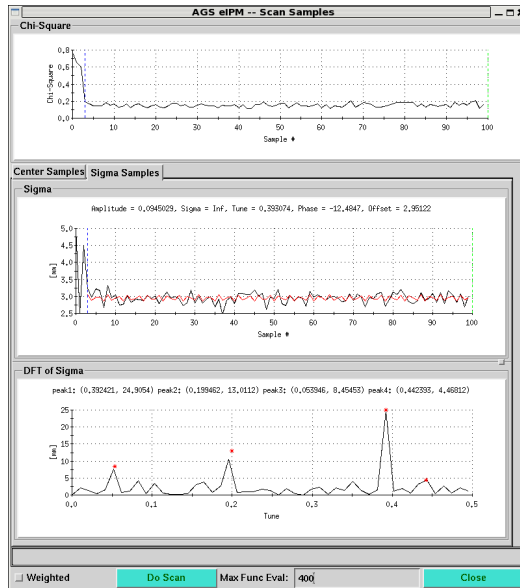
For a profile measurement, the digitizers are triggered on each turn for a set number of turns. These measurements used 100 turns of data. An emittance measurement is obtained by averaging all of the single-turn measurements. We also fit gaussian curves to each single-turn profile. We plot the measured beam centers vs. turn number (below left) and profile sigmas vs. turn number (below right) at injection, together with the discrete Fourier transforms of these signals. This gives peaks at the dipole and quadrupole frequencies.

We plan to optimize the injection match by changing steering and focusing in the BtA line to minimize the amplitudes of the dipole and quadrupole lines in the DFTs. We planned an experiment at the end of Run 16 to measure the effects of matching on the final emittance, but we ran out of time from beam problems. We will make these measurements in Run 17.
