BNL-112662-2016-TECH

A close look at beam aborts with rise times less than 40 ms from the years  
2014-2016. Case studies.

A. Drees

September 2016

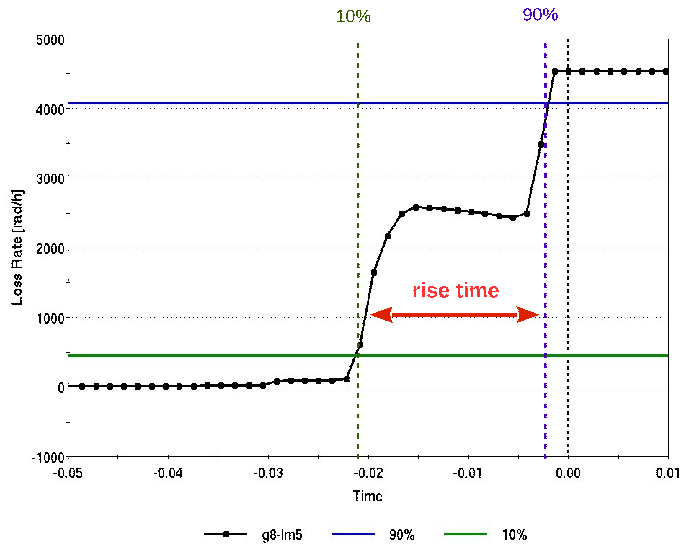
Figure 1: Definition of risetime as the time between 10% and 90% of the loss monitor data. Showcase fill is 19769.

definition. In this example the saturation level of 4530 rad/h for g8-lm5 constitutes the

maximum. The time of the abort trigger is indicated by a black dashed vertical line. In this particular case the rise time appeared to be 19.4 ms. The Post Mortem database provides loss monitor data with a granularity of 720 Hz for each abort. Due to the 720 Hz granularity all rise times constitute an integer multiple of  $1/720 = 1.39$  ms.

For all beam aborts by loss monitors a rise time leading up to the abort trigger was calculated by Yun Luo. The rise time, according to [2] was defined as the time between reaching 10% of the signal maximum and 90% of the signal maximum. Fig. 1 represents a sketch of the

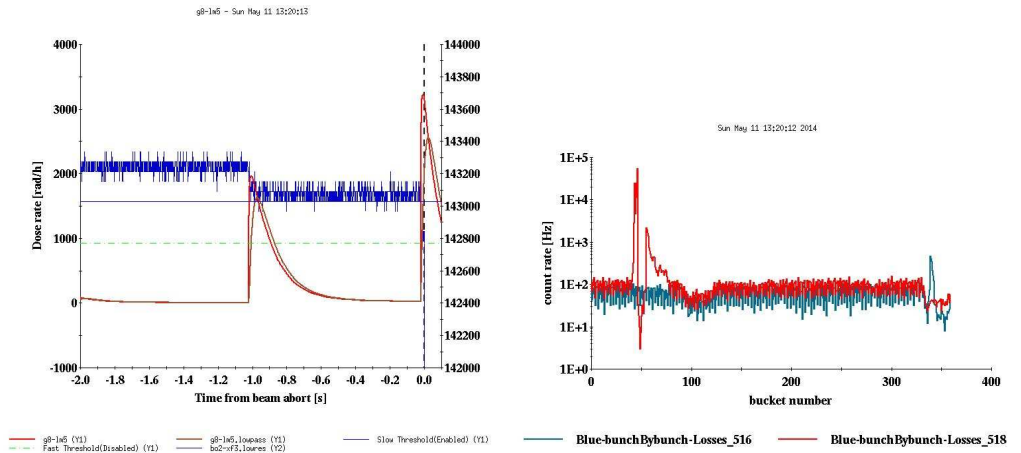
No quench associated with this abort. The gapCleaner was set to a 1 Hz frequency and the losses, as shown in Fig. 4, left, clearly show a 1 Hz structure. During the trigger at -1.0 s about 0.1% of the beam was lost and just before the abort another 0.2%. The bunch-by-bunch losses, shown in Fig. 4, right, were accumulated in a second before (trace 516) and during the abort (trace 518). They clearly show how the losses moved from the gap to an occupied bucket. A modest lowering of the trip threshold would have aborted the beam easily 1 s earlier. The FEC (cfe-2a-tune1) apparently rebooted itself spontaneously. A warning

Figure 4: Left: 720 Hz loss monitor and current transformer data from PMViewer. Right: Bunch by bunch losses accumulated two seconds before and the second including the abort.

message (not to reboot with beam in the machine) has been added since.

**Conclusion:** The gapCleaner, due to its kicker pulse length of only about 100 ns, affects only one bunch at a time and cannot impact the entire beam. Hence the associated beam loss is relatively modest and not close to a damaging amount.

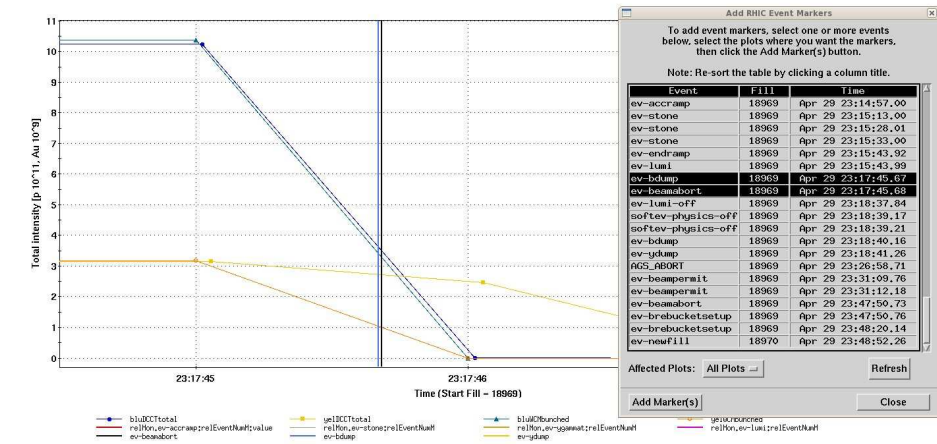
There were no quenches associated with this event. In principal, this event should not be listed here since it happened during ramp development. However, we need to check if this type of failure could not happen at other times as well. In any case, looking closely at the time of events as shown in Fig. 6, it shows that the permit pull by b10-lm4 comes following an ordinary beam dump. According to the list of RHIC event times, the two are 10 ms apart. b10-lm4, the first loss monitor down stream of the blue abort, is prone to and known for

Figure 6: LogView graph showing beam current data and list of events for end of store 18969.

permit pulls due to “spilled” losses from an ordinary beam dump, particularly during proton operation.

**Conclusion:** This event can be ignored for the purpose of this study.

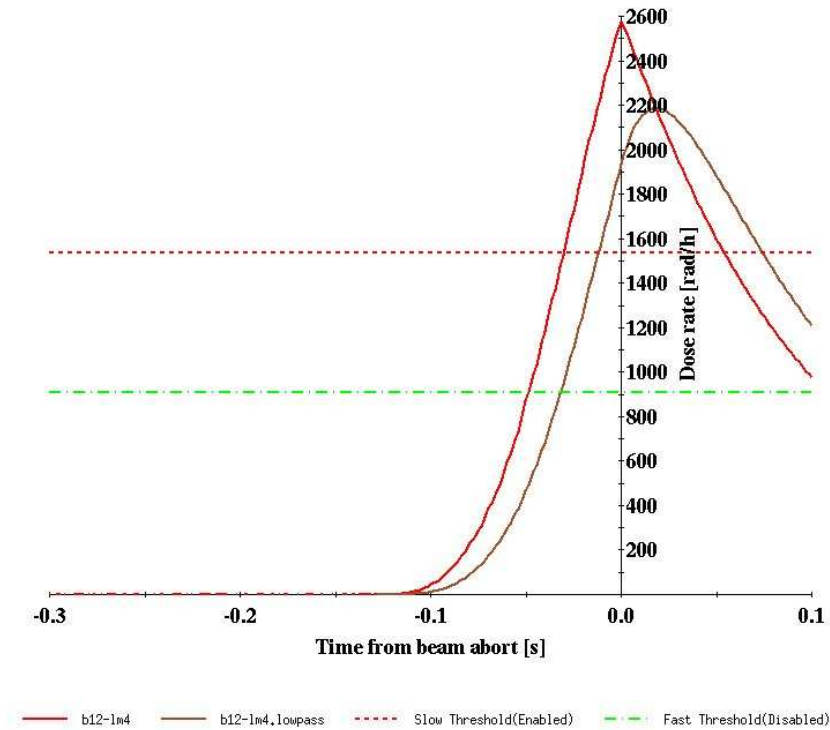
No quenches were associated with this abort. y9-lm4 (yellow!) actually goes above threshold after the abort and the triggering loss monitor is b12-lm4 (blue!). Fig. 7 shows the corresponding data. The rise time for this monitor is approximately 100 ms. Therefore this case is of no interest for this study. y9-lm4, the first loss monitor down stream of the yellow abort, is the yellow LM known for permit pulls due to “spilled” losses from an ordinary beam dump, particularly during proton operation.

Figure 7: PM 720 Hz b12-lm4 data

**Conclusion:** This event can be ignored for the purpose of this study.

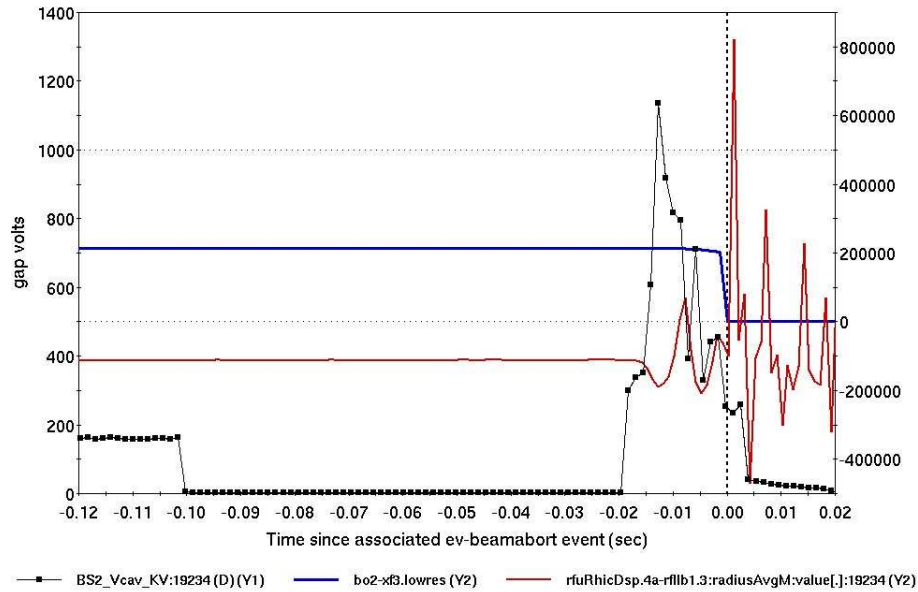
B6Q3 triplet quadrupole quenched in this case. This abort portrays the perfect storm of cavity trips where a faulty damper was not secured when the trip happened. Fig. 8 summarizes the course of events. Shown are the BS2 gap volts (black squares) in kV, the radius (red line) in micron and the beam current transformer data (blue line). The cavity trips 100 ms before the abort ( $t=0$ ). The unsecured tuner starts moving towards the beam, changing the cavities tune in the process. 20 ms before the abort very fast instabilities entail, visible as rapid oscillations of the cavity voltage as well as the radius. Actual beam loss is concentrated in the last  $5 \times 1.39 \text{ ms} = 7 \text{ ms}$  before the abort.

Figure 8: 720 Hz RF BS2 voltage data, radius data and beam current transformer data.

**Conclusion:** Only if the BS2 cavity would have been in the permit (it wasn't) this quench (with or without an additional 40 ms of delay) could have been prevented.

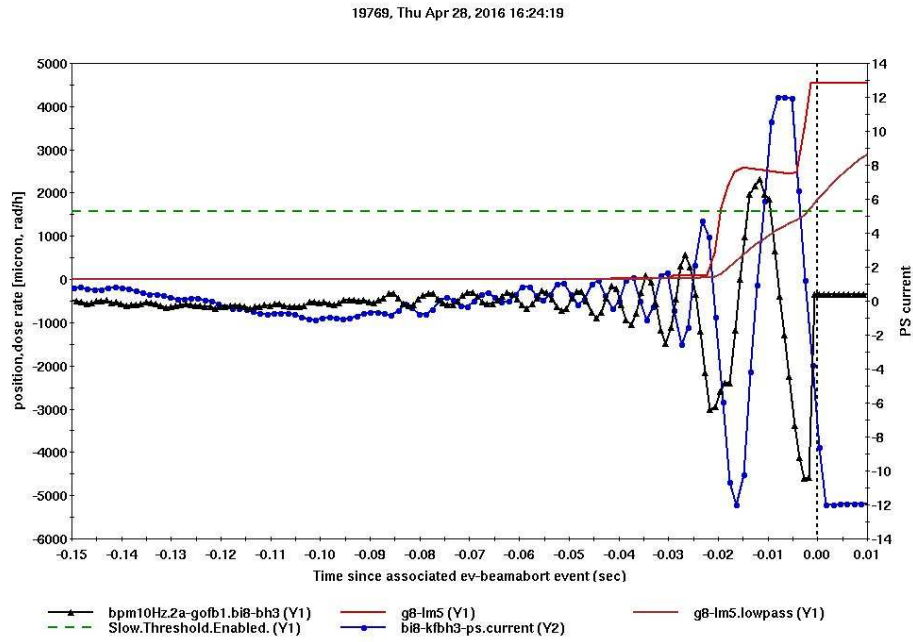
No quenches were associated with this case. This abort is caused by a failure of a GOFB\_FB 10Hz PS without any connection to the 56 MHz RF cavities. As can be seen in Fig. 11, the power supply and the orbit start oscillations about 70 ms before the abort (indicated by the dashed black vertical line), significant losses appear about 20 ms before.

Figure 11: Orbit oscillations, power supply current and loss monitor data during 0.15 s before the abort.

**Conclusion:** In order to trigger an abort 40 ms before the recorded time here, either a BPM based permit or a 10 Hz PS based permit would be needed with a response time of approx. 10 ms.

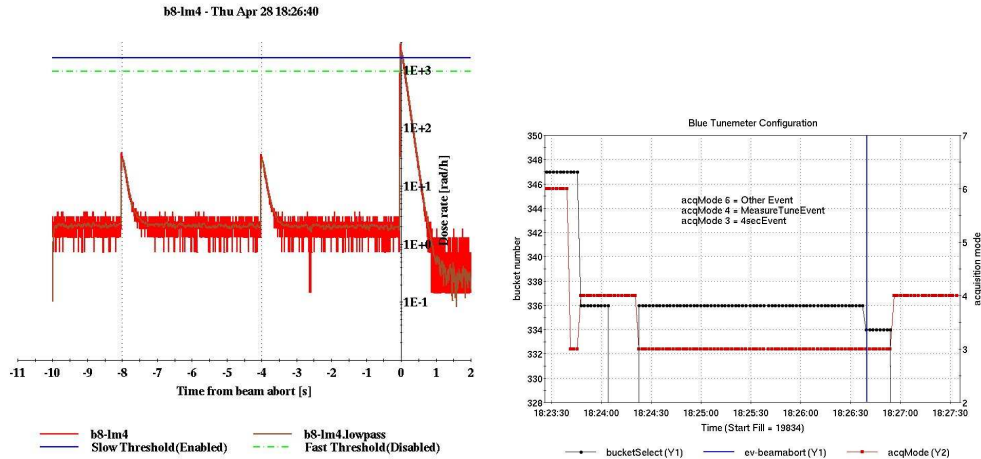
There were no quenches associated with this abort. The culprit in this case was not the 56 MHz cavity but operator error. b8-lm4 is the first loss monitor down stream of the blue

collimators with an enabled permit threshold. As can be seen in Fig. 12, left, gap cleaning was in progress at a modest level at 0.25 Hz, one of the three frequency options. This can be confirmed by the configuration setup for the blue gap cleaning kickers (Fig. 12, right). Acquisition mode is set to “3”, i.e. the 4secEvent, minutes before the abort. At the same time the default bucket for gap cleaning, was changed by operators from 347 to 336 and eventually to 334. Note that bucket numbers are offset by +1, starting from 0 and going up to 359. In addition, it can be expected that the kicker pulses are not perfectly centered on the occupied buckets. Timing shifts can occur during the ramp to store. The effect of the

Figure 12: Left: b-lm4 PM data, right: blue tune meter kicker setup before and during the abort.

**Conclusion:** There is very little risk for damage since the gap cleaner kickers will only affect one bunch at a time with a repetition rate of 0.1 s or slower. Adding a delay of 40 ms would still have aborted the beam well before the next trigger could have occurred, even if it was set to 10 Hz.

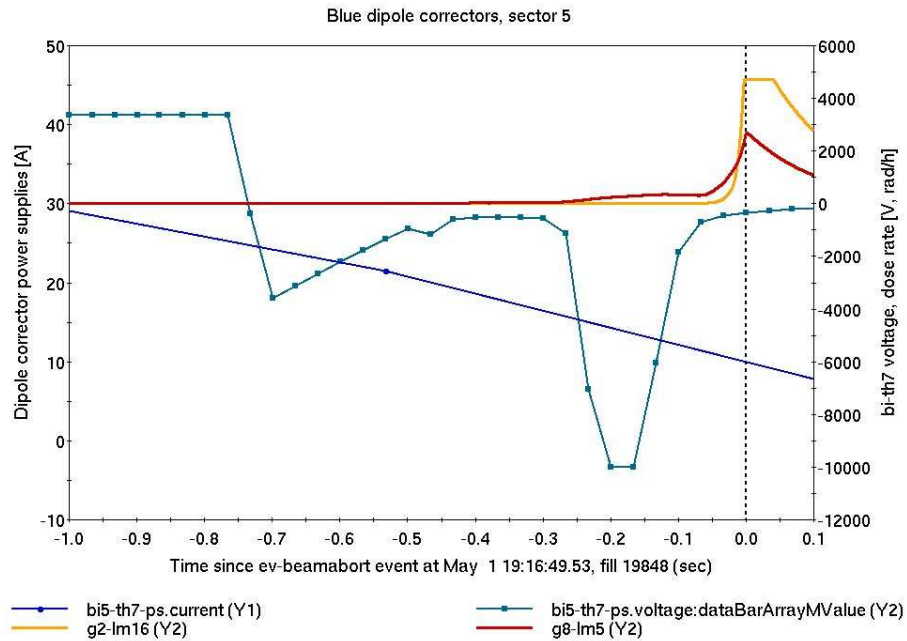
No quenches were associated with this abort. The blue longitudinal pick-up was certainly not involved in this event. Actually, about 700 ms prior to the abort a total of 11 dipole corrector supplies controlled by cfe-5c-ps1 started to fail. It is likely that cfe-5c-ps1 was compromised by the bad vacuum in sector 5, causing the concerted trips of many corrector supplies. One of the power supplies is shown in Fig. 14, together with the PM data for LM g2-lm16, at the maximum of the blue protection bump. Losses in g2-lm16 start showing over 500 ms after the dipole correctors first signs of errors. Only the LM down stream of the blue collimators experience some earlier losses, reaching only about 450 rad/h about 50 ms before the abort.

Figure 14: PM data from g2-lm16, g8-lm5, and bi-7th. LogView current data from bi-5th.

**Conclusion:** In order to violate the beam permit 40 ms earlier than the current abort time, a PS based permit system appears most promising. A much reduced permit threshold (about 25% of current level) for g8-lm5 could potentially do the same with the added risk of unnecessary and premature permit pulls. In addition, it relies on the collimators being in the proper position.
