Injection Porch Parameters for Heavy Ion Injection

AGS Studies Report

Date(s)-----December 23, 1985 Time(s)---0400-0700

Subject ----Injection Porch Parameters for Heavy Ion Injection.

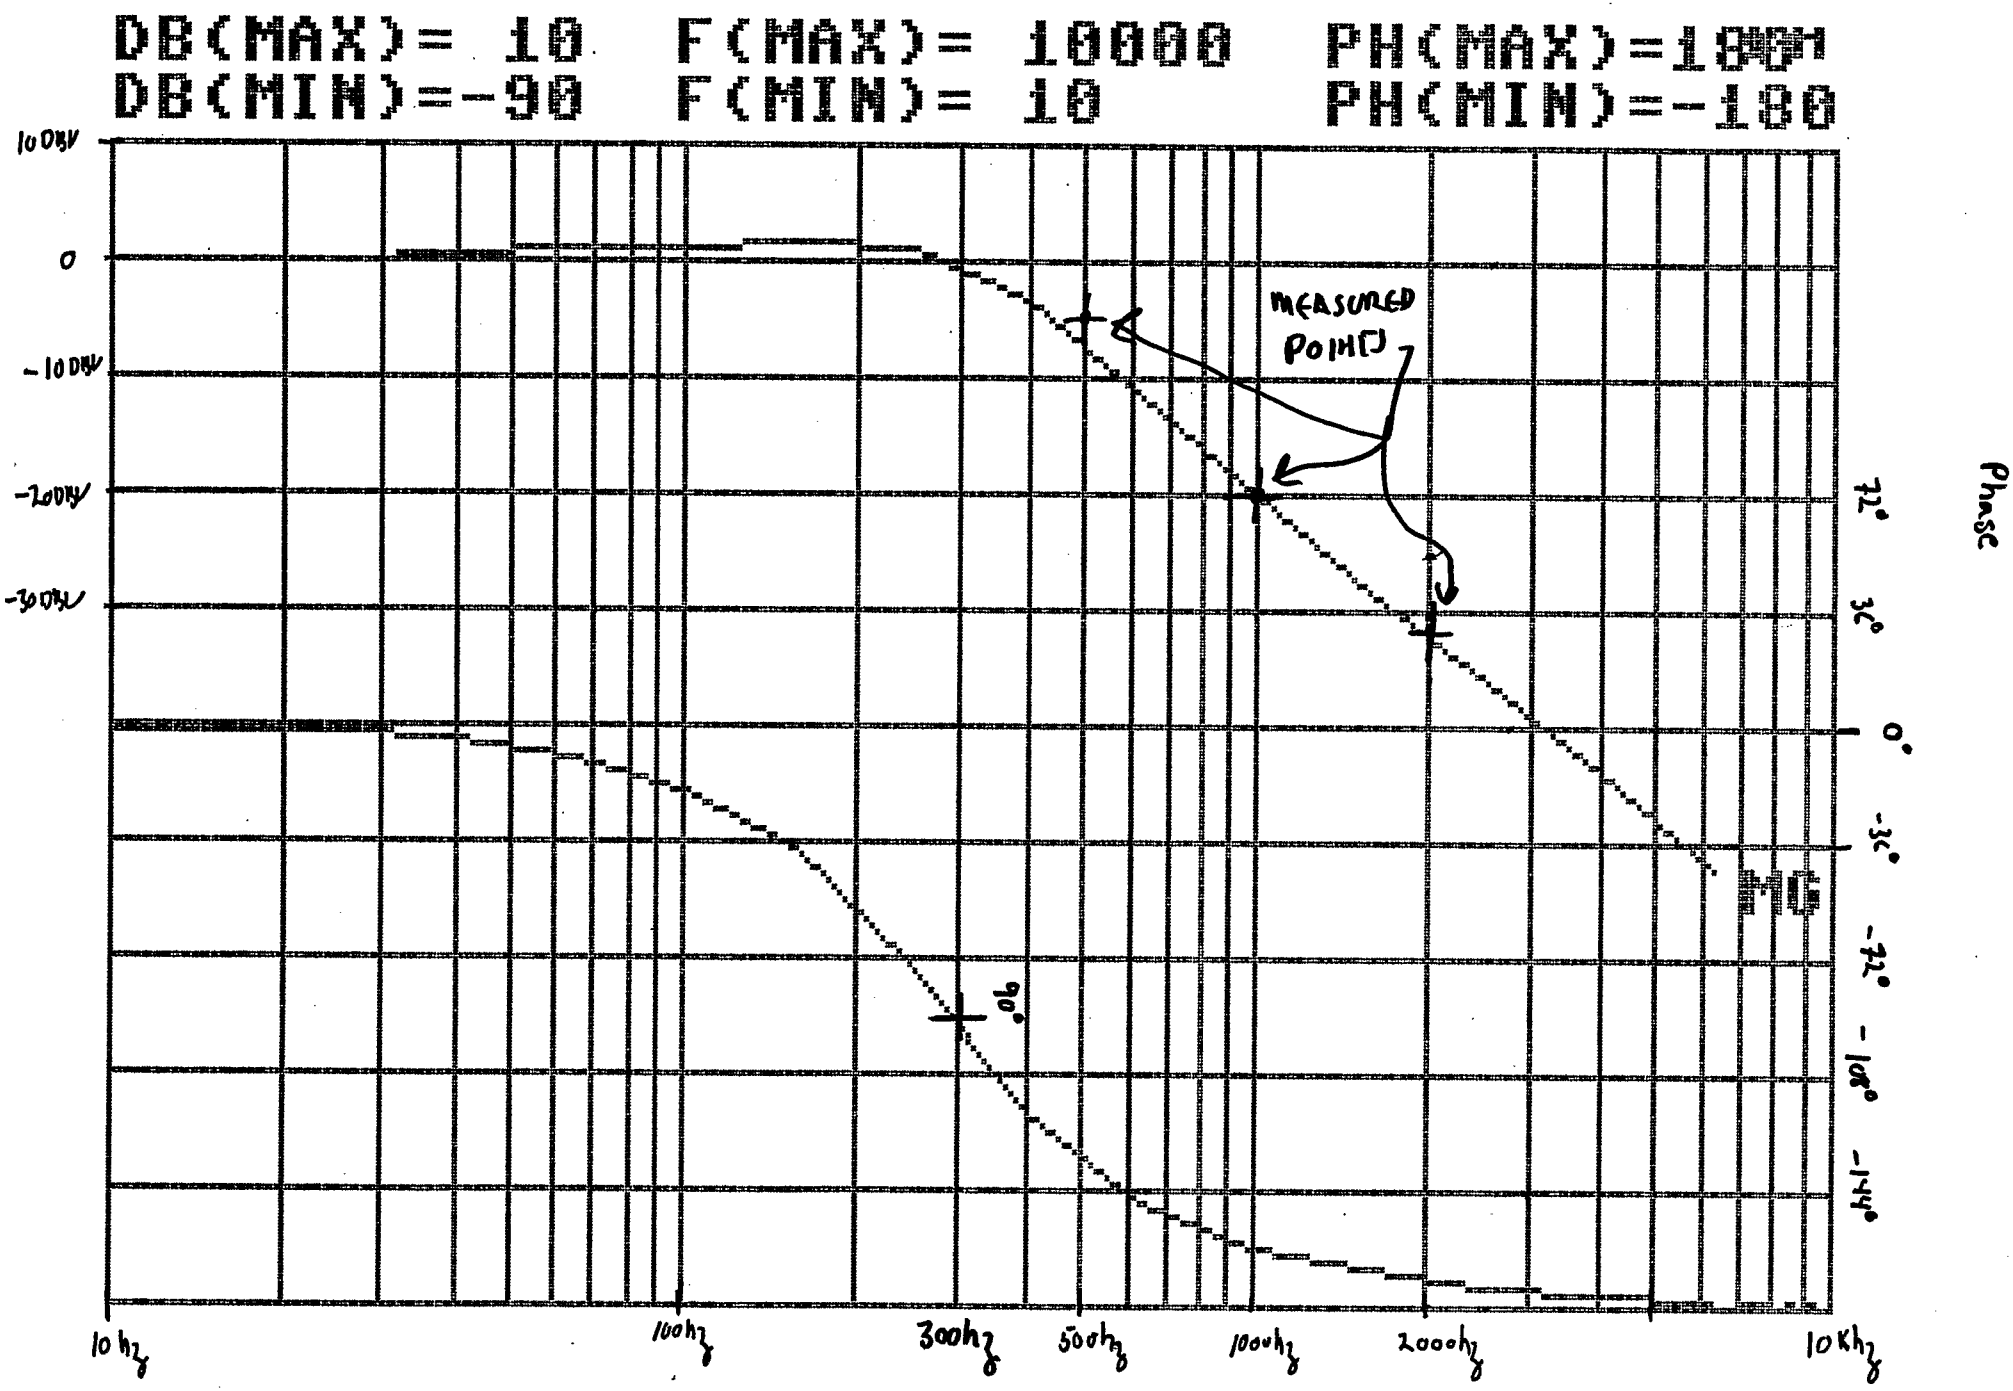
Using a nominal value of 10 mh. for the ripple filter inductance, the frequency magnitude and Phase responses of the ripple filter were calculated and compared to several nominal measured Point on the roll of. The ripple filter calculations agree very well with the measurements. The filter break frequency is at about 300 hz. and the roll off is about 40 db. Per decade or 12 db. Per octave. The overshoot is 28% at 200 hz.

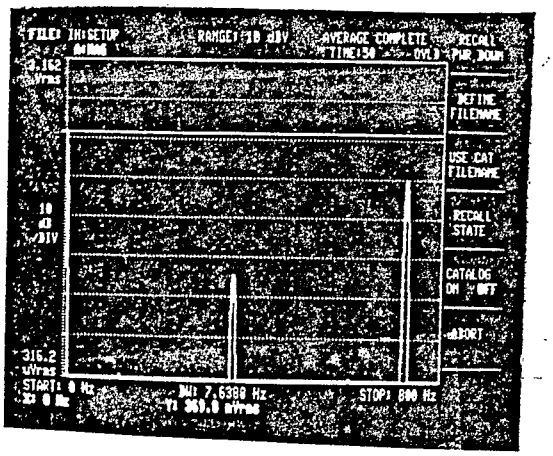
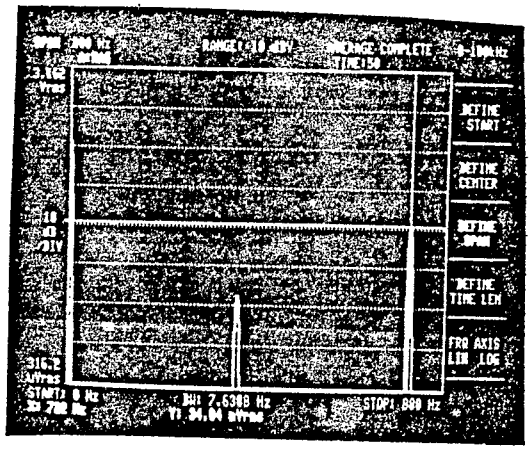
STATION #1

As indicated in the spectrum diagrams for station #1 before and after the ripple filter all the subharmonic components of ripple are well behaved. The 360 Hz. component of ripple however is somewhat higher than anticipated and although the ripple adjustment controls of this station were able to minimize it they were not able to reduce it to zero. It appeared as though there was a quadrature component of 360 Hz signal being introduced from an ununderstood reason. This will be investigated in greater detail.

D.C	261.5V	258V
120	1V P/P	—
360	16.5V P/P	11.7V P/P
720	270.2V P/P	96V P/P

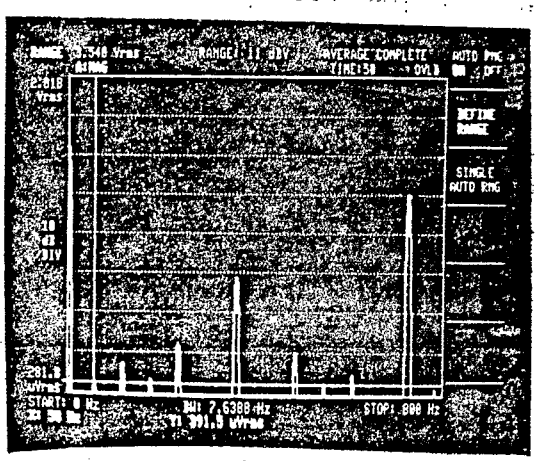
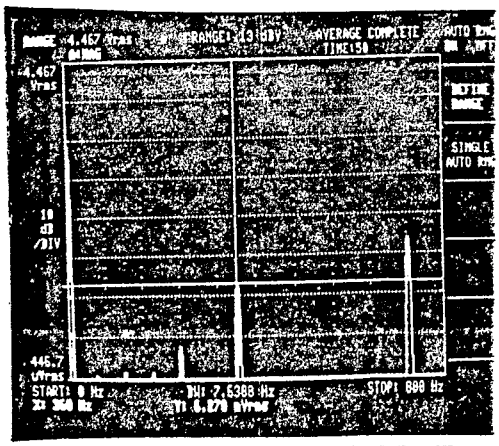
STATION #2

For station #2, the results are not so easily interpretable because of some inconsistencies that have not been fully analyzed at present time. All components of signals as determined by the spectrum analyzer after the ripple filter were about 10% higher than they should have been. This includes even the D.C. component of magnet voltage. If a 10% correction is included in the data everything falls into place.

As Previously Pointed out, station #2 had some subharmonic ripple left in. This ripple can now be used to compare the filter against calculations. At 360 hz, the filter response calculates that it should be down to about 80% . the 360 hz component before and after the filter measure 21.3 and 16 (corrected) volts P/P. this is 75%, which agrees closely with calculations. At 720 hz., the filter calculation predicts that the filter response should be about 20%. the 720 hz. before and after the filter measured 251.5 and 54 (corrected) volts P/P. this is a response of 21%, which is a good close fit.

DC	249	273 → 245
60	1V P/P	1.41V P/P → 1.25V P/P
120	1.85V P/P	1.5V P/P → 1.35V P/P
180	1.18V P/P	1.55V P/P → 1.4V P/P
240	2.85V P/P	2.8V P/P → 2.54V P/P
360	21.24V P/P	17.7V P/P → 16V P/P
720	251.5V P/P	60V P/P → 54V PP

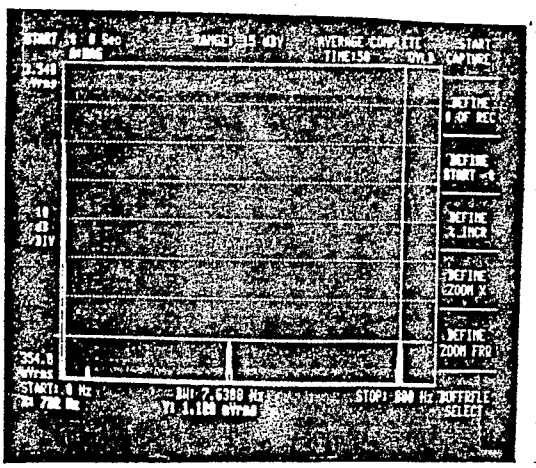
I MAGNET

The magnet current frequency spectrum shows that the 60 Hz. component of current is of the order of 0.3 Amps. R.M.S. and do to the fact this was intentionally introduced, could in Principal be reduced to essentially zero. The most troublesome component of subharmonic is the 1400 Hz. component. This component is about equivalent to 4.0 amps Peak to Peak. This Peak to Peak value is about 4% of the injection current and can Produce Prohibitively large radial excursions of the beam Position during injection. I do not believe this number for the following reason.----------

D.C. = 351/√2 = 248 MV = 150A DV

60 = .45Z MRMS = 0.3AMPS

360 = 1MVRMS = 0.6 AMPS

720 = 1.12 URMS = 0.672AMPS

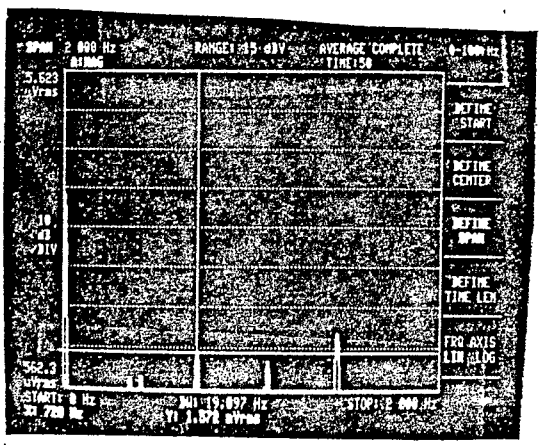
If the Power supply were Phased back to Produce zero volts D.C. (the worst condition for ripple), the raw ripple would be 750 volts Peak to Peak at 1400 Hz. The waveform would be a Pup tent which would therefore yield a value of 2(750)/(3.1416)=477 volts Peak to Peak applied to an inductance of greater than 0.5H. This would yield a current of something of the order of 0.1 Amps. Peak to Peak at 1400 Hz. The conclusion could only be that the 4.0 Amps Peak to Peak is inconsistent with the rough calculation of 0.1 Amps Peak to Peak. Additional studies will be required to resolve this discrepancy.

DC = 149.8/√2

360 = .763MV

420 = .82MV

720 = 1.57ZMV

1085 = 1.2 MV

1440 = 2.664MV = 1.5784 AMPS 4APP
