THE 1988 VERTICAL SURVEY OF THE AGS

E. J. Bleser

October 1988

Brookhaven National Laboratory

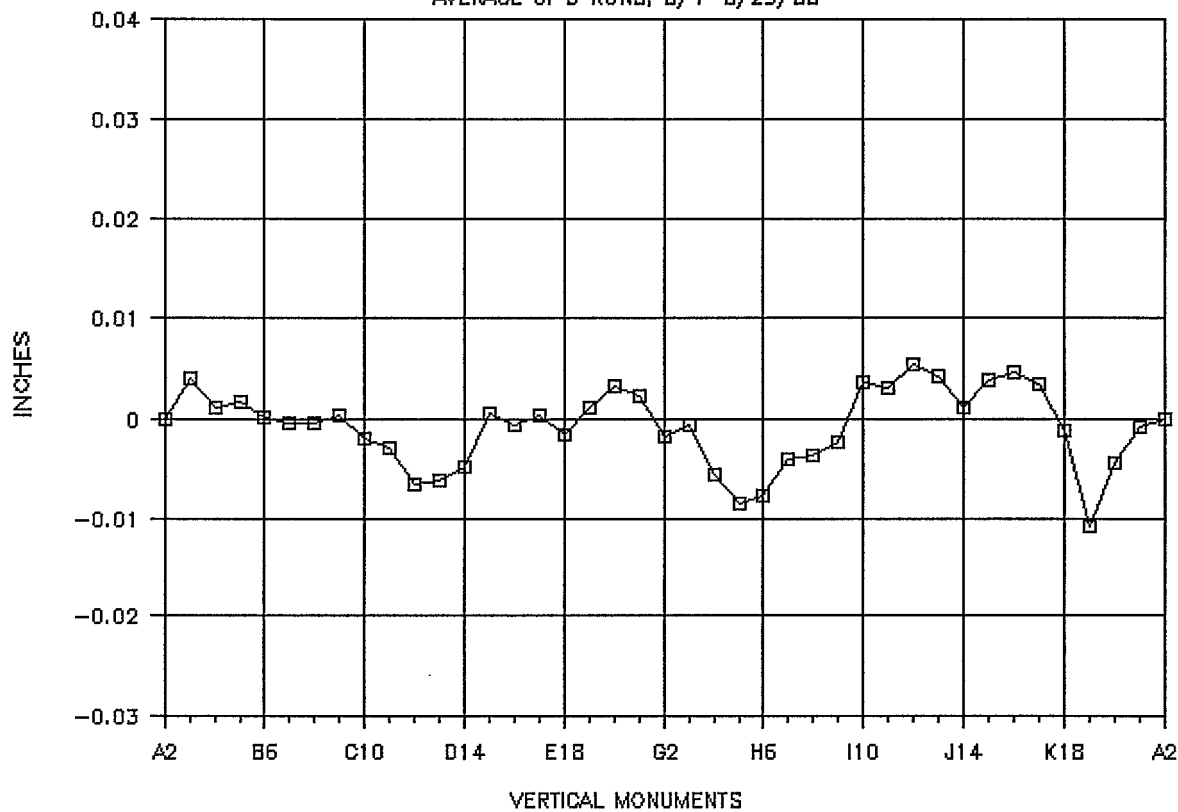
VERTICAL MONUMENT ELEVATIONS GRAPH 1

AVERAGE of 3 RUNS, 8/1-8/29/88

INCHES (A2 set to 0.616)

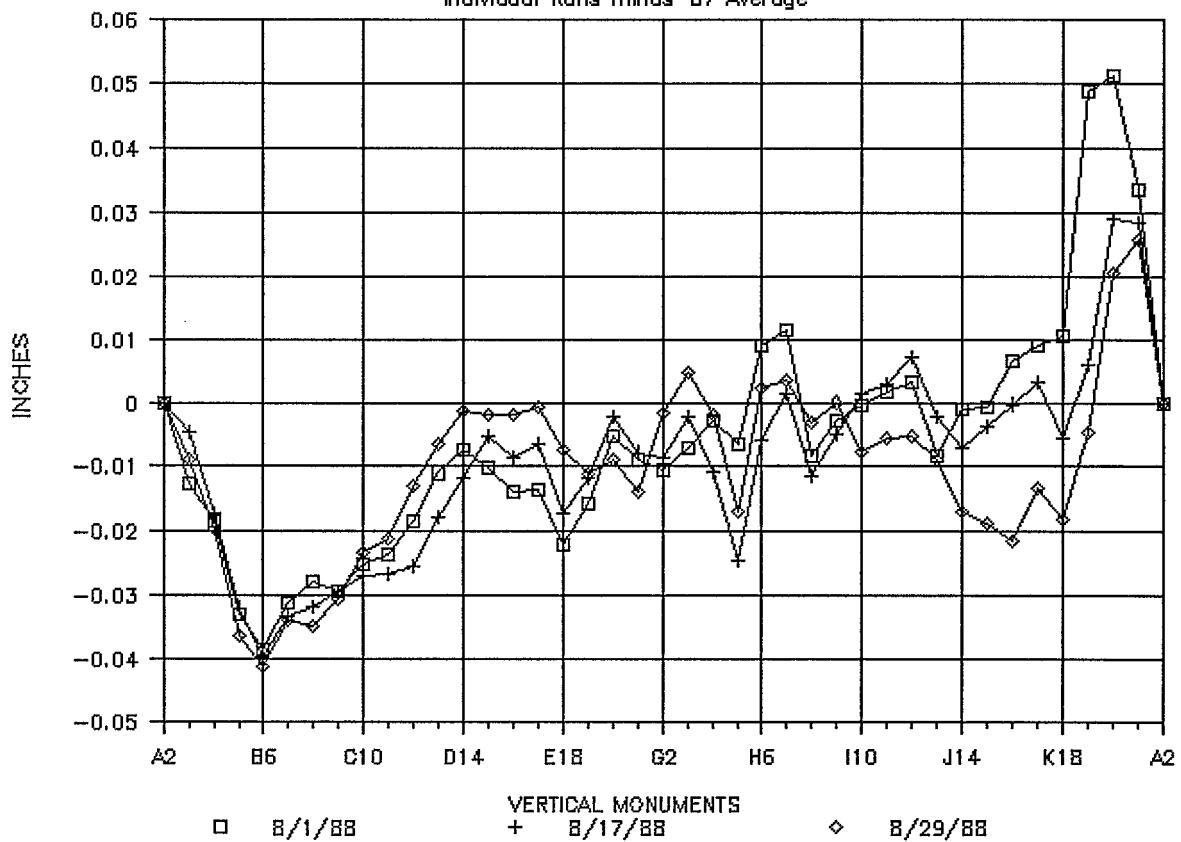
1988 MINUS 1987 ELEVATIONS   GRAPH 7

Figure 6 shows the three individual runs minus the average value of the five runs that were taken in 1987. Figure 7 shows the 1988 average minus the 1987 average. There are three areas we might comment on. In L sector shielding was removed in June and July for the booster penetration, and the monuments rose by 0.050 inches at the time of the first run. During August the shielding was replaced and by the end of the month the monuments had settled back by 0.020 to 0.050 inches. We shall continue to watch this area.

There is a very tentative suggestion that the region of G-20 is sinking. This is near the junction of the target building and the tunnel and is perhaps a region of instability. The most striking effect is in B sector which seems to low by 0.040 inches. This looks to be a very believable effect. Historically the 1985 survey found B sector to be high 0.030 inches. The magnets were lowered appropriately and resurveyed. In 1986 they were found to be low by 0.030 inches but were not repositioned. In 1987 B sector was low by 0.035 inches and was repositioned. Now in 1988 we find that the monuments have settled by 0.030 inches since 1987.

Sectors D through K look reasonably flat and stable. They are about 0.005 inches below where they were last year but we can explain that by saying our normalizing point, A2 has risen by 0.005 inches. Then the scatter of points in D thru K seems to be well within that which would be allowed by the curves of Figure 5.
