SIEMENS POWER SUPPLY MOTOR-GENERATOR SET MOTOR ROTOR FAILURE

Collider Accelerator Department
Brookhaven National Laboratory

AGS DIVISION TECHNICAL NOTE

No. 99

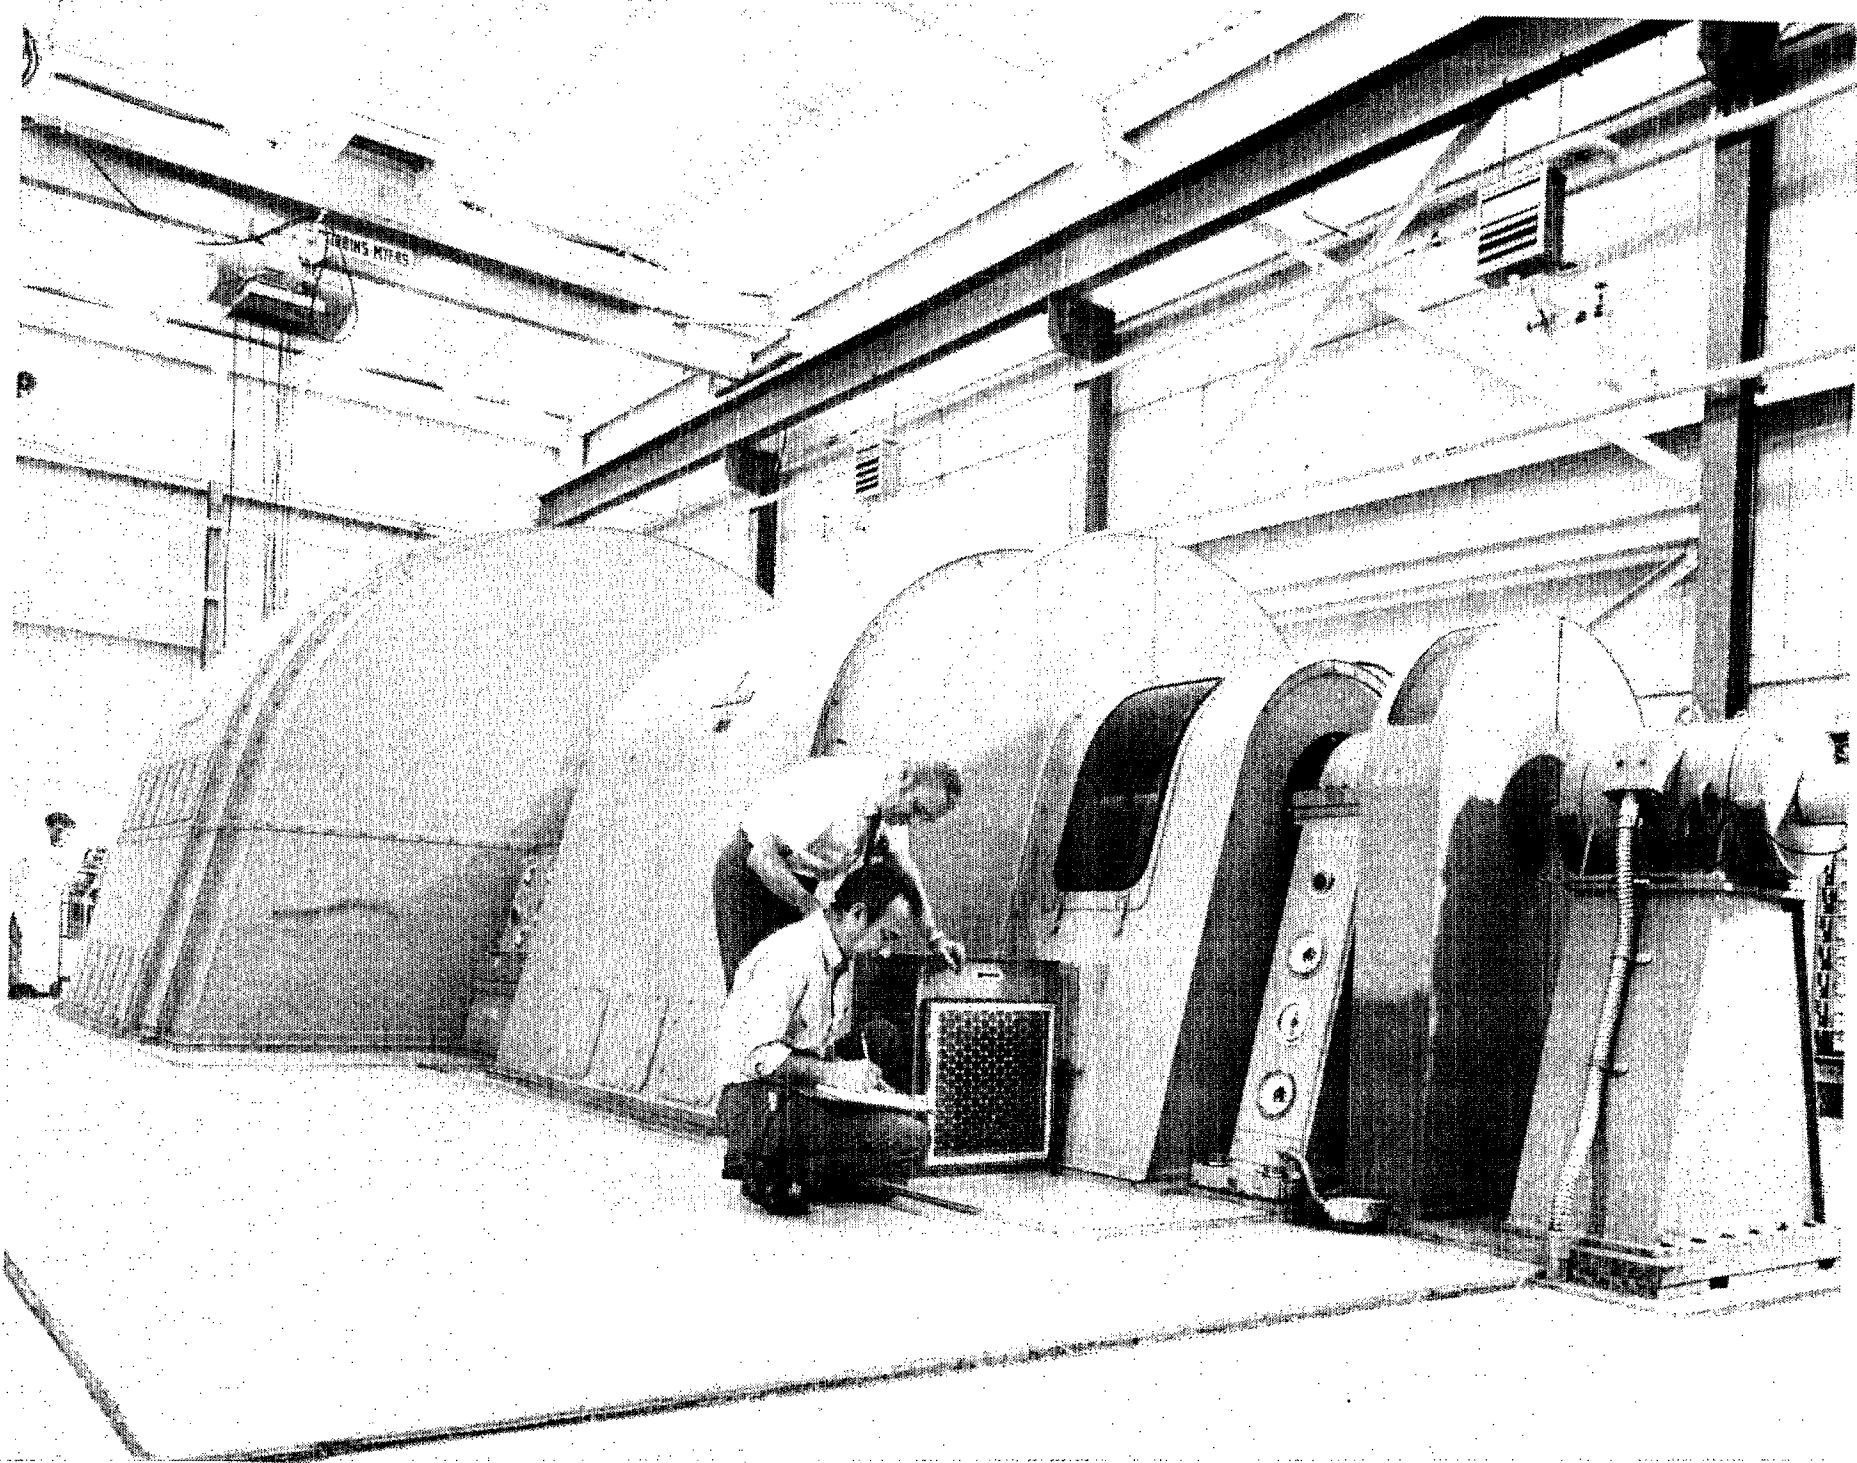
Fig. 1

The Siemens power supply is used to power the 33 GeV Alternating Gradient Synchrotron main magnet. It consists of a motor-generator set (Fig. 1) supplying energy to banks of mercury-arc rectifiers through transformers. The motor is a wound-rotor induction motor rated at nine megawatts, 13800 volts, 3 phase, 60 hertz, 1200 rpm. The generator is rated at 50 MVA continuous 95 MVA surge, 7500 volts, 3 phase. The power supply output is 12000 volts, 7000 amperes, pulsed duty.
