SIEMENS POWER SUPPLY MOTOR-GENERATOR SET MOTOR ROTOR FAILURE

AGS DIVISION TECHNICAL NOTE

No. 99

September 29, 1972

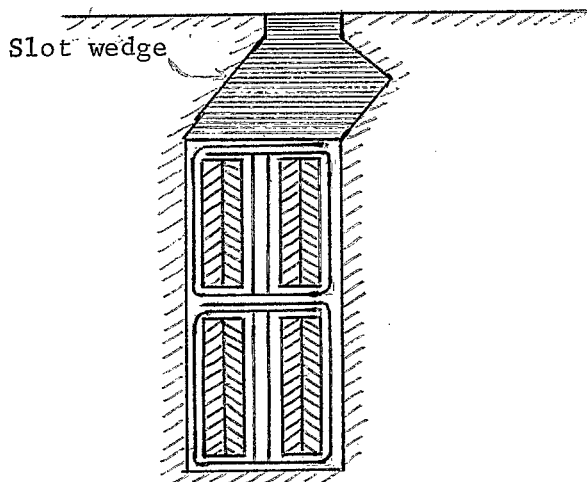
After removing the slip-ring cover and the motor end shields, it was found that one or two rotor winding end connections and the rotor to slip-ring connections were severely burned. Figures 2 to 6 show different views of the external damage at the rotor winding end connections, and Figs. 7 to 9 show the physical damage at the rotor to slip-ring connections.
