AGS/AD/Tech Note No. 144;BNL-104573-2014-IR

## VIDEO SPLATTER ON VERSATEC HARD COPY

W. Frey

February 1978

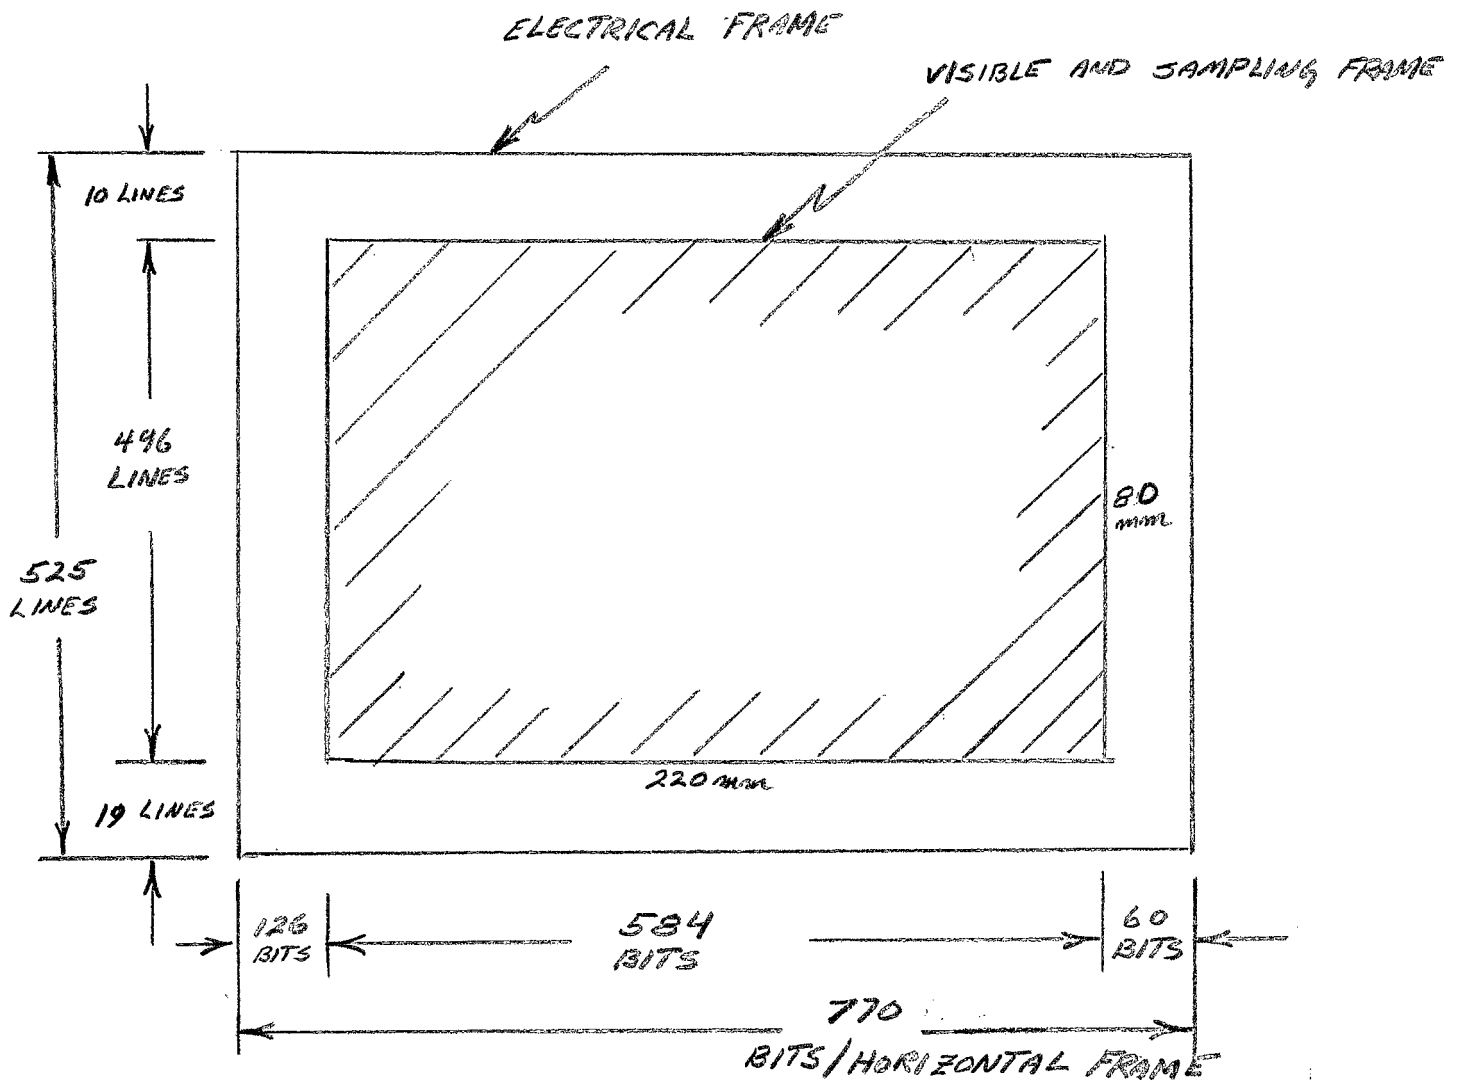
Fig. 1 Video Frame Parameters

Attempts to get a hard copy of the Infoton (Monitor 7) terminal on the Main Control console have resulted in unreadable text. The Versatec Hard Copy Controller, Model 210 series, located in rack R8 in the Main Control Room is used to convert incoming video from the selected video source and drive the Printer/Plotter unit. The Controller unit samples the incoming video on a horizontal line-by-line basis. The Controller converts video line into digital data to control the printing of one line on the Printer/Plotter unit. The Controller is limited to 100 bytes maximum of information to a line. The Controller is set up to sample data as shown in Fig. 1. The Infoton terminal can generate 80 characters per line, thus there are 480 elements per line (for a 5 x 7 dot characters plus 1 space). Thus the vertical stroke width of a character is slightly less than the sampling element ( $480/584 = 0.82$ ). The incoming video data black/white threshold is set at 20% up from black reference level.
