A close look at beam aborts with rise times less than 40 ms from the years  
2014-2016. Case studies.

Collider Accelerator Department  
**Brookhaven National Laboratory**

C-A/AP/570  
September 2016

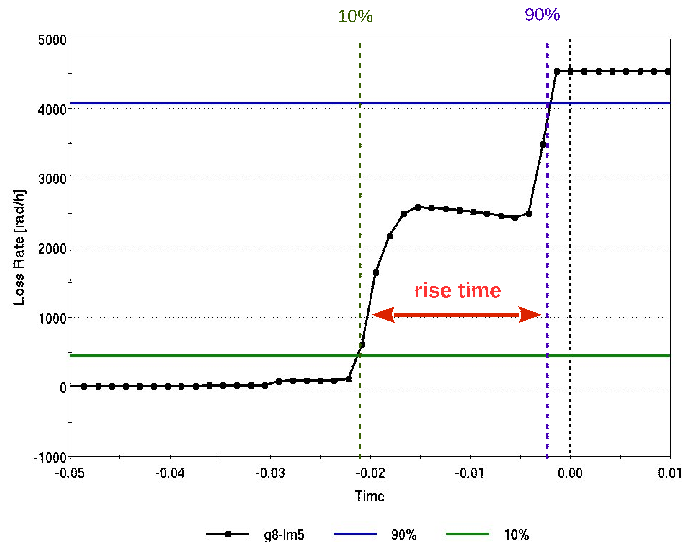
Figure 1: Definition of risetime as the time between 10% and 90% of the loss monitor data. Showcase fill is 19769.

definition. In this example the saturation level of 4530 rad/h for g8-lm5 constitutes the
