A close look at beam aborts with rise times less than 40 ms from the years 2014-2016. Case studies.

A. Drees

September 2016

Collider Accelerator Department Brookhaven National Laboratory

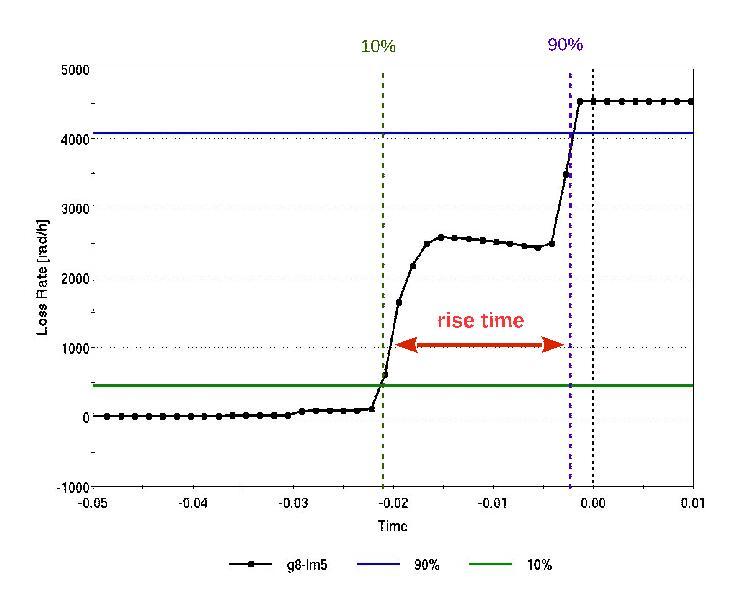
Figure 1: Definition of risetime as the time between 10% and 90% of the loss monitor data. Showcase fill is 19769.

definition. In this example the saturation level of 4530 rad/h for g8-lm5 constitutes the
