The H5 Kicker Test

AGS STUDIES REPORT

Date <u>4/21/81</u> <u>4/24/81</u>		
	W. Weng, L. Ahrens, J. Gabusi, E. Gill, J. G.	·
Reported by	W. Weng The H5 Kicker Test	
subject _

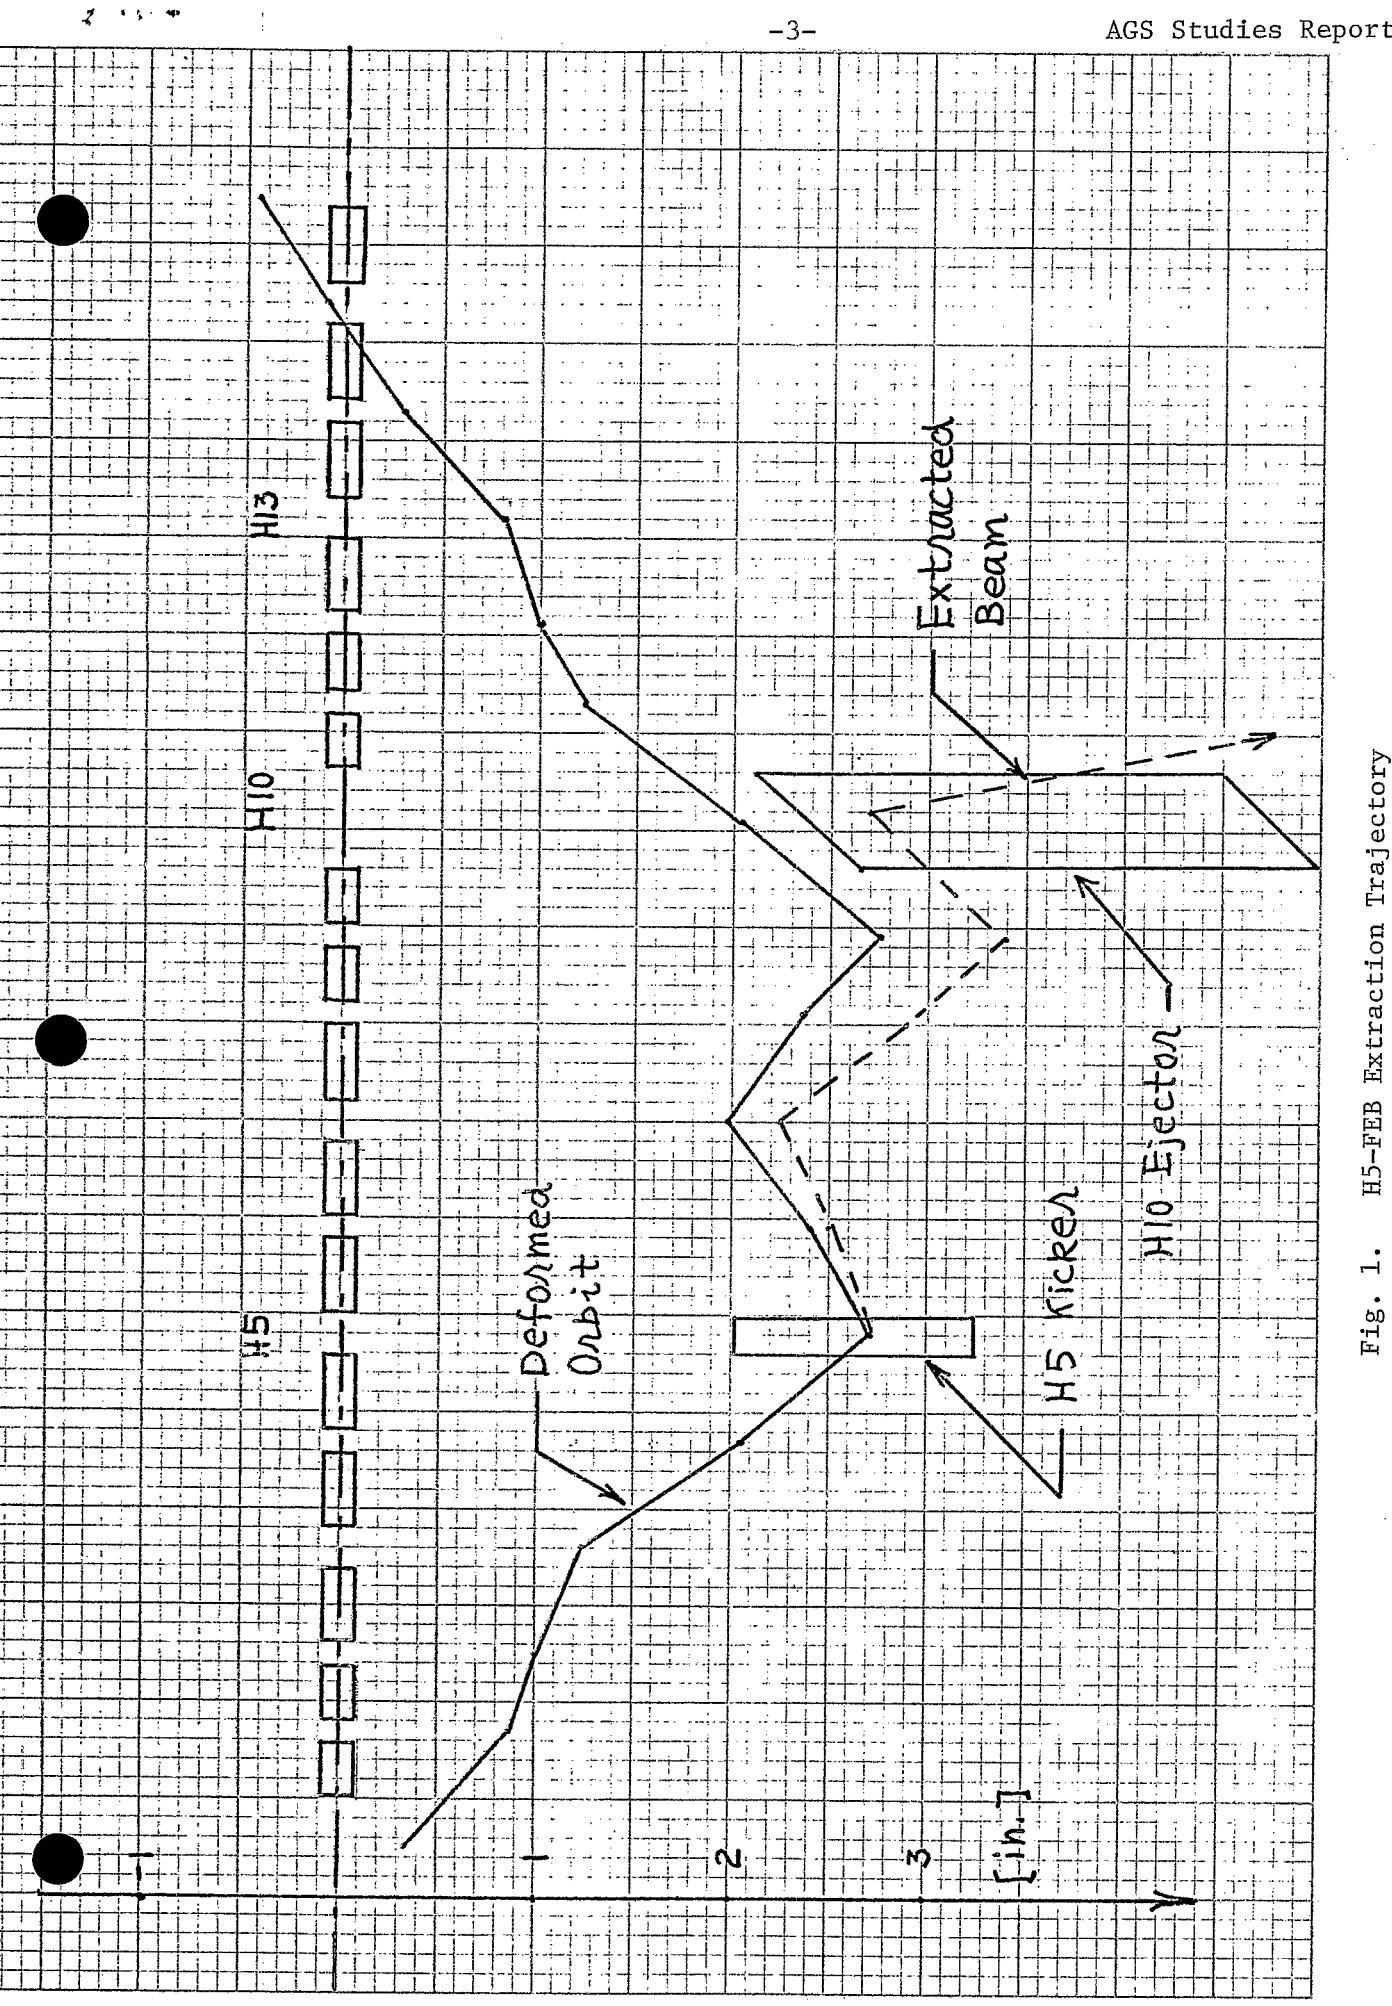
H5-FEB Extraction Trajectory

The designed central orbit of the deformed beam had been calculated and plotted in Fig. 1. The beam position at H5 s.s. is 2.7" and at H10U and H10D are 2.3" and 1.7" respectively. The edge of the H5 kicker was surveyed in at 2.06". With the good field region of the H5 kicker starts at 0.2" inside the edge of the ferrite and beam half width 0.35", the beam center point should be at 2.06 + 0.2 + 0.35 = 2.61" as desired. The position of the H10 ejector was set to be 2.65" U and 2.1"D respectively.
