## SHORT COLUMN PROGRESS REPORT

AGS DIVISION TECHNICAL NOTE

No. 19

SHORT COLUMN PROGRESS REPORT

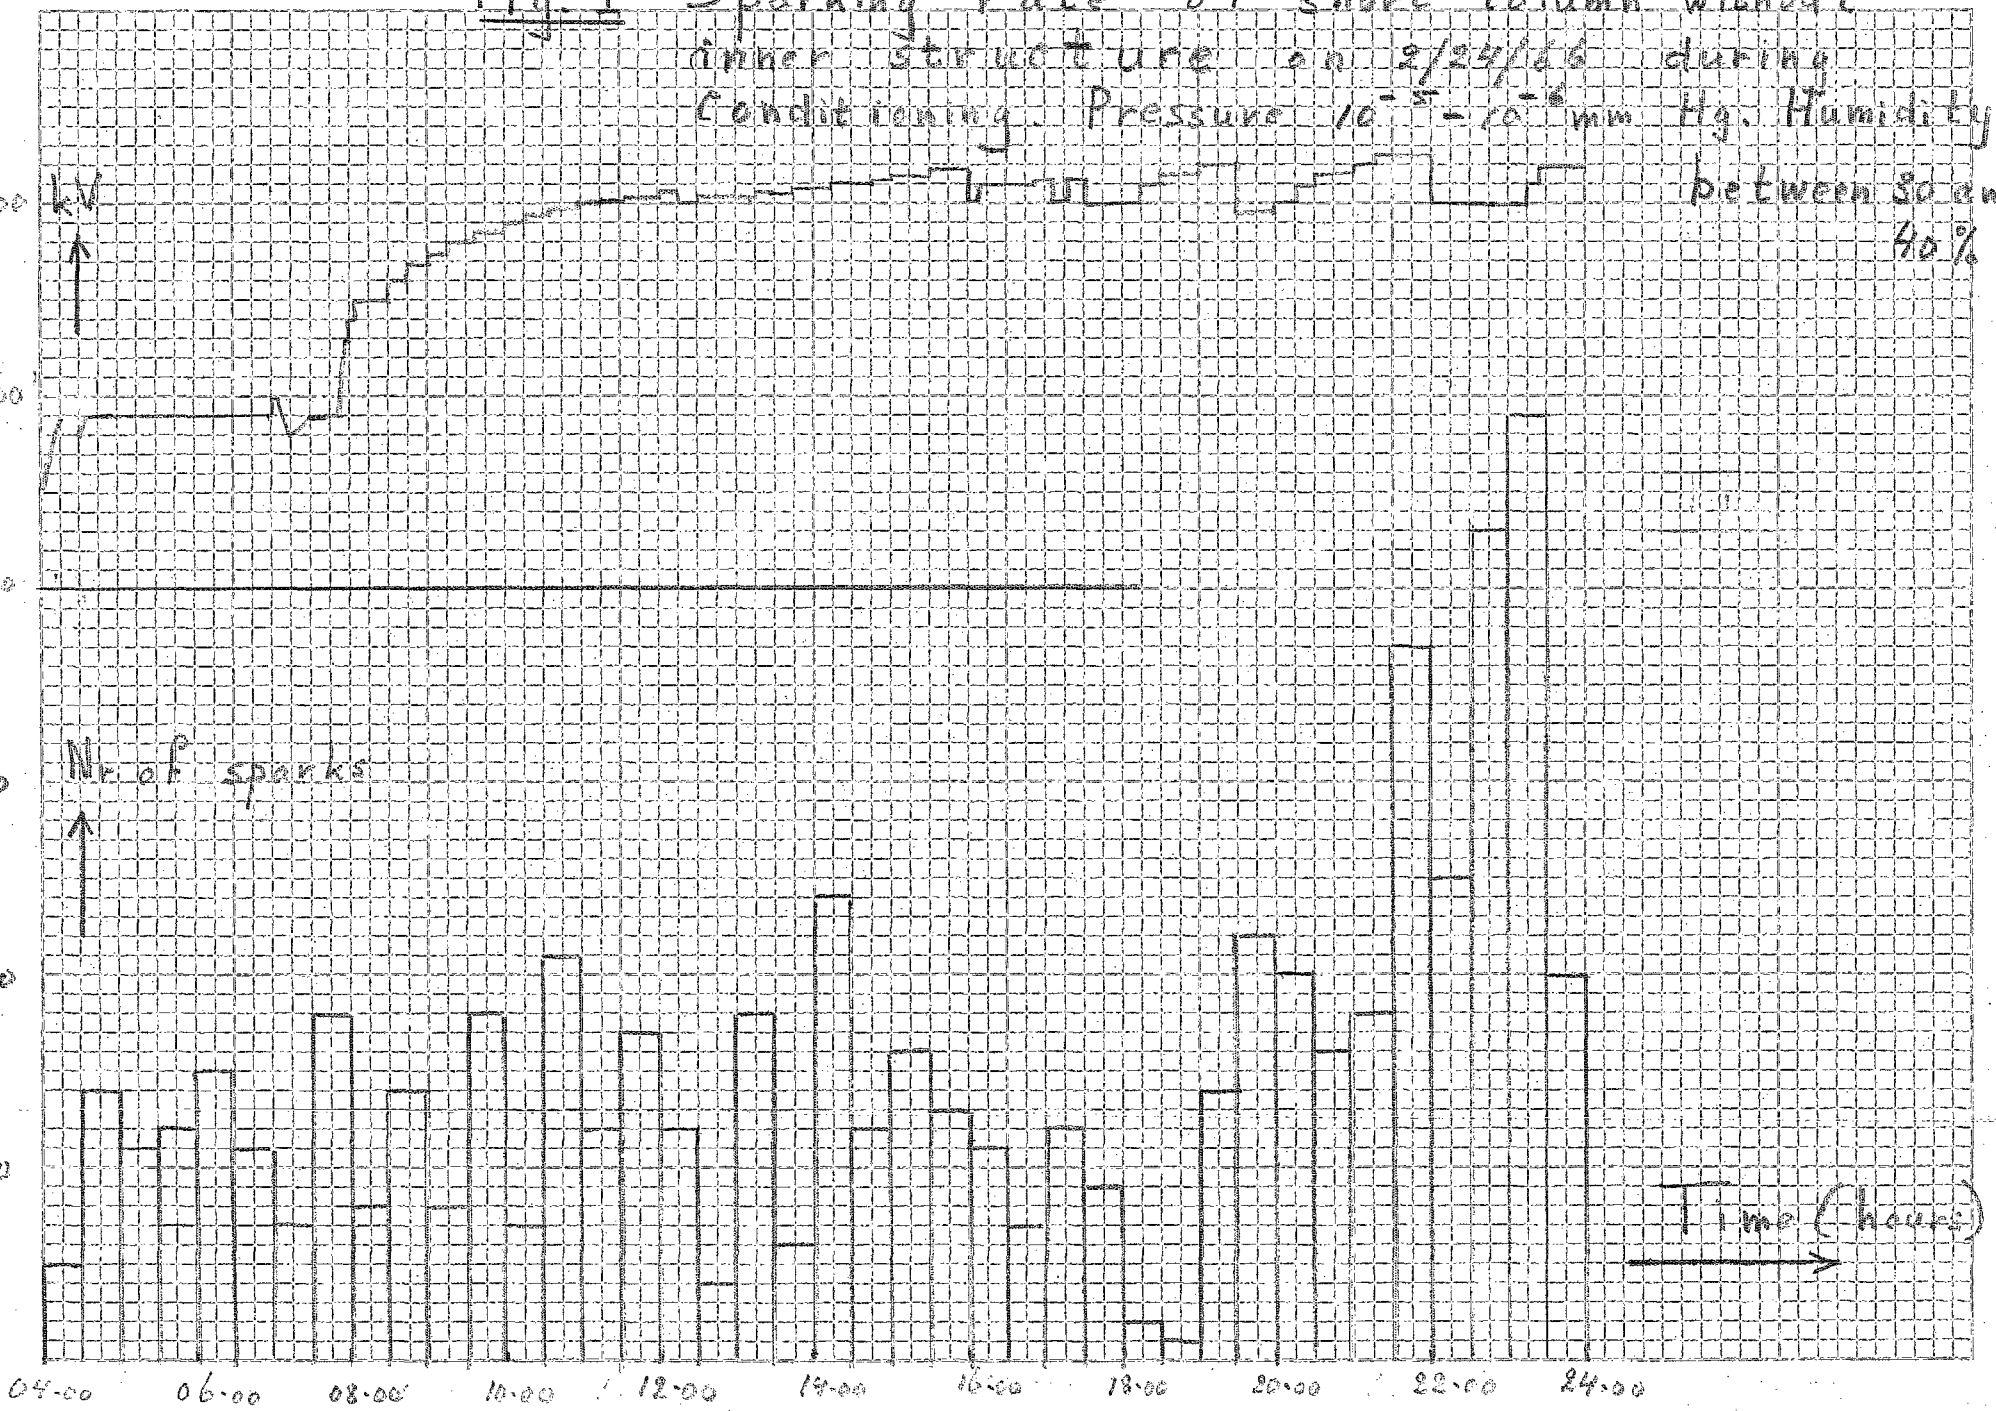
Fig 1 Sparking rate of short column without inner structure on 2/24/66 during Conditioning. Pressure  $10^{-5}$  -  $10^{-6}$  mm Hg. Humidity between 30 and 40%

An H.V. test of the short column without inner structure has reached 650 kV after four days of continuous conditioning. Figure 1 shows a plot of the sparking rate in time. After these promising results, we decided to stop conditioning, to install the inner-structure of the column and to condition at the same time the large surfaces of the inner structure. The R.D.I. power supply worked fine up to 650 kV at least; the H.V. bushing sitting in oil was a right solution up to now. The control panel of the R.D.I. will be rewired and the equalization resistances around the filter capacitances will be used as measuring resistance after a careful calibration. Not much success was obtained in tests with modified Machlett rectifiers to replace eventually the very expensive Machlett tubes (\$250), bought via Radio Dynamics Corporation. The general layout of the H.V. equipment in Building 905A seems to work for at least 650 kV.
