Gas Load (Q) Measurements of the AGS Ring Vacuum Sectors

* AGS Accelerator Division *
* Technical Note # 225 *

H.C. Hseuh and M(Sanki) Tanaka

07-November-85

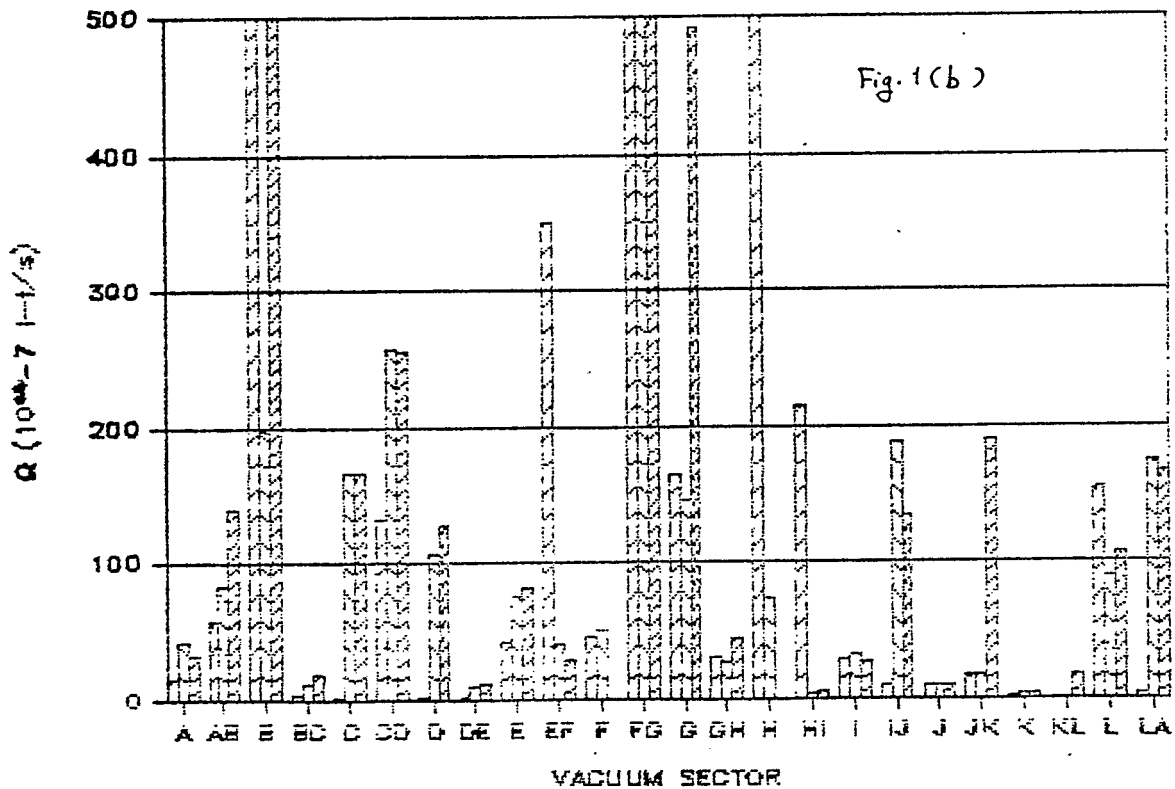
Q Measurement

During the 1985 summer shutdown, the rate of pressure rise of each ring vacuum sector was measured several times by turning off H.V. of the ion pumps. The resulted gas load per sector, Q, varies from 1.0×10^{-7} to 1.0×10^{-4} torr-lit/sec.

The pressure P before turning off the ion pump H.V., and the gas load Q have been measured several times for each vacuum sector. The results are listed in Table 1. and plotted in Fig.1. Based on a single chamber measurement at the vacuum lab, the outgassing of 10 standard ring vacuum chambers (i.e. 1 sector) after one week of pumping is estimated to be approximately 2×10^{-6} torr-l/s which is in reasonable agreement with the results for more than half of the sectors. However there are

- A:
AB: Leak near B3 by VSCAN; found small leaks(10^{-8} range) at A-20 box on Oct. 14
B: Still in the process of pumping down from the B-10 cavity repair; the high outgassing of 1×10^{-4} Torr.l/s is due to the current transformer at B-5 (this is consistent with the measured outgassing in lab. by V. Castillo)
BC:
C: May be due to the outgassing of the bump coil installed at C-13 in September
CD: May have leaks around C-20 pipe
D: May be due to the outgassing of the bump coil installed at D-7 in September
DE: May have small leak around D-19 by VSCAN
E: Small leak around E-9 by VSCAN
EF: Area worked on in September; more ion pumps are on line
F: No measurement due to local controlled turbo at F-10 box
FG: Leak at G-3 bellow; found leak at F-14 bellow on Oct. 15
G:
GH: Small leak near G-19 by VSCAN
H: Leaks at H-12 and H-13 bellows were repaired
HI: Leaks at H-16, H-17, H-19 and I-3 were found
I: Small leaks were found at I-4, I-8 and I-11

IJ: May have leaks near I-17 and I-20 by VSCAN
J:
JK: May have leaks near K-2 by VSCAN
K: May have leaks near K-9 by VSCAN
KL:
L: Have leaks near L-6 by VSCAN
LA: May have leaks near L-17 and L-19 by VSCAN
