Run 16, eIPM Summary

C-A/AP/567
August 2016

Run 16
eIPM Summary

**R. Connolly, C. Dawson,
S. Jao, V. Schoefer, S. Tepikian**

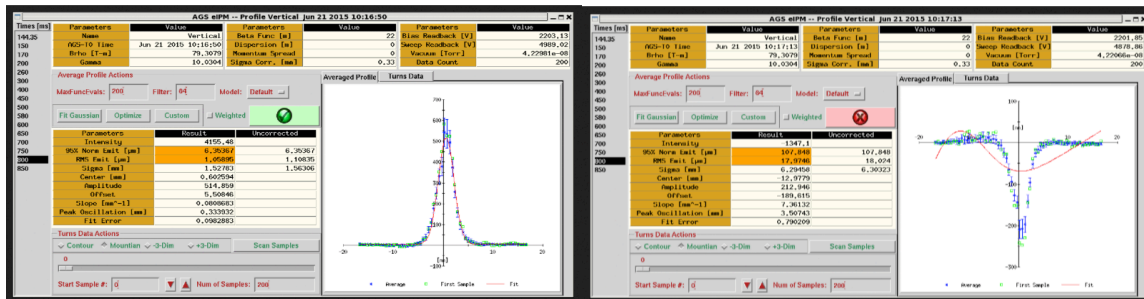
We installed new amplifiers for Run 15. These were charge-sensitive amps designed to integrate over the 200ns-long injected bunches and decay to baseline in one full revolution period, $\sim 2.7\mu\text{s}$. The input stage was built on a small circuit board which replaced the fast pulse amplifiers used originally in RHIC. We used the existing output drivers on the carrier board which were transformer-coupled to the twisted-pair signal lines leaving the tunnel. With AC coupling, there could be no DC component in the output signal. When the digitizers were triggered on the beam pulse we got good profiles, left. When we moved the trigger point we got 'inverted profiles' from the undershoot, right. In these two examples the trigger signal timing is different by 70° at harmonic number 1.

The "negative profiles" were not a problem during proton fills when only one bunch was injected in each AGS cycle. However when several bunches were injected the individual bunch profiles interfered with each other and dramatically reduced the average profile. During the shutdown we removed the output transformers to dc couple the amplifiers to the digitizers. This eliminated the "negative" profiles and provided good profile measurements with heavy-ion operation.

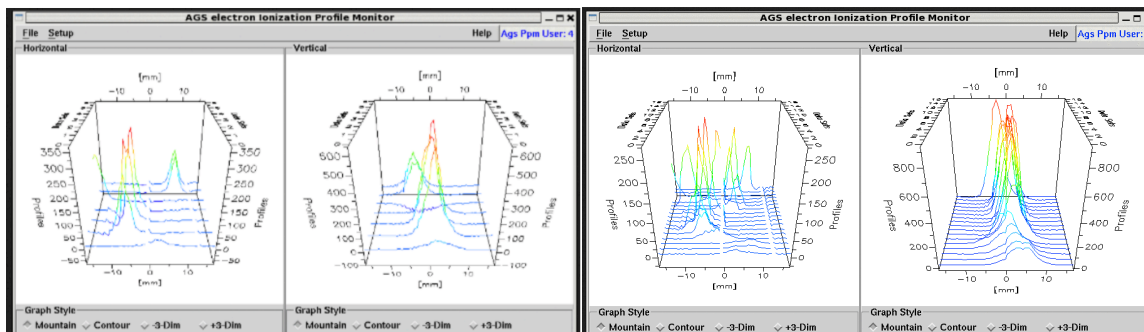
The measurement aperture issue with the vertical eIPM was discovered during beam studies. When beam is extracted from AGS a steering bump is introduced which moves the beam to the outside of the ring. Normally the beam leaves the AGS so the disappearance of vertical profiles was expected. During the beam studies the steering bump was being introduced but the beam was not extracted. The left plot below shows the horizontal and vertical profiles records from the beginning of the machine cycle (front) to the end (back) taken at seven different times. At the fifth measurement the beam moves out of the horizontal eIPM aperture to the left and the vertical profile disappears, which is the behavior we had been observing. However the bump is removed for the last two measurements and both horizontal and vertical profiles are back. The vertical eIPM was installed with the MCP on the outside of the ring. The extraction bump was moving the beam into the dead zone of the detector.

To correct this measurement artifact, we rotated the detector head by 180° moving the dead zone to the inside of the ring. The right figure shows that in this configuration we get good vertical profiles during the full machine cycle with large horizontal movements of the beam.

Once we were aware of the measurement artifacts arising when the beam was near the dead zone boundary we were able to understand that this was the cause of strange behavior of the horizontal eIPM. Dedicated measurements showed that the AGS orbit in the horizontal IPM was consistently below beam line center, in the direction of the MCP. During the Run 15-16 shutdown we flipped over the horizontal eIPM detector to place the 'dead zone' at the top of the chamber.

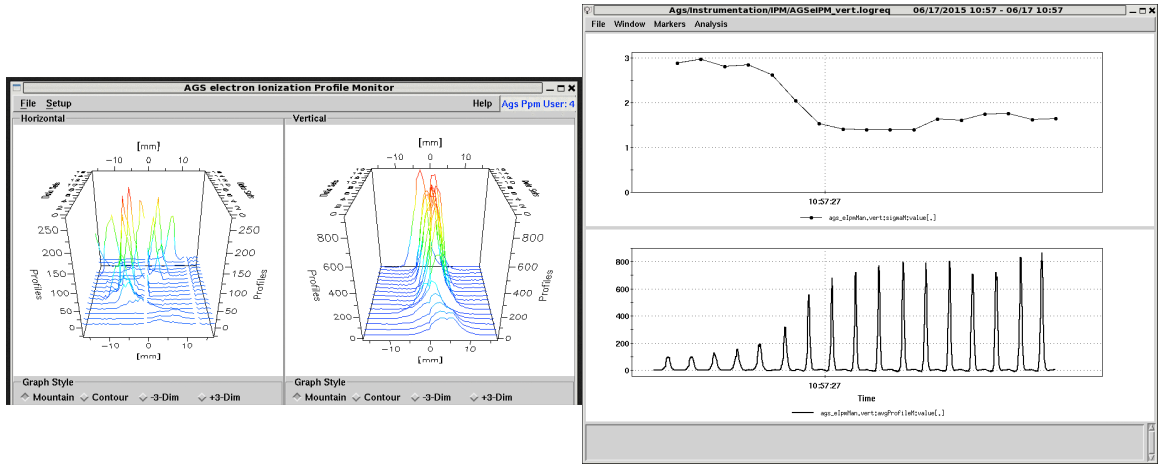
In the AGS we want to make several profile measurements during a single machine cycle. As the beam is accelerated, the profile width decreases and the amplitude increases. This is shown in the two figures below. We would like the amplitudes of the measured profiles to remain about the same during the machine cycle. To do this we added the

Top of right plot shows the beam sigmas and the bottom shows profile amplitudes during the full AGS acceleration cycle.

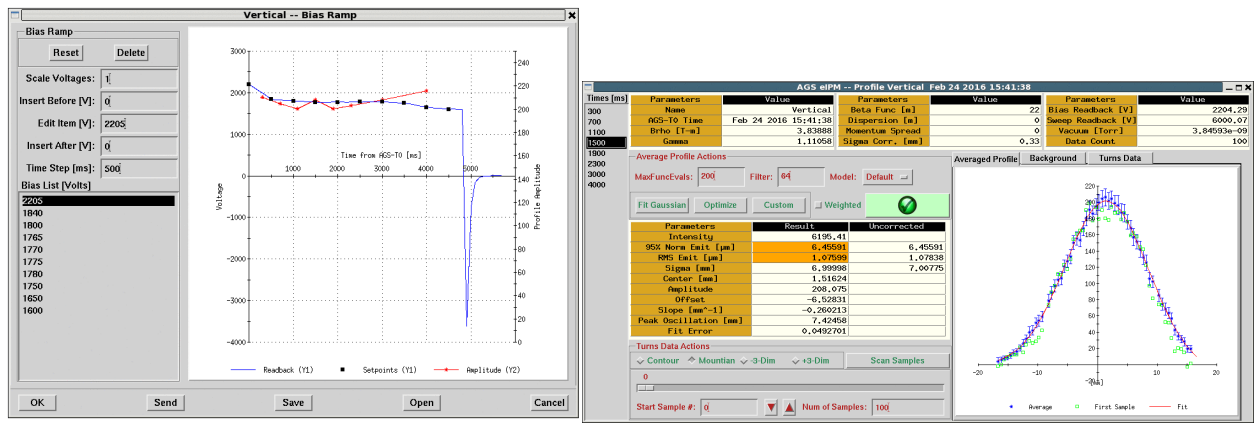
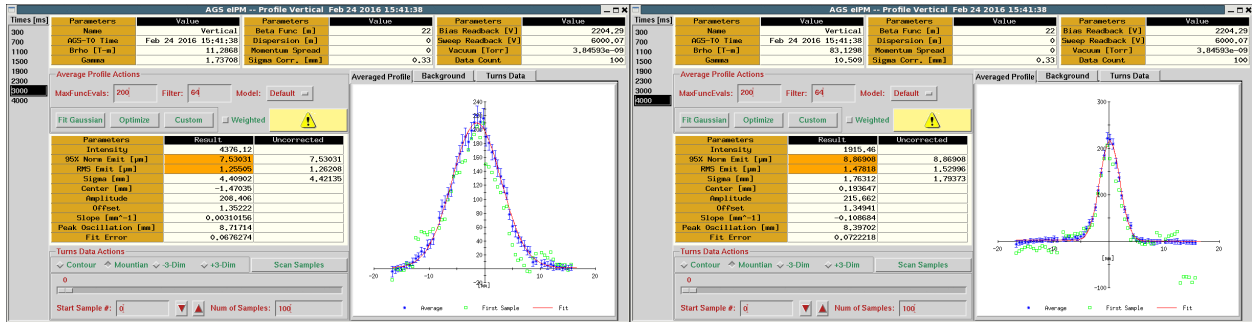
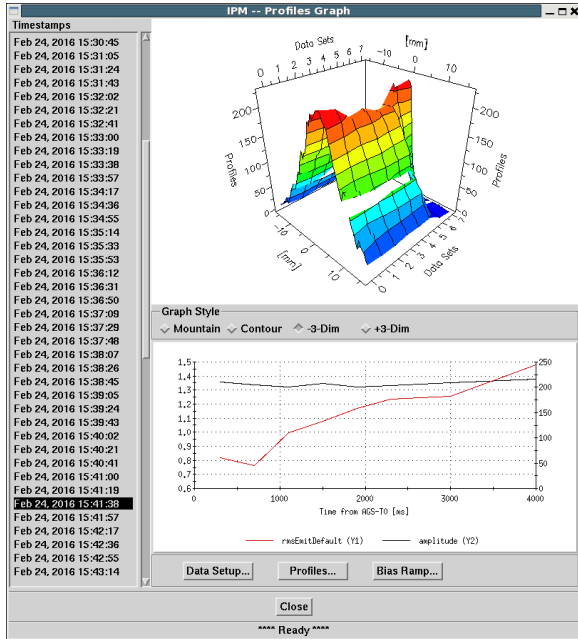
The plots below show the gain control results. The first plot shows the Bias Ramp editing page. The blue data shows the set voltage points and the read back of the MCP bias voltage. Here we have ten points at 0.5s intervals. The red points show the measured profile amplitudes. The next three plots show the measured beam profiles before, during and after the acceleration ramp. The last plot is a mountain range plot of the ten-profile record with a plot of the profile amplitudes and the measured emittances.

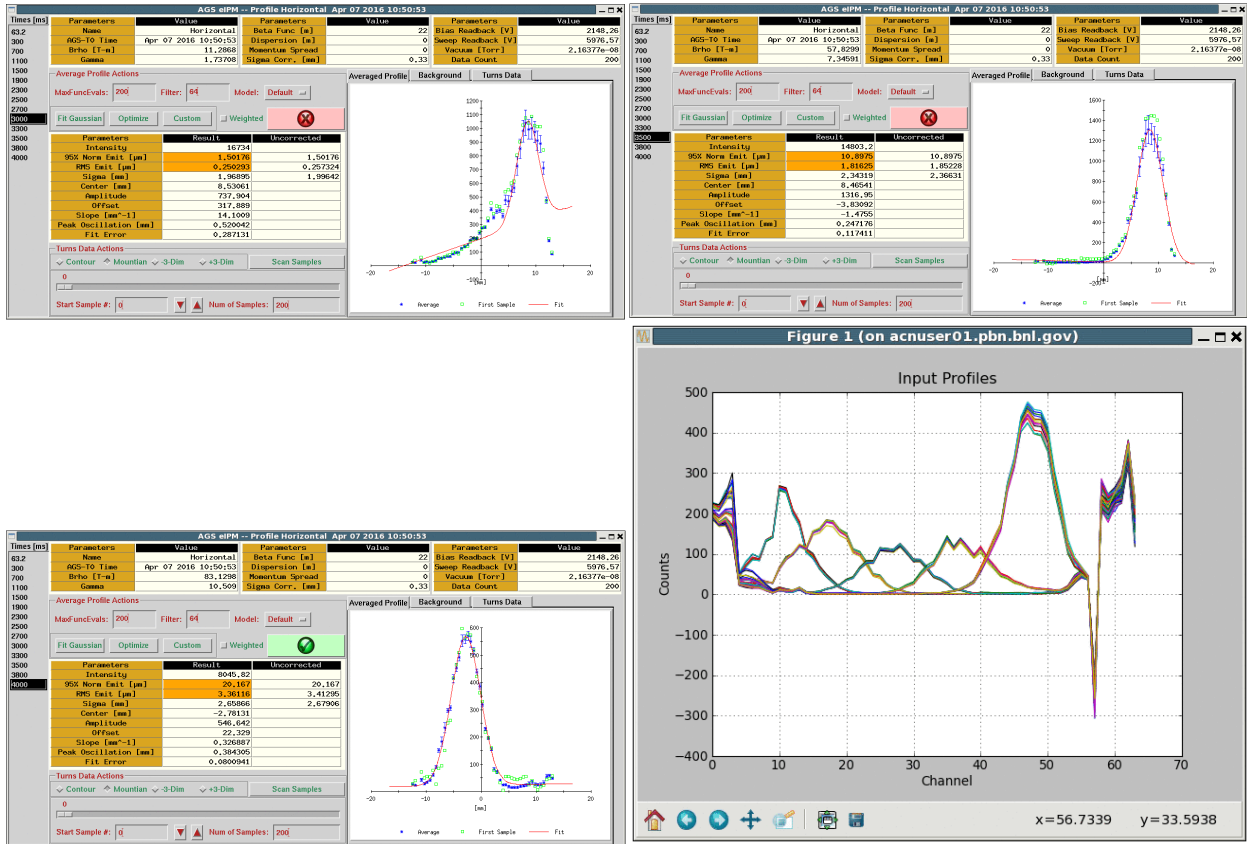
The top three figures show this effect. These are measurements taken at 3.0s, before acceleration, and at 3.5s and 4.0s after acceleration. The profile before acceleration has a long tail and the Gaussian fit shows the beam to be smaller before acceleration than after. Figure 4 is a crude calibration scan showing five profiles taken at different horizontal

positions. This shows that MCP is severely damaged over the center and left parts of the aperture, but maintains good gain on the far right. The first profile actually is a broad beam peaked at about 4mm with the right tail amplified by a factor of three higher than the center and left of the profile.

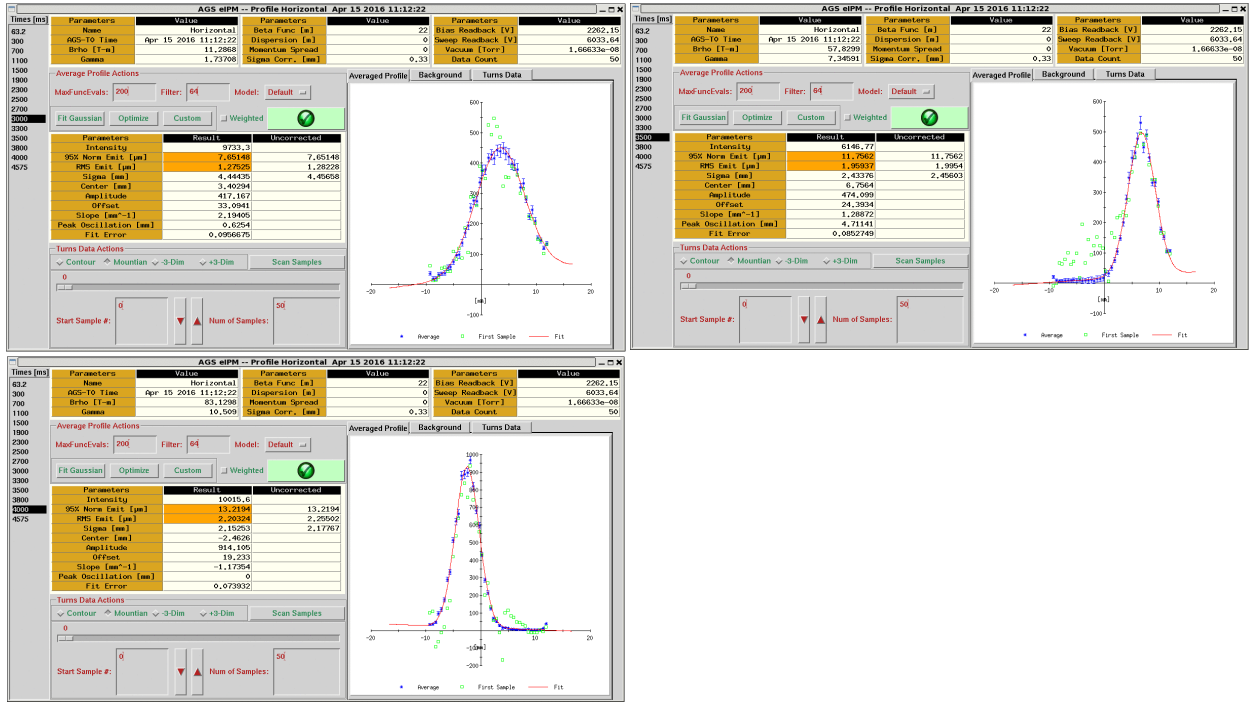
We constructed approximate gain correction values for channels 10-48 from the scan. Below is a calibration scan after these first corrections were applied. Also are profiles after corrections at the same times as those above. The profile at 3.0s is Gaussian and the beam sigmas decrease as the beam is accelerated.

These results show that the distorted profiles are caused by a severely damaged MCP from beam exposure. The damage is most severe in the MCP center. It is least damaged on the right side which is the inside of the AGS ring. The left side which is damaged is the outside of the ring where the beam is kicked for extraction.

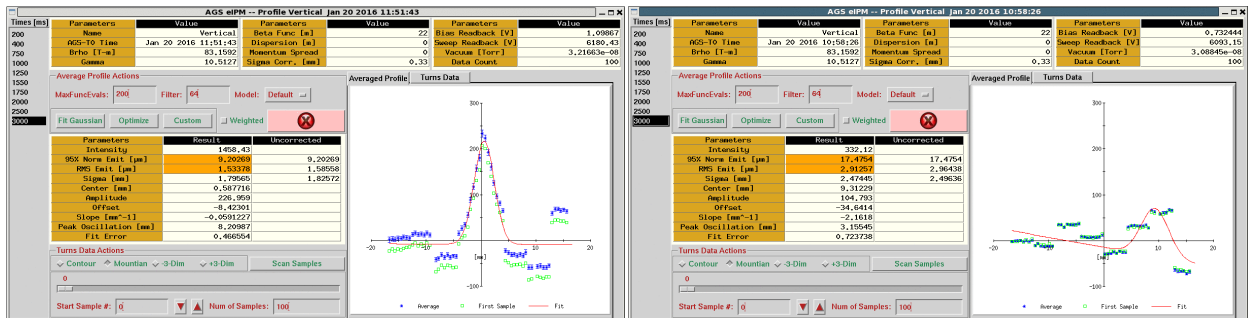
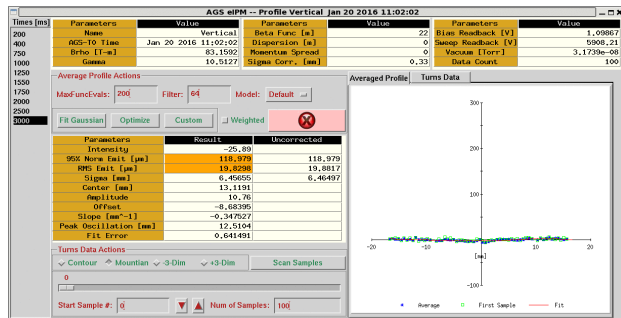
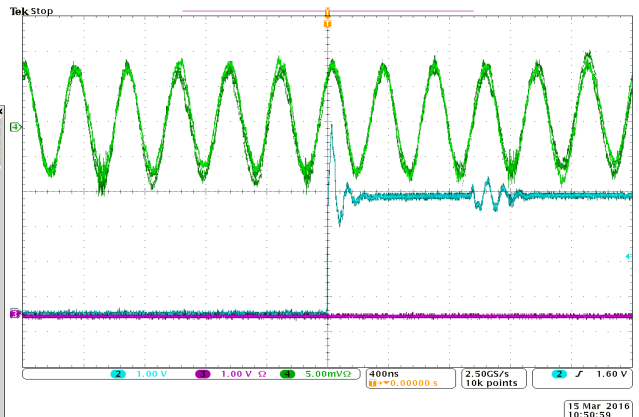
Before Run 16 started the dc offsets on the eIPM amplifiers were measured and corrections were entered into the Manager. When beam operations started we saw large dc offsets. These offsets appeared in groups of 8, corresponding to the 8-channel amplifier boards. For each board the dc offsets were about the same, but the value of the dc offsets were different for the eight amplifier boards. The left figure below shows a beam profile and the right figure shows the baseline with no beam. This 8-channel grouping of dc offsets is due to rf noise being picked up in the tunnel. The left figure in the second row shows the dc offsets with the acceleration rf turned off and the right figure shows the rf signal on one of the signal cables from the amplifiers in the tunnel to the digitizers in E10.

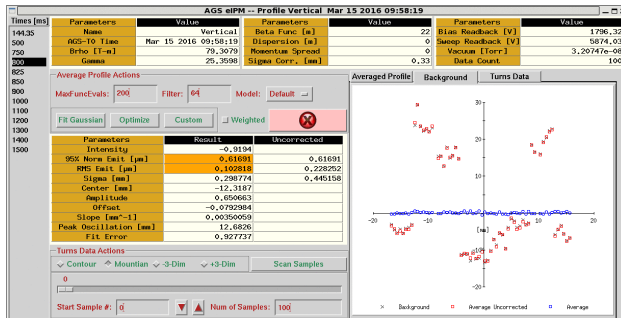
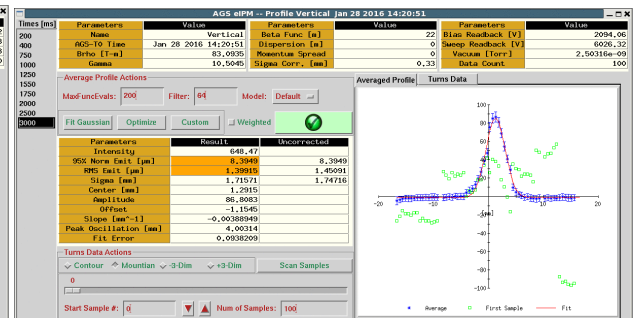
To correct the rf pickup we added active background subtraction in the manager. Each measurement now uses two machine cycles. One is done normally and one is done with the electron gate turned off. The "off" data are subtracted from the "on" data to produce a complete profile data set. An example of this is shown in the two figures below. The left figure shows the baseline with no beam and rf subtraction and the right figure shows a beam profile with background subtraction.

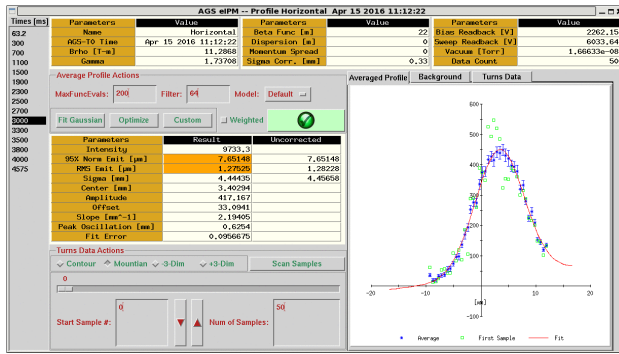
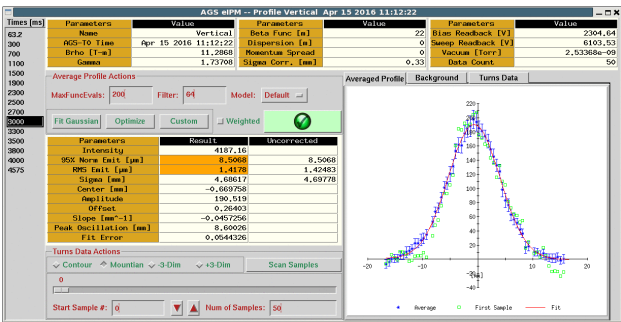
The rf background subtraction was implemented early in the run. After that the vertical eIPM gave good results, but there were still problems with horizontal. The biggest issue was the depleted MCP. The gain corrections implemented on April 12 brought the vertical and horizontal eIPMs into agreement, as shown in the figures below. The top pair are horizontal and vertical profiles of Au beam made just before acceleration on April 15 and the bottom pair are profiles from the deuteron beam at full energy on May 10.

One issue with the horizontal detector can be seen in the two left profiles. On April 15 we had all channels to the left of -10mm and to the right of +10mm removed from the data analysis. On both extremes of the detector we were getting anomalous signals which are not understood. This is seen in the left of the profile from May 10 with all of the channels enabled.

Profiles of Au beam at injection energy, April 15

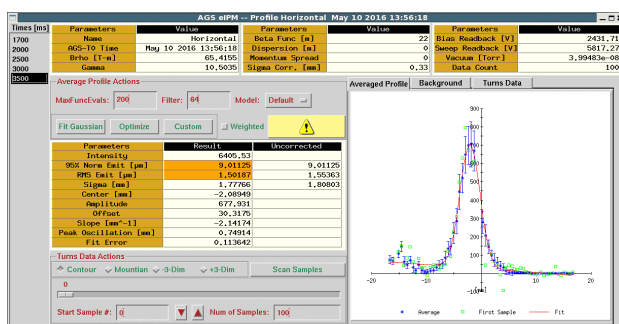
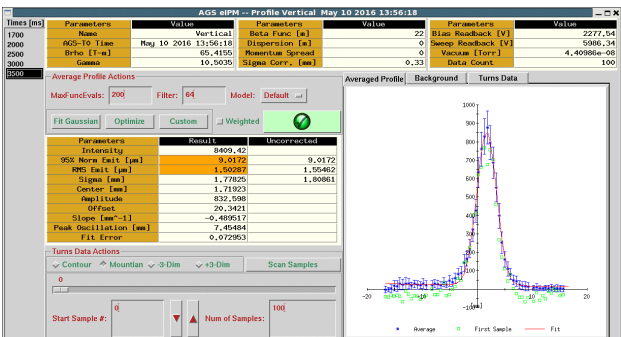
Profiles of deuteron beam at extraction energy, May 10

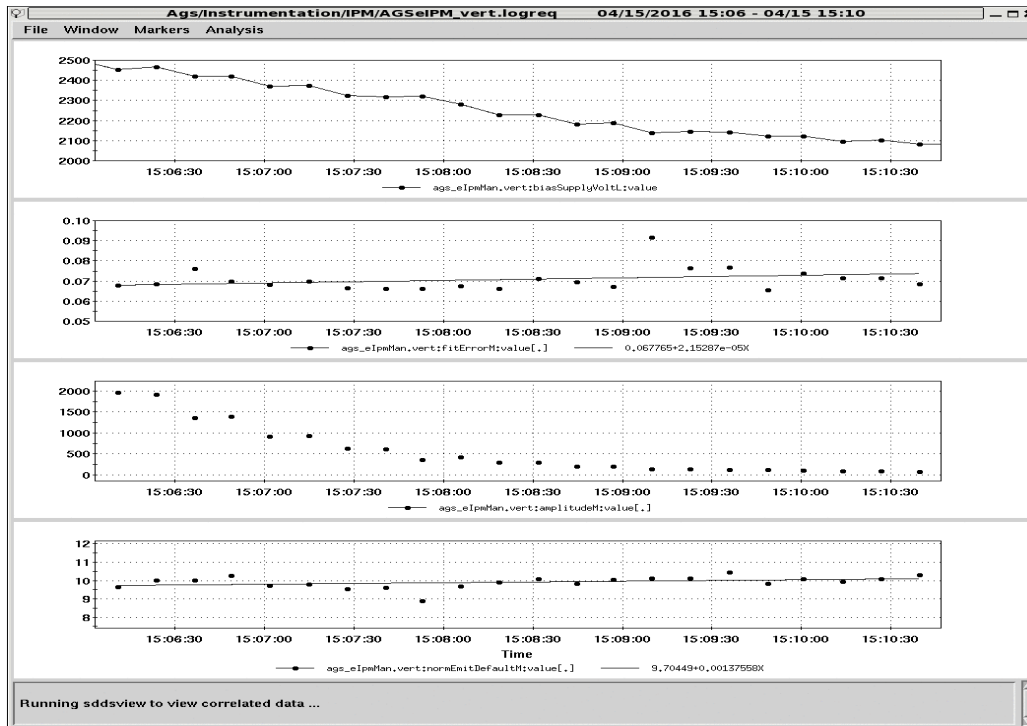
Finally we show a study where the MCP bias voltage was continuously lowered (top plot). This lowers the gain of the MCP resulting in lowering the profile amplitude from 2000 to 83 (third plot). Dropping the gain through the full range of the VME digitizers increases the measured emittance by only 4% (bottom plot) and increases the fit error from 0.068 to 0.074 (second plot).

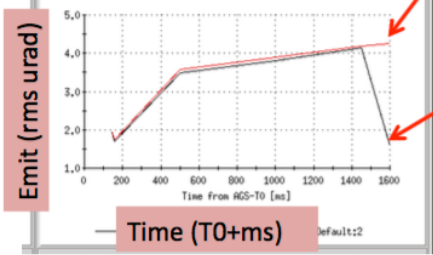
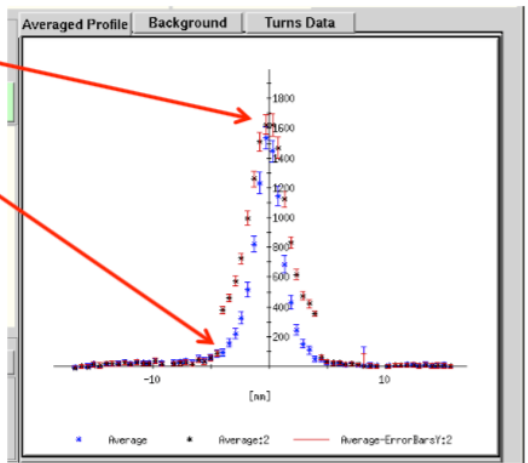
Vert eIPM

The surprise from this run was that the rf noise pickup had a different effect on the profile measurements than it had for the entire Run 16. For these three days, the rf had very little effect on the baseline but had a strong effect on the beam profile. This is seen in the first figure below. We noticed the measured emittance at full energy was about twice as large with the rf on than with it off (left). When the profiles were compared with beam centered on the vertical eIPM, the rf-on case shows the portion of the profile covered by the center two 8-channel amplifier groupings was raised and broadened compared to the rf-off case but the rest of the 8-channel groupings show no difference with rf on and off (right).

eIPM strongly affected by turning the RF on and off on the flattop

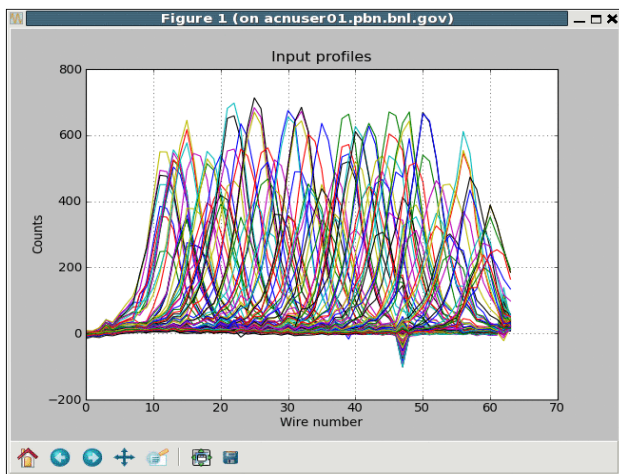
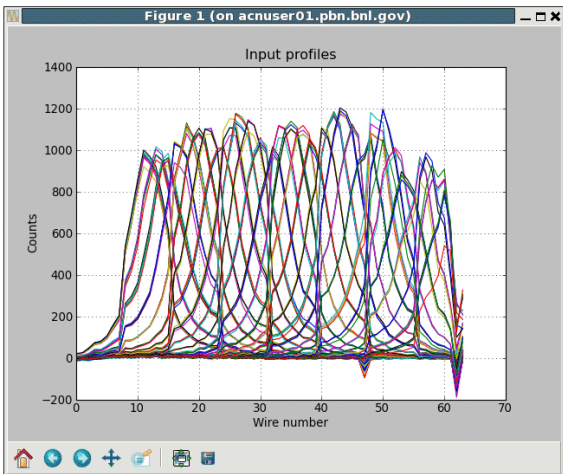
This pattern of profiles discontinuities at the breaks between the 8-channel amplifier groupings with the rf on appeared across the entire eIPM as shown here. The left figure shows a composite of all the profiles taken with rf off and the right figure shows the profiles with the rf on.

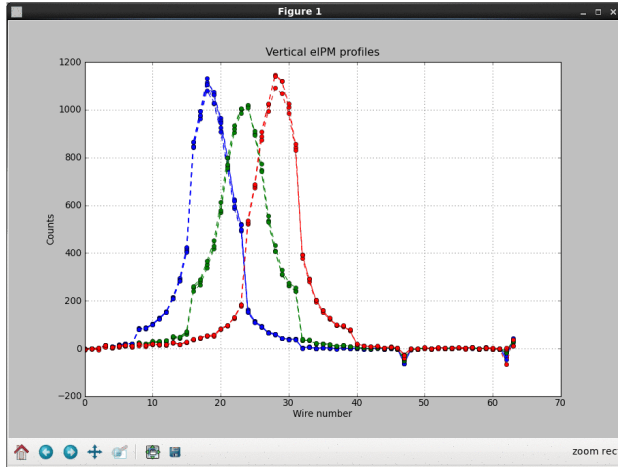
The figure above shows profiles of the beam with the beam in three positions in the vertical eIPM. There is a gain step between 8-channel amplifier boards and the size of the step increases as the profile amplitude gets larger. This behavior results in a position-dependent emittance as shown below. Here we plot the measured σ^2 vs. position of the center of the beam. This 8-channel gaps in the profile measurements was not seen in the rest Run 16 and it is not understood.

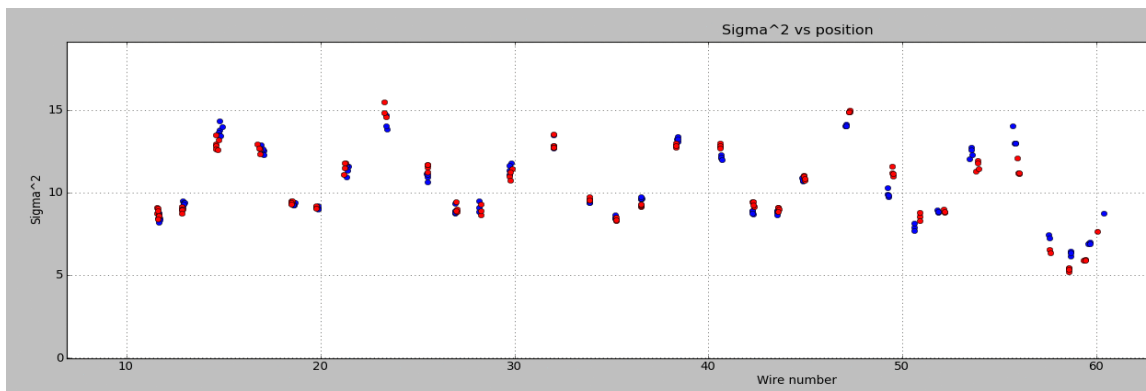
Measured σ^2 vs. position of the center of the beam

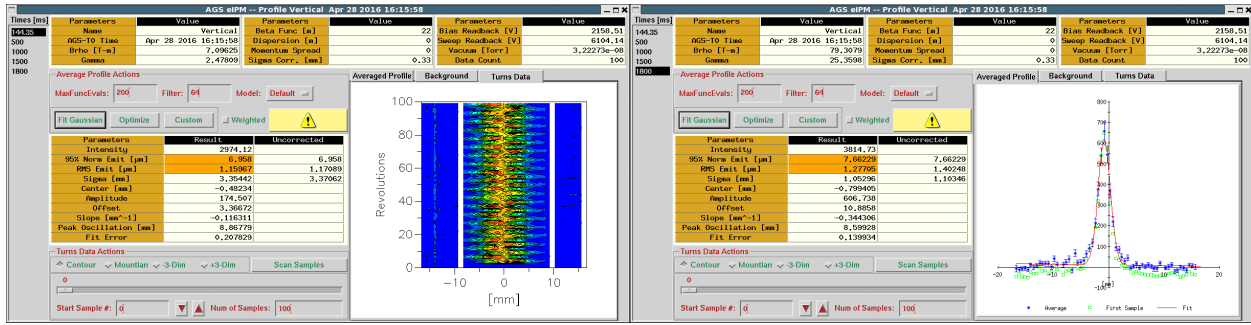
These two figures are proton-beam measurements made with the vertical eIPM on April 28, 2016. The left plot is a contour plot of the first 100 turns at injection (144ms past t_0) showing dipole oscillations. The right plot is the beam profile at top energy showing the measured beam sigma and the calculated beam emittance.

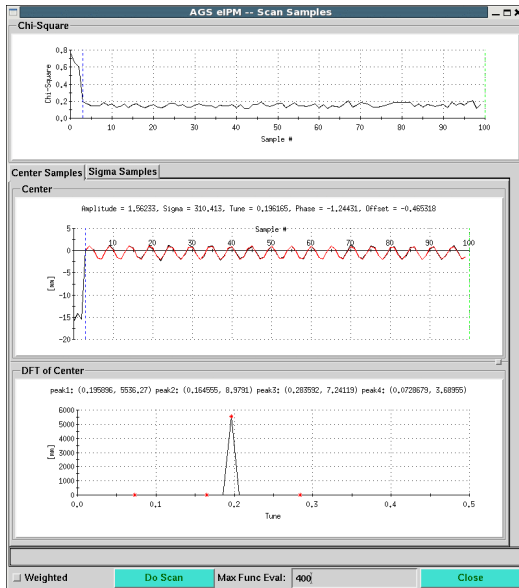
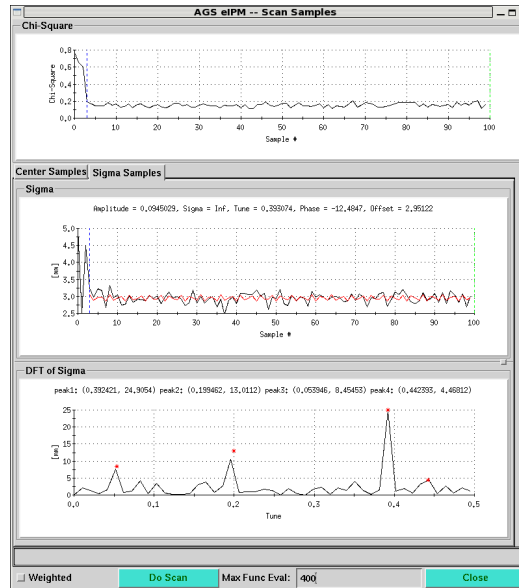
For a profile measurement, the digitizers are triggered on each turn for a set number of turns. These measurements used 100 turns of data. An emittance measurement is obtained by averaging all of the single-turn measurements. We also fit gaussian curves to each single-turn profile. We plot the measured beam centers vs. turn number (below left) and profile sigmas vs. turn number (below right) at injection, together with the discrete Fourier transforms of these signals. This gives peaks at the dipole and quadrupole frequencies.

We plan to optimize the injection match by changing steering and focusing in the BtA line to minimize the amplitudes of the dipole and quadrupole lines in the DFTs. We planned an experiment at the end of Run 16 to measure the effects of matching on the final emittance, but we ran out of time from beam problems. We will make these measurements in Run 17.
