C-A/AP/567
August 2016

**Run 16
eIPM Summary**

**R. Connolly, C. Dawson,
S. Jao, V. Schoefer, S. Tepikian**

**Collider-Accelerator Department
Brookhaven National Laboratory
Upton, NY 11973**

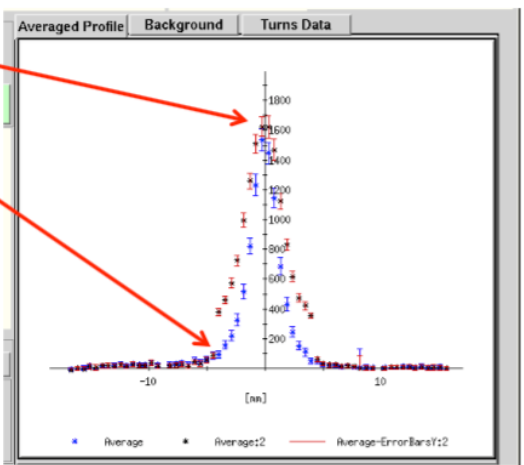
Vert eIPM

The surprise from this run was that the rf noise pickup had a different effect on the profile measurements than it had for the entire Run 16. For these three days, the rf had very little effect on the baseline but had a strong effect on the beam profile. This is seen in the first figure below. We noticed the measured emittance at full energy was about twice as large with the rf on than with it off (left). When the profiles were compared with beam centered on the vertical eIPM, the rf-on case shows the portion of the profile covered by the center two 8-channel amplifier groupings was raised and broadened compared to the rf-off case but the rest of the 8-channel groupings show no difference with rf on and off (right).

eIPM strongly affected by turning the RF on and off on the flattop

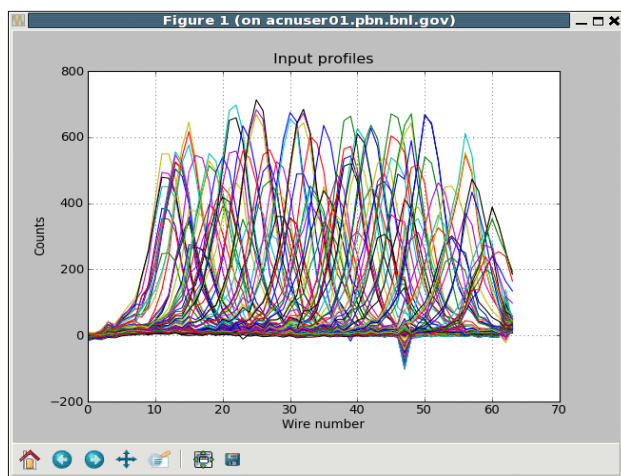
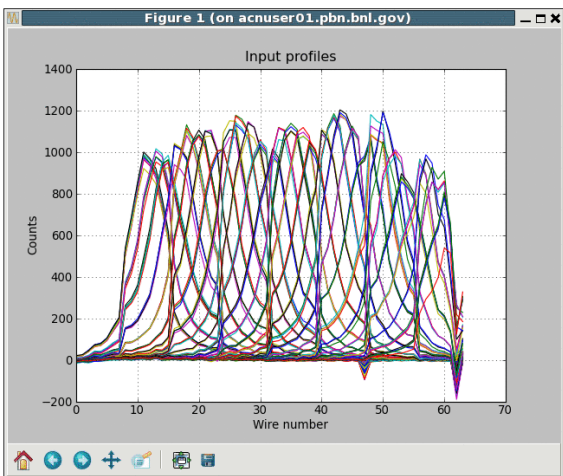
This pattern of profiles discontinuities at the breaks between the 8-channel amplifier groupings with the rf on appeared across the entire eIPM as shown here. The left figure shows a composite of all the profiles taken with rf off and the right figure shows the profiles with the rf on.

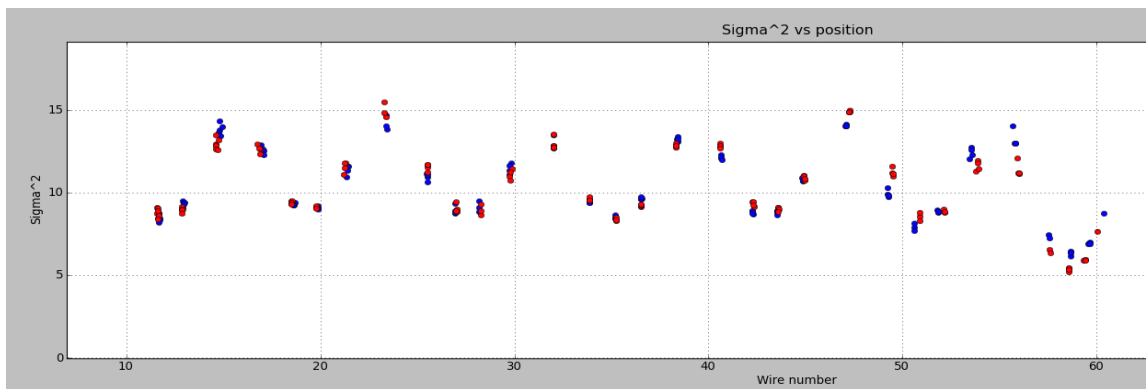
The figure above shows profiles of the beam with the beam in three positions in the vertical eIPM. There is a gain step between 8-channel amplifier boards and the size of the step increases as the profile amplitude gets larger. This behavior results in a position-dependent emittance as shown below. Here we plot the measured σ^2 vs. position of the center of the beam. This 8-channel gaps in the profile measurements was not seen in the rest Run 16 and it is not understood.

Measured σ^2 vs. position of the center of the beam
